## New Pipe Technology Helps Fish and Aquatic Life Swim Upstream

*Halton Region, Ontario, Canada*

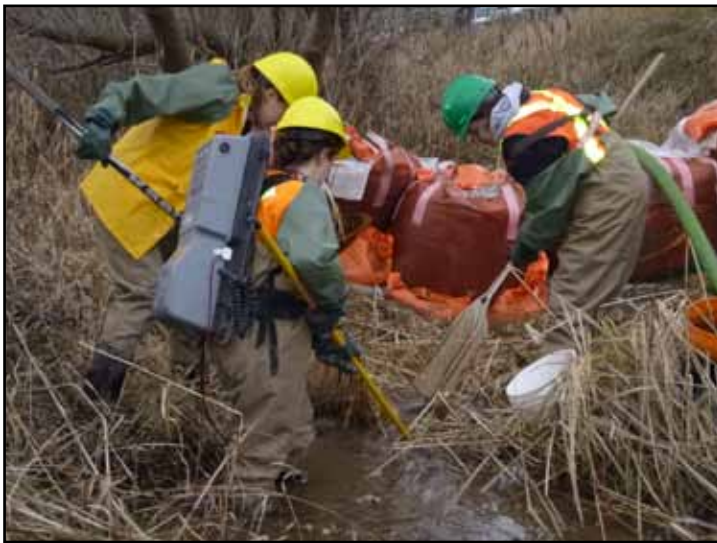
*The fish extraction specialist is shocking the water to stun the fish and bring them to the surface so they can be netted and relocated.*

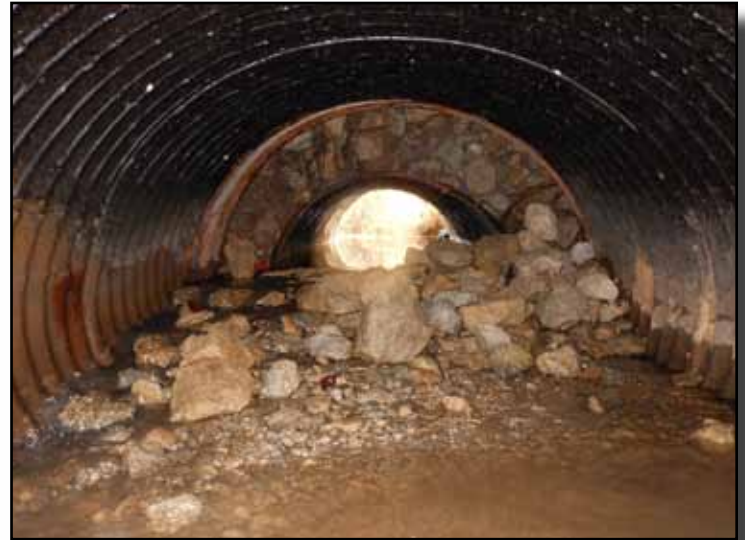
In the Canadian town of Milton, Ontario in Halton Region, an existing corrugated steel pipe (CSP) culvert was damaged. The CSP was located underneath Steeles Avenue and adjacent to railway tracks, approximately four meters deep. Steeles Avenue was starting to collapse at the shoulder where the 1,070 mm CSP separated and failed. As a result, a small sink hole opened up and grew larger due to the failure.

As CSP pipes age they become weaker and eventually lose their shape, especially as the backfill is undermined. In addition, CSP pipes put in the ground are joined by external bands. Generally the gauge or thickness of the material can be as much as half the thickness of the pipe itself, resulting in the joint being the weakest part, causing it to fail first.

*A view inside the failing structure at the joint.*

Provincial Underground Services Ltd. repaired the old CSP pipe by sliplining the new IOP pipe inside the old pipe. The IOP pipe was delivered in five meter sections with bell and spigot ends with gaskets providing leak-free joints. The Hydro-Bell was fused on to the end of one of the sections of IOP pipe, prior to being delivered to the jobsite. Finally, any annular space between the CSP and the IOP pipe was filled in with grout.

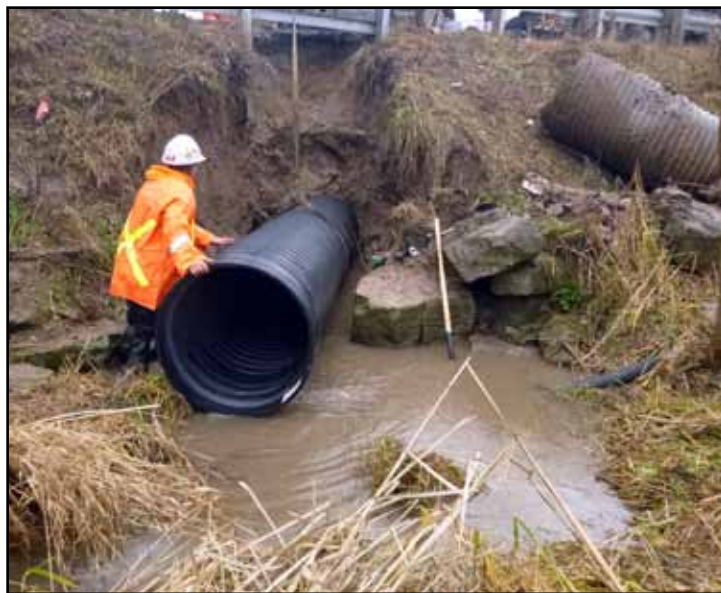
A view of the worksite from the upstream side. A piece of the failed CSP is removed and on the right side of the picture.

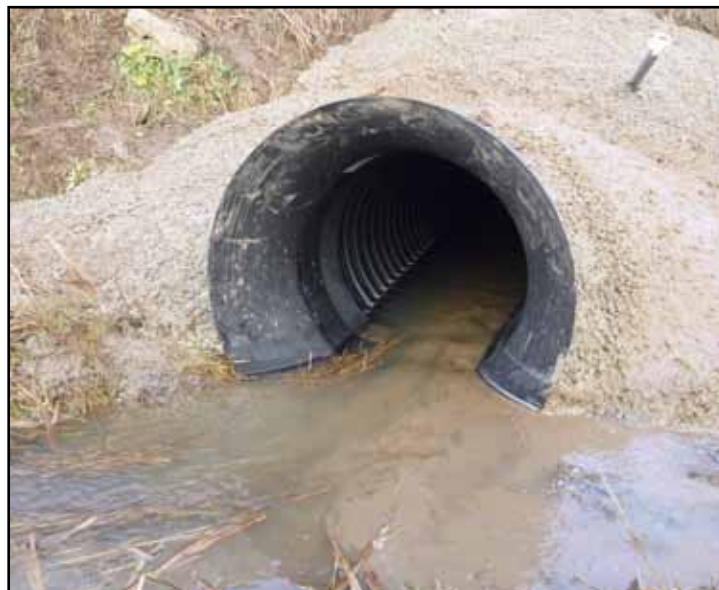
A view of the upstream side of the IOP pipe with the Hydro-Bell attached, after the project is completed.
