New Pipe Technology Helps Fish and Aquatic Life Swim Upstream

Halton Region, Ontario, Canada

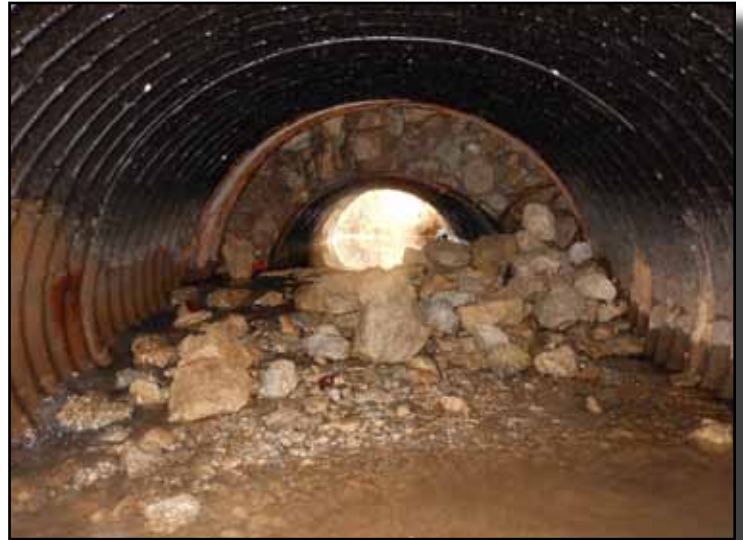
As CSP pipes age they become weaker and eventually lose their shape, especially as the backfill is undermined. In addition, CSP pipes put in the ground are joined by external bands. Generally the gauge or thickness of the material can be as much as half the thickness of the pipe itself, resulting in the joint being the weakest part, causing it to fail first.

A view inside the failing structure at the joint.

Provincial Underground Services Ltd. repaired the old CSP pipe by sliplining the new IOP pipe inside the old pipe. The IOP pipe was delivered in five meter sections with bell and spigot ends with gaskets providing leak-free joints. The Hydro-Bell was fused on to the end of one of the sections of IOP pipe, prior to being delivered to the jobsite. Finally, any annular space between the CSP and the IOP pipe was filled in with grout.

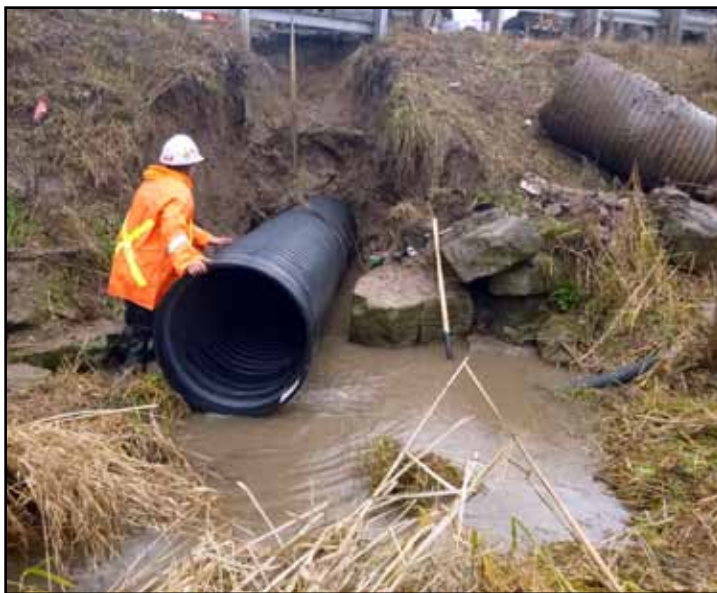
In the Canadian town of Milton, Ontario in Halton Region, an existing corrugated steel pipe (CSP) culvert was damaged. The CSP was located underneath Steeles Avenue and adjacent to railway tracks, approximately four meters deep. Steeles Avenue was starting to collapse at the shoulder where the 1,070 mm CSP separated and failed. As a result, a small sink hole opened up and grew larger due to the failure.

A view of the worksite from the upstream side. A piece of the failed CSP is removed and on the right side of the picture.

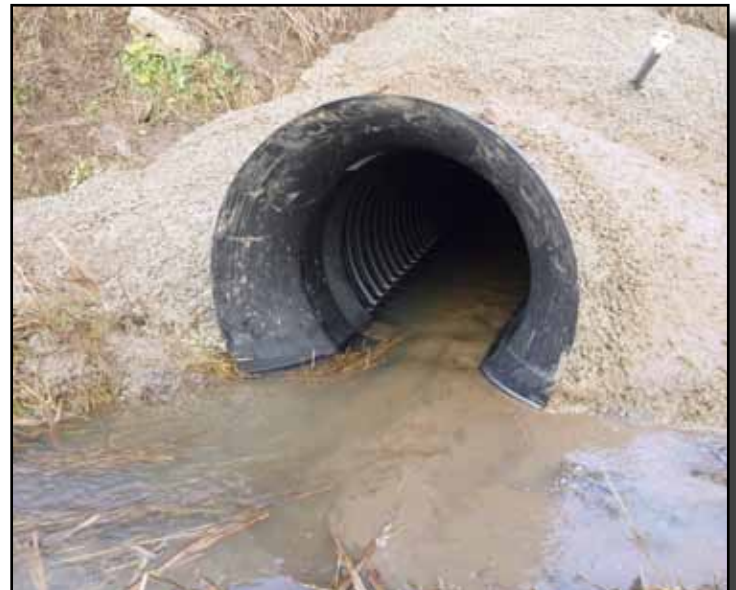
A view of the upstream side of the IOP pipe with the Hydro-Bell attached, after the project is completed.
