## Levee Pipe Relined with Large Diameter HDPE Pipe to Prevent Flooding

Prestonsburg, KY

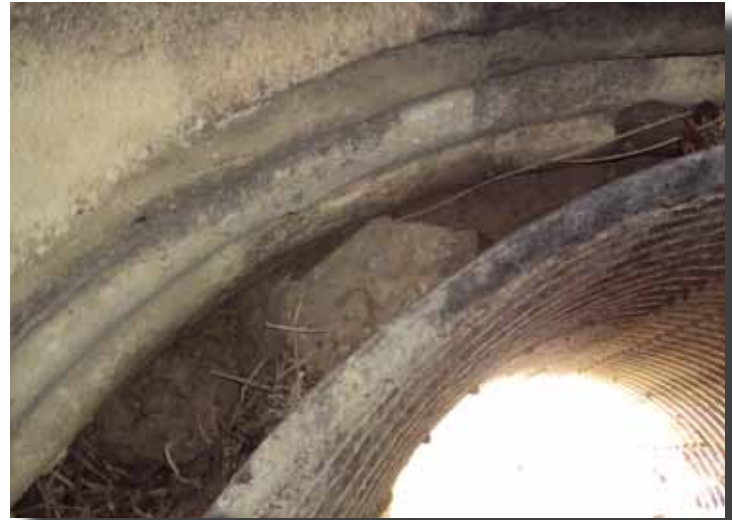
The poor condition of the 96-inch corrugated metal pipe (CMP) included several sections that were eroded or collapsing. If the pipe failed, which could happen at any moment in its current condition, the city would be flooded. A repair solution was urgent.

*The old levee culvert was damaged and failing in several areas of the length of the pipe. Flooding was a concern.*

Indiana Reline, the contractor, lined the 96-inch CMP with the 72-inch HDPE pipe. They electrofused the pipe at the joints and then slid it inside the old pipe. The use of electrofused joints assured a watertight seal. Finally, the contractor grouted any annular space between the old CMP and the new profile wall pipe.

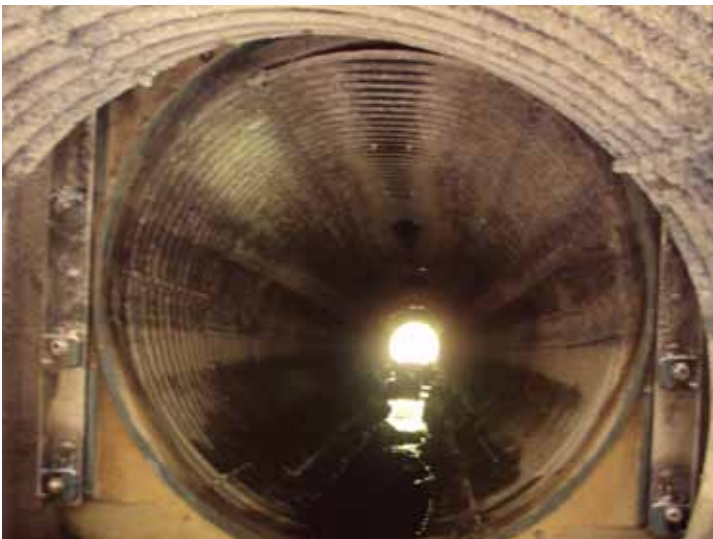
*Parts of the old culvert were collapsing. Repair was essential to prevent flooding.*

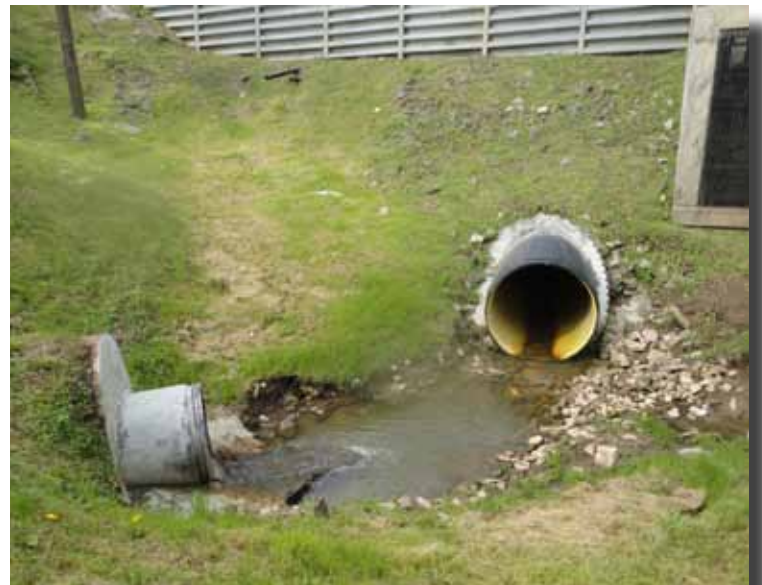
Relining the CMP culvert was the best option because it eliminated the need to dig and replace the old pipe. There was no excavation necessary of the pipe or the area surrounding the levee. Once the pipe was relined, the flow through the pipe was increased by 19 percent.

*Once the culvert was relined, the flow through the culvert improved.*
