## Popular Alaskan Park Relines 19 Culverts

*Auke Bay, Juneau, Alaska*

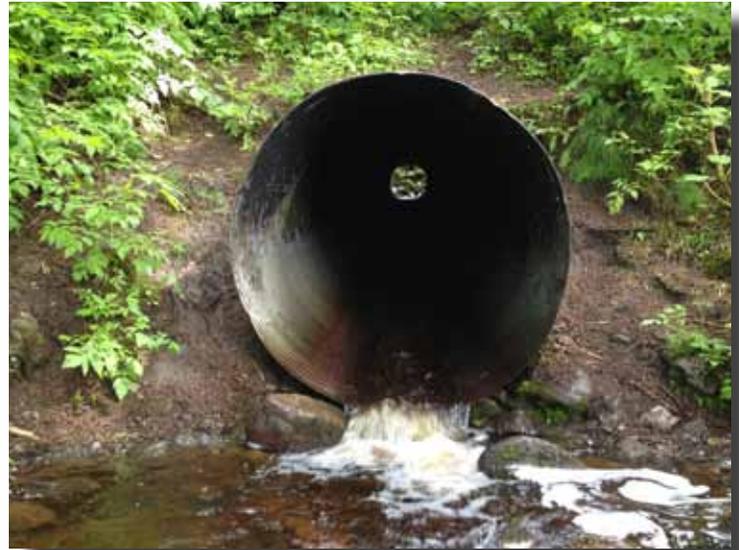
There were 19 aging culverts located underneath a public access road that leads to the Auke recreational area. One of the culverts serves as a stream that drains into the Auke Bay through the park, while the other 18 culverts serve as drainage pipes under the roadway. The culverts ranged in size from 24-inch to 60-inch in diameter, with a total of 1200 linear feet. The 70-year-old culverts, though still intact, were badly deteriorated, visibly rusting at the invert. This was a problem because the road above the culverts was the sole access to the popular park.

*One of the deteriorated culverts.*

During installation for each of the culverts, the contractor first inserted one end of the Snap-Tite pipe into the damaged culvert. Next, the other end was "snapped" on to a new piece of Snap-Tite pipe, joining the male and female ends together. The process continued until each culvert was fully lined with the new Snap-Tite pipe. Finally, any annular space between the old culverts and new liner was filled in with grout. The contractor did not have to dig up or disturb the road in order to restore any of the damaged pipes.

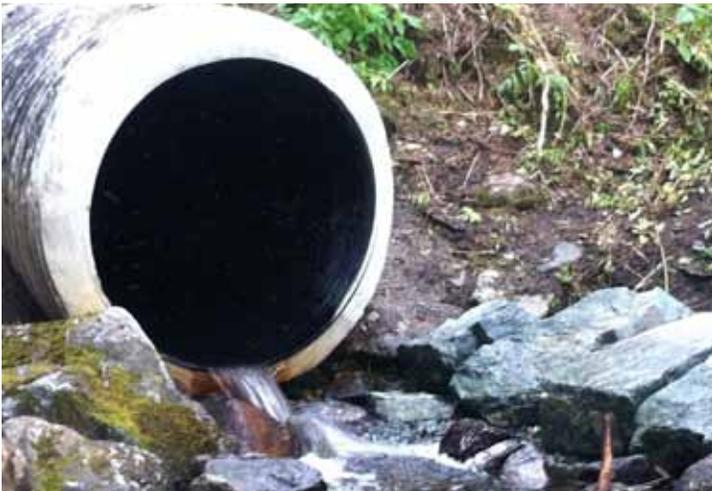
*Culvert relined with Snap-Tite pipe.*

The culvert that serves as a stream measured 60 inches in diameter and 100 feet in length. It was lined with 54-inch Snap-Tite pipe. The other culverts were lined with various sizes of Snap-Tite pipe ranging from 24 to 36 inches, with lengths averaging around 70 feet.
