Popular Alaskan Park Relines 19 Culverts

Auke Bay, Juneau, Alaska

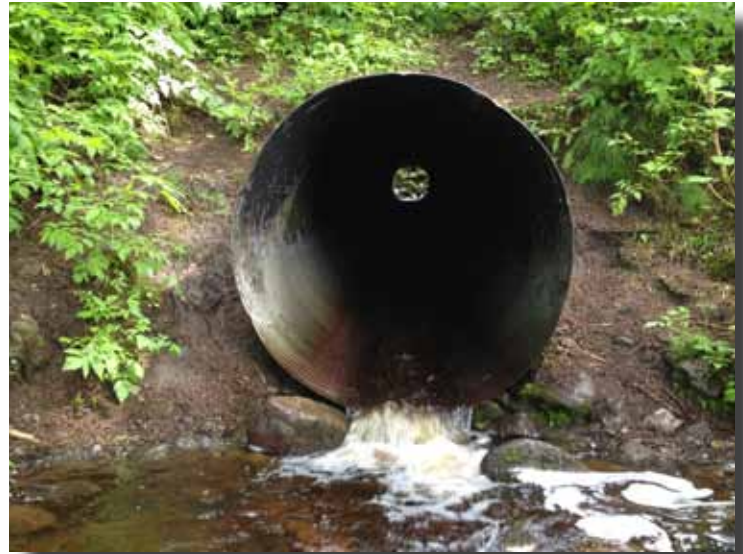
There were 19 aging culverts located underneath a public access road that leads to the Auke recreational area. One of the culverts serves as a stream that drains into the Auke Bay through the park, while the other 18 culverts serve as drainage pipes under the roadway. The culverts ranged in size from 24-inch to 60-inch in diameter, with a total of 1200 linear feet. The 70-year-old culverts, though still intact, were badly deteriorated, visibly rusting at the invert. This was a problem because the road above the culverts was the sole access to the popular park.

One of the deteriorated culverts.

During installation for each of the culverts, the contractor first inserted one end of the Snap-Tite pipe into the damaged culvert. Next, the other end was "snapped" on to a new piece of Snap-Tite pipe, joining the male and female ends together. The process continued until each culvert was fully lined with the new Snap-Tite pipe. Finally, any annular space between the old culverts and new liner was filled in with grout. The contractor did not have to dig up or disturb the road in order to restore any of the damaged pipes.

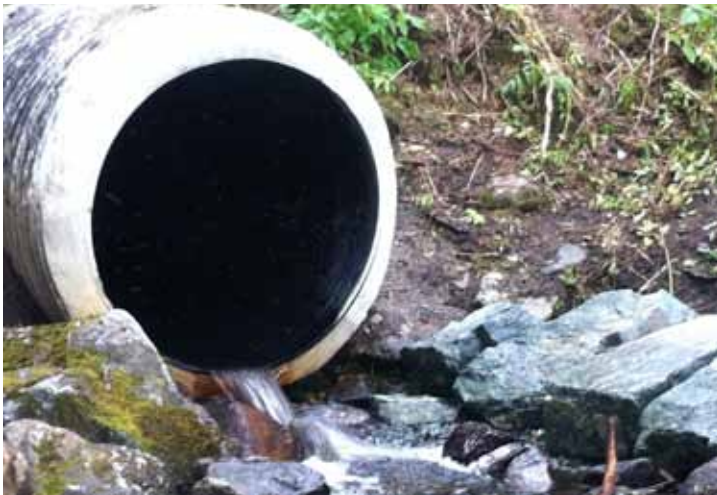
Culvert relined with Snap-Tite pipe.

The culvert that serves as a stream measured 60 inches in diameter and 100 feet in length. It was lined with 54-inch Snap-Tite pipe. The other culverts were lined with various sizes of Snap-Tite pipe ranging from 24 to 36 inches, with lengths averaging around 70 feet.
