## BOYNTON BEACH, FLORIDA CMP SPILLWAY

### Abstract

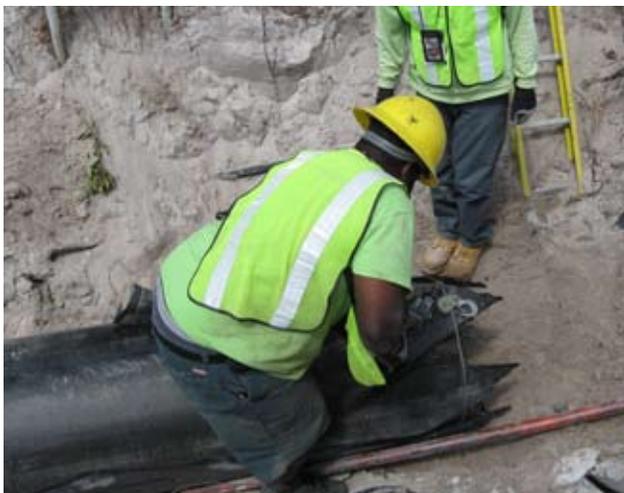
*The crew makes a nose cone out of Snap-Tite.*

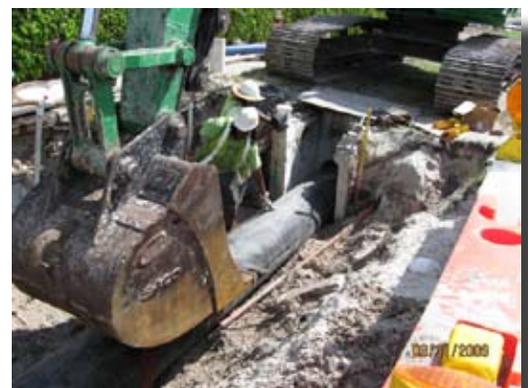
*Snap-Tite pipe pushed in the culvert.*

Under the direction of storm water superintendent, Louis Johnson, the crew cut a 30-inch opening through the back of the catch basin to insert the new 24-inch Snap-Tite pipe. The pipe was "snapped"

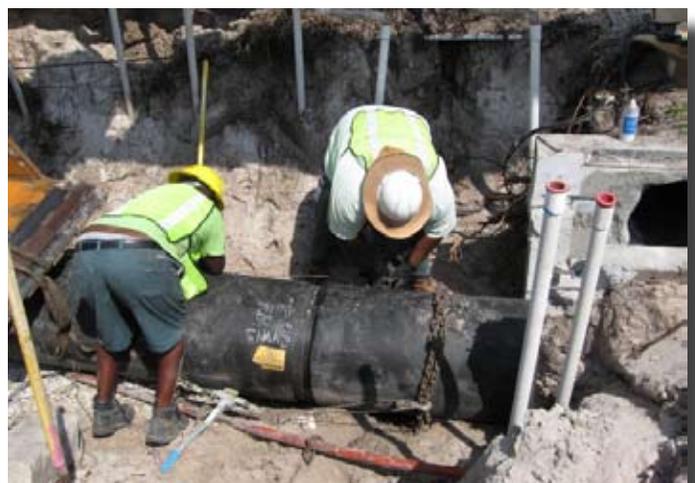
*The pipe "snapping" together.*

together in the trench and the crew pushed the 24-inch pipe easily through the opening of the severely deteriorated storm drain line. The installation process was completed in three days. Once the pipe was installed, the annular space between the new and old pipe was grouted with fly ash flowable fill.

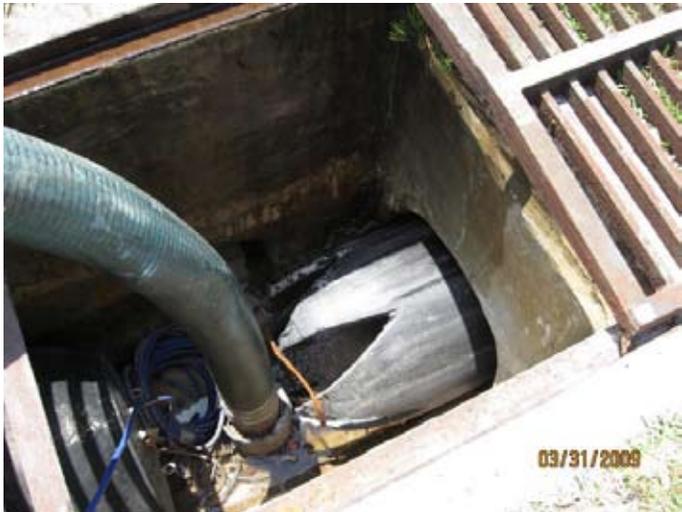
*The nose cone coming through the culvert.*

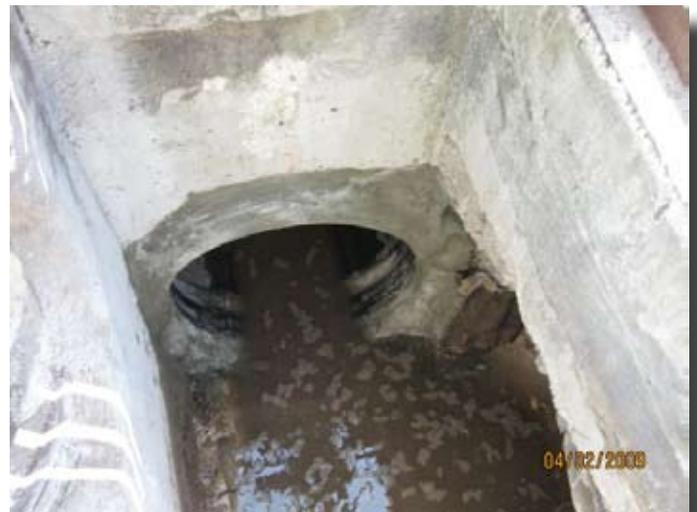
*The rehabilitated culvert, with water flowing through.*
