BOYNTON BEACH, FLORIDA CMP SPILLWAY

Abstract

The city of Boynton Beach, Florida had 384 feet of 30-inch deteriorated corrugated metal pipe (CMP) in use for under-the-road drainage. Corrosion causes CMP to fail. This corrosion creates voids and causes the road bedding to erode. This Field Report presents an application where the deteriorated culvert was replaced using Snap-Tite.

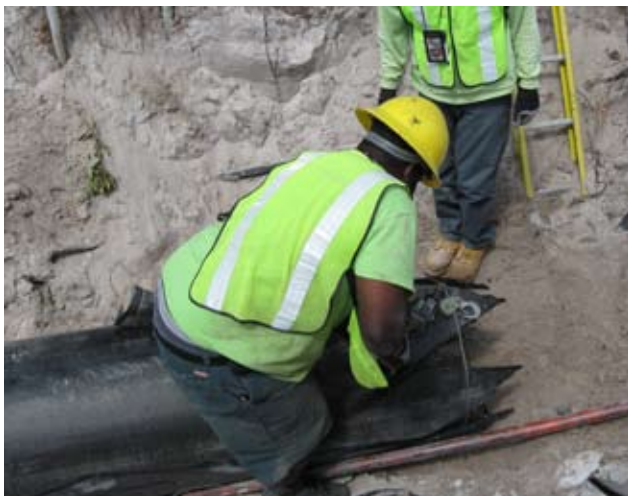
The crew makes a nose cone out of Snap-Tite.

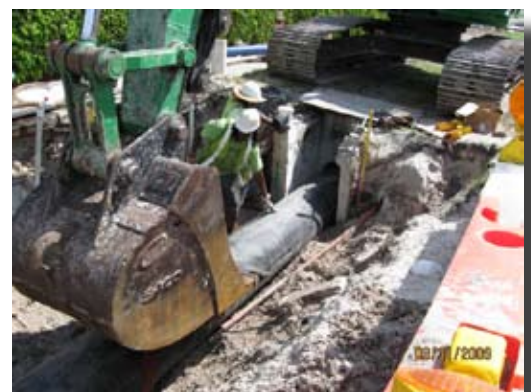
Snap-Tite pipe pushed in the culvert.

Under the direction of storm water superintendent, Louis Johnson, the crew cut a 30-inch opening through the back of the catch basin to insert the new 24-inch Snap-Tite pipe. The pipe was "snapped"

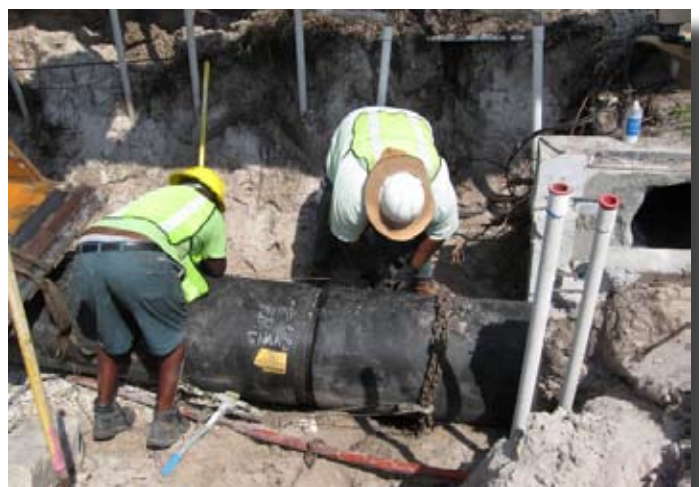
The pipe "snapping" together.

together in the trench and the crew pushed the 24-inch pipe easily through the opening of the severely deteriorated storm drain line. The installation process was completed in three days. Once the pipe was installed, the annular space between the new and old pipe was grouted with fly ash flowable fill.

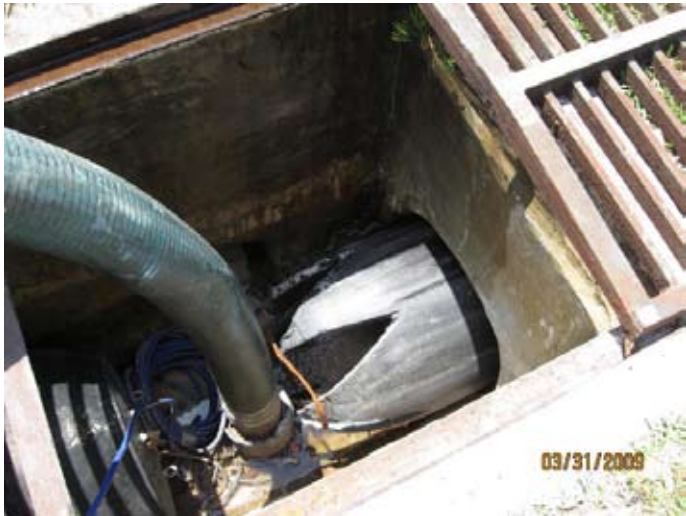
The nose cone coming through the culvert.

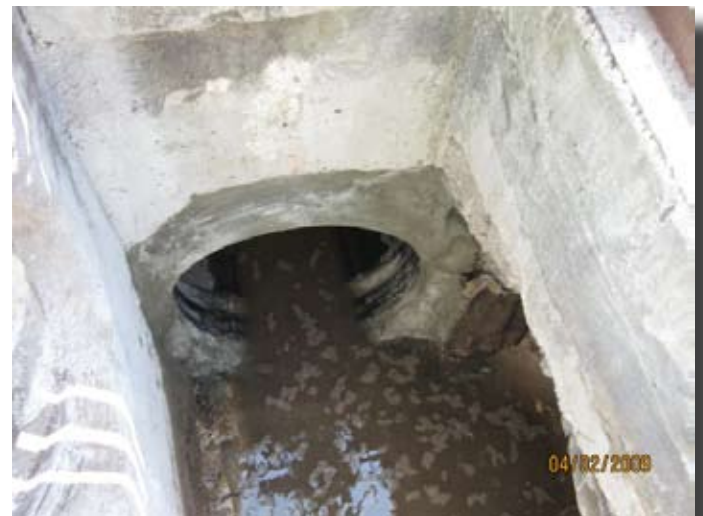
The rehabilitated culvert, with water flowing through.
