New Mexico DOT Saves Money and Time Relining Multiple Culverts with Snap-Tite HDPE Pipe

Carlsbad, NM

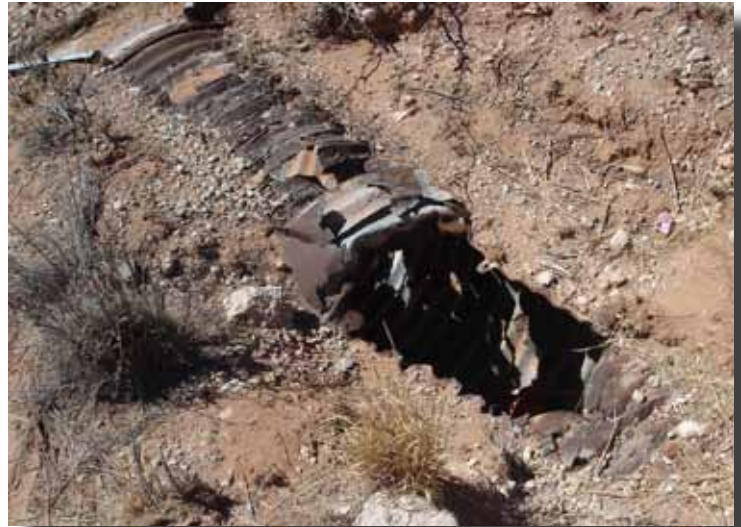
One of the deteriorated culverts underneath SR 31. This one is severely rusted and eroded on top.

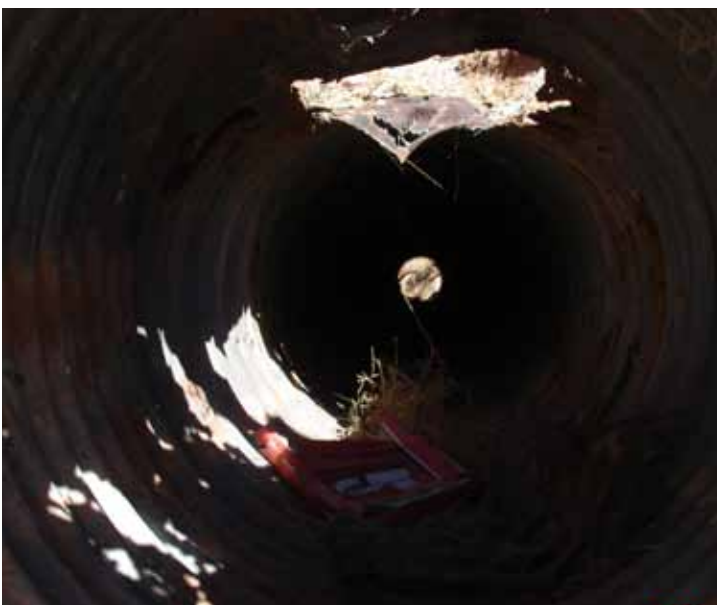
A view of the culvert from the inside. Note the hole at the top where the culvert has completely deteriorated and caved in on itself.

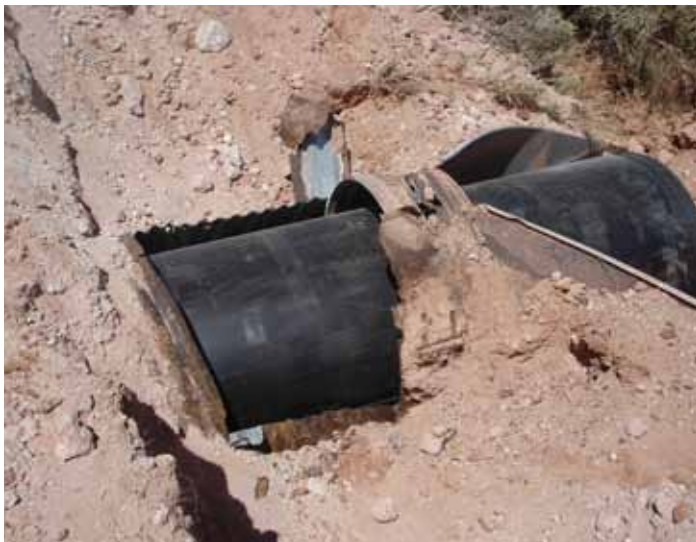
The Snap-Tite liner lengths are snapped together onsite and slid inside the deteriorated culverts. The Snap-Tite liner is going into another culvert that has disintegrated on top.

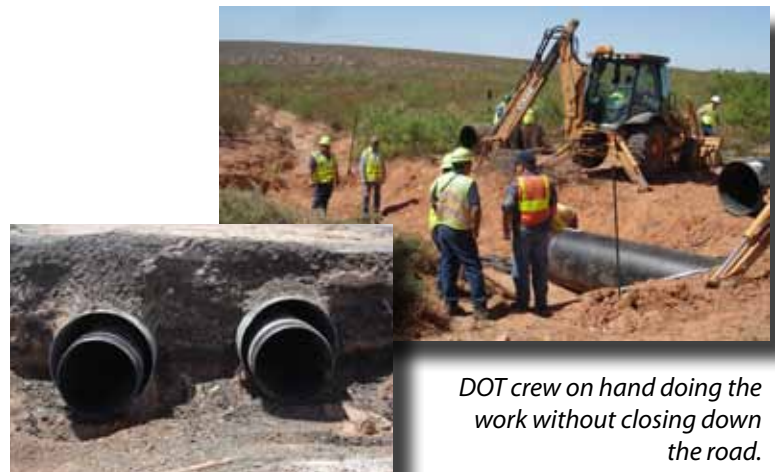
DOT crew on hand doing the work without closing down the road.

Two culverts side-by-side with the Snap-Tite liner in place, awaiting grout.
