Stormwater Management Pond Pipe Relined with the Snap-Tite Culvert Lining System

Columbia, Maryland

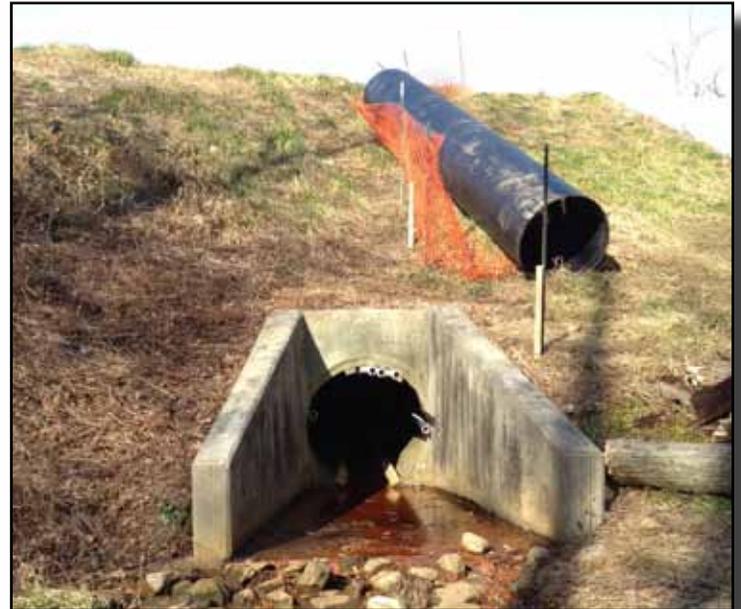
Snap-Tite pipe will be slid inside the old culvert during the installation process.

The Snap-Tite culvert lining system does not require any specialty equipment for installation. All the material that is needed to install the liner on site includes come-a-longs and chains. The come-a-longs and chains are used to snap the male and female machined ends of the Snap-Tite pipe together. The snapped pipe is then pushed inside the old culvert until it is fully lined with the new pipe. Then, the liner is grouted in place to fill

in annular space between the liner and old pipe.

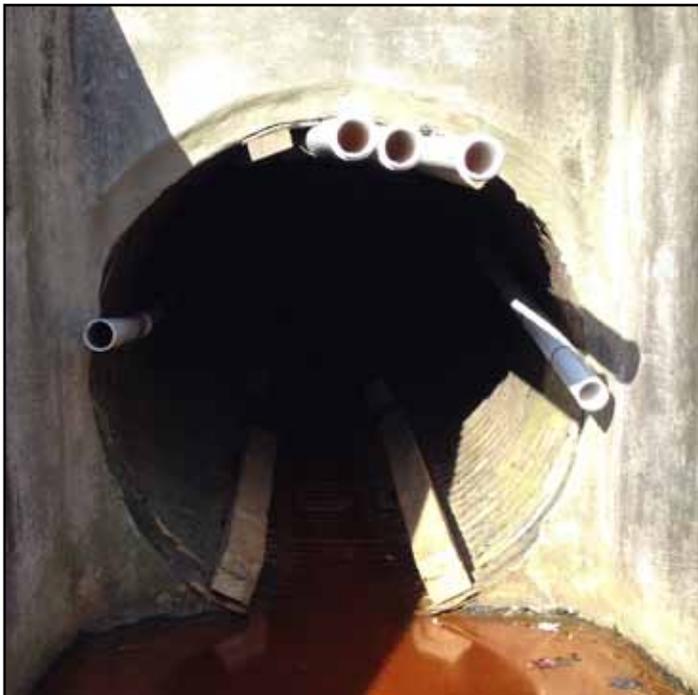
A stormwater management pond in Columbia, Maryland needed an upgrade to meet the Maryland Department of Environmental Protection (DEP) regulations. The main spillway pipe made of corrugated metal pipe had deteriorated and needed to be repaired or replaced. The large SWM pond is located in a very large and busy business park. Plus, the spillway pipe was deeply buried under a highly trafficked roadway. If traffic was disrupted due to construction it would interrupt the businesses and customers using the business park. Therefore, a method of repair such as digging and replacing the pipe was not an option. In addition, a dig and replace method would require digging a dam embankment, which could be costly.

The damaged culvert is readied for the relining process.
