## Snap-Tite® Chosen as a Quick, Cost-Effective Solution for Denver's Southeast Metro Stormwater Authority

*South Metro Denver, Colorado*

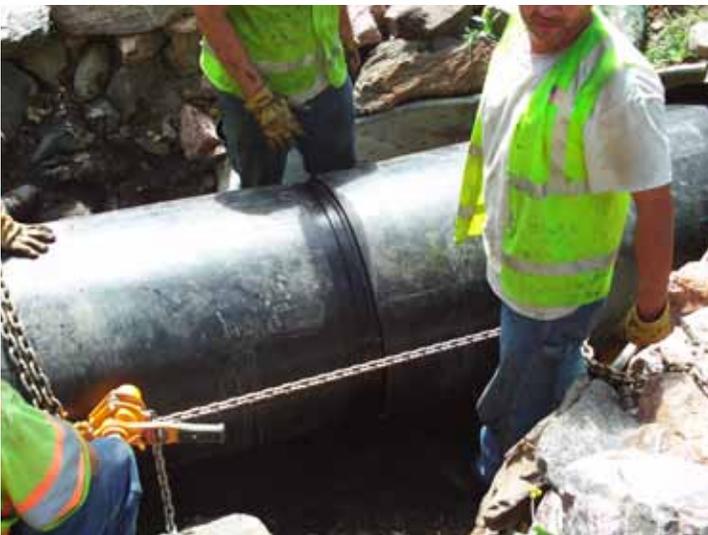
*SEMSWA crews join the Snap-Tite pipe sections using a come-along and chains.*

The SEMSWA crews were able to quickly move the 30-inch Snap-Tite pipe in place for lining the CMPs using a mini excavator. For each of the culverts, one section of Snap-Tite pipe was slid inside the old culvert. Then the next section was snapped on using a come-along and chains. This process was repeated for each culvert until the liner was in place from end-to-end. Finally, grout was used to fill in any annular space between the old wood culverts and the new pipe liner.

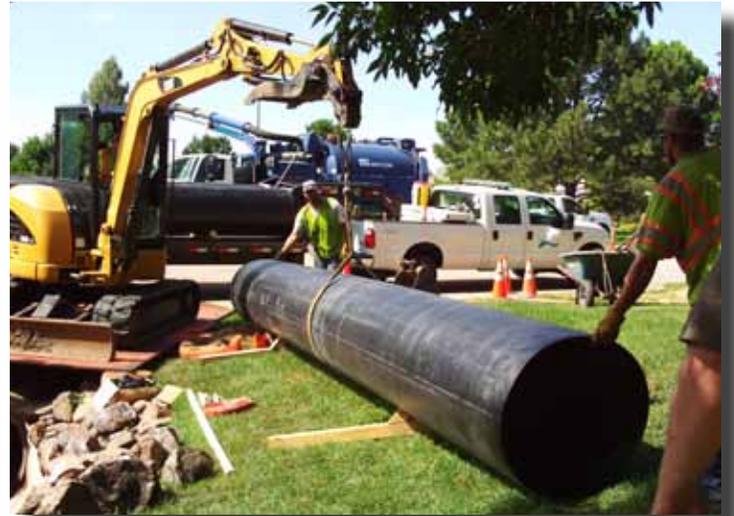
*The Snap-Tite pipe is moved in place to line the old CMP using a mini excavator.*

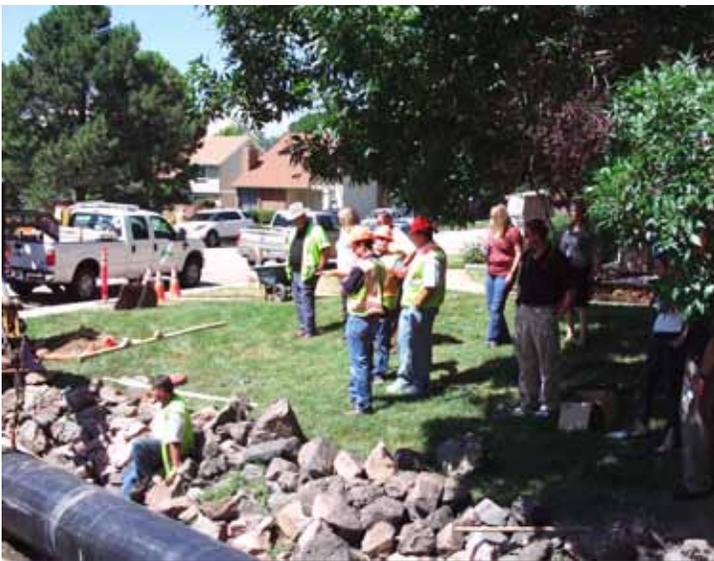
*Demonstration attendees view the first installation of the Snap-Tite pipe liner.*

The first relining project served as a Snap-Tite demonstration where other government agencies were invited to watch. Attendees included representatives from the Colorado DOT as well as some local contractors.

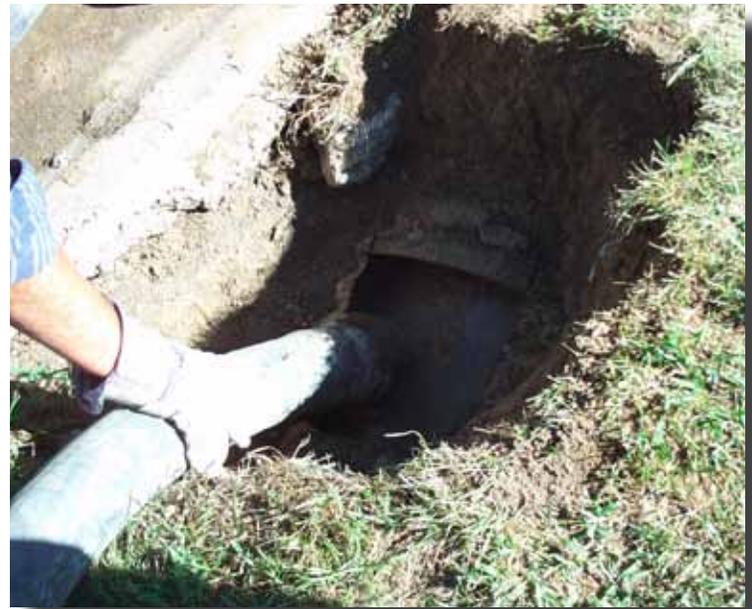
*Any annular space between the old CMP and the Snap-Tite pipe liner is filled in with grout.*
