County Keeps Newly Paved Road Intact Despite Failing Culvert Underneath

Douglas County, Kansas

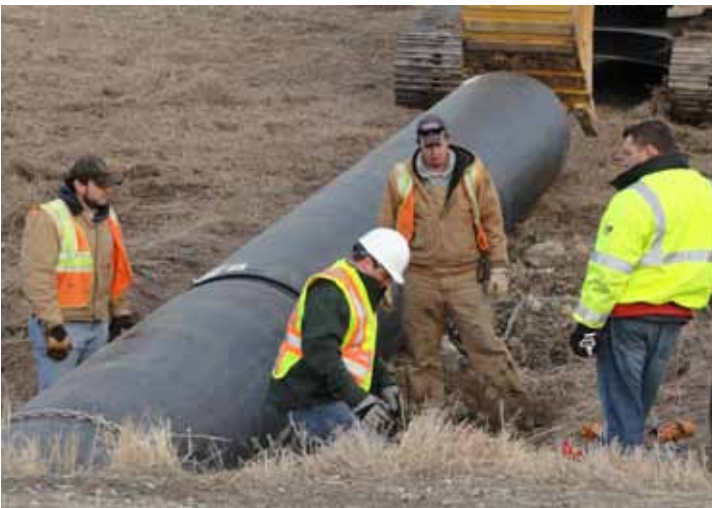
One section of the liner is first inserted into the CMP and then snapped to another section.

The no-dig HDPE Snap-Tite® culvert-lining pipe, which has a patented male/female machining at each end of the HDPE, is 'snapped' together,

piece-by-piece, and pushed into the full length of an existing pipe. Any annular space and voids between the old culvert and new liner are filled in with grout. The pipe liner is available in lengths from two feet to 50 feet, and is available for culverts with diameters from eight inches to 84 inches. Snap-Tite® also meets American Association of State Highway and Transportation Officials (AASHTO) Standard M326 for rehabilitating culverts.

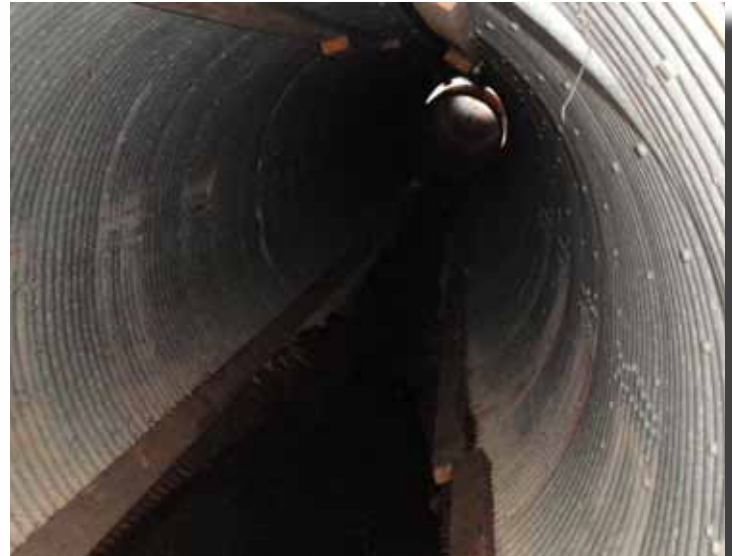
Inside the old CMP culvert, showing signs of wear and deflection.

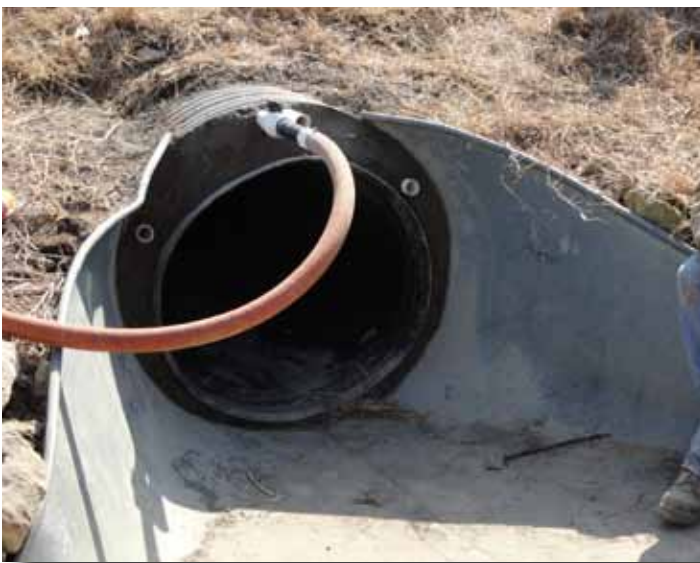
Grout is pumped in to fill in any voids in the annular space between the liner and CMP.

Cooney and Perkins decided to also showcase the installation as a demonstration for local county personnel, contractors and engineers. The installation began at 8 a.m. and by 9:30 a.m. that day, all the pipe had been snapped and pushed through the existing pipe. At 10:30 a.m. the crew built both of the bulkheads needed to pump grout into the space between the old culvert and new Snap-Tite® pipe. The ready-mix trucks for the grout arrived in the afternoon and the pipe and liner were grouted in place, also on the same day.
