## County Keeps Newly Paved Road Intact Despite Failing Culvert Underneath

*Douglas County, Kansas*

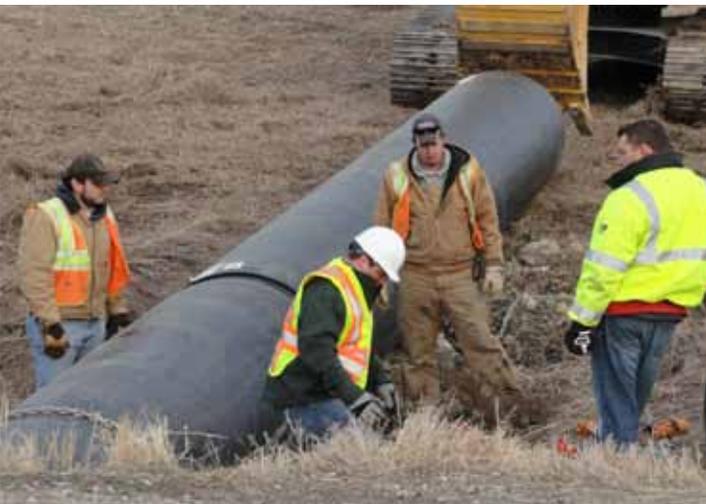
*One section of the liner is first inserted into the CMP and then snapped to another section.*

The no-dig HDPE Snap-Tite® culvert-lining pipe, which has a patented male/female machining at each end of the HDPE, is 'snapped' together,

piece-by-piece, and pushed into the full length of an existing pipe. Any annular space and voids between the old culvert and new liner are filled in with grout. The pipe liner is available in lengths from two feet to 50 feet, and is available for culverts with diameters from eight inches to 84 inches. Snap-Tite® also meets American Association of State Highway and Transportation Officials (AASHTO) Standard M326 for rehabilitating culverts.

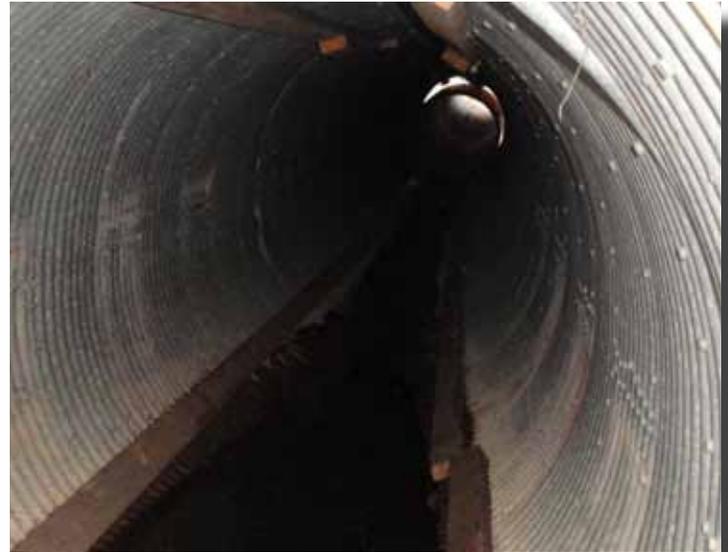
In Douglas County, Kansas, a 48-inch diameter, 82-foot long corrugated metal pipe (CMP) culvert started to fail. The culvert was located under a newly-paved road. The Douglas County Department of Public Works had to act quickly to repair the culvert without digging up or disturbing the road above.

*Inside the old CMP culvert, showing signs of wear and deflection.*

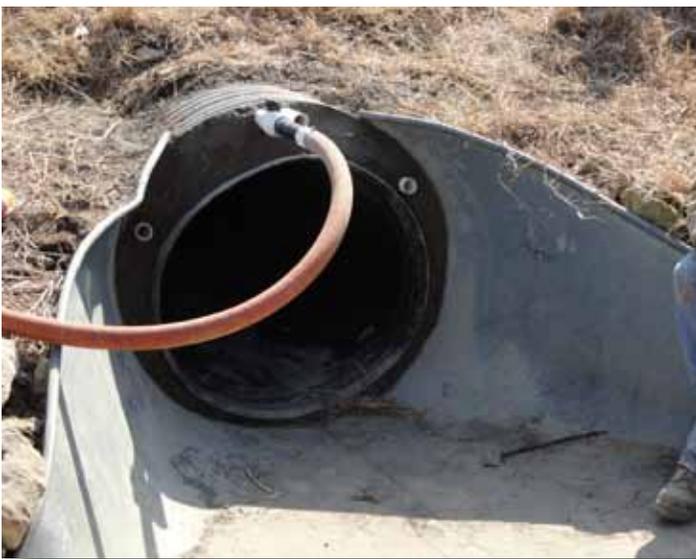
*Grout is pumped in to fill in any voids in the annular space between the liner and CMP.*

Cooney and Perkins decided to also showcase the installation as a demonstration for local county personnel, contractors and engineers. The installation began at 8 a.m. and by 9:30 a.m. that day, all the pipe had been snapped and pushed through the existing pipe. At 10:30 a.m. the crew built both of the bulkheads needed to pump grout into the space between the old culvert and new Snap-Tite® pipe. The ready-mix trucks for the grout arrived in the afternoon and the pipe and liner were grouted in place, also on the same day.
