Residential Property Left Undisturbed with Culvert Lining Solution

Franklin, Tennessee

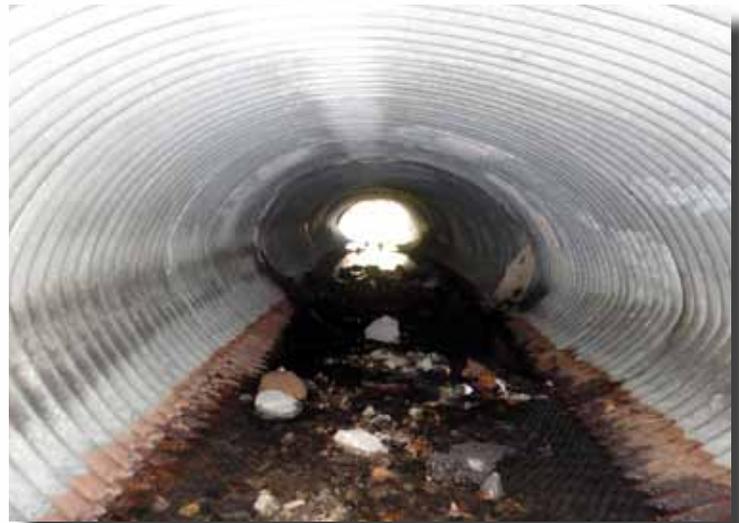
The original culvert was corroded and in bad shape. It was located in a residential neighborhood so if it failed it could compromise the foundation of some homes.

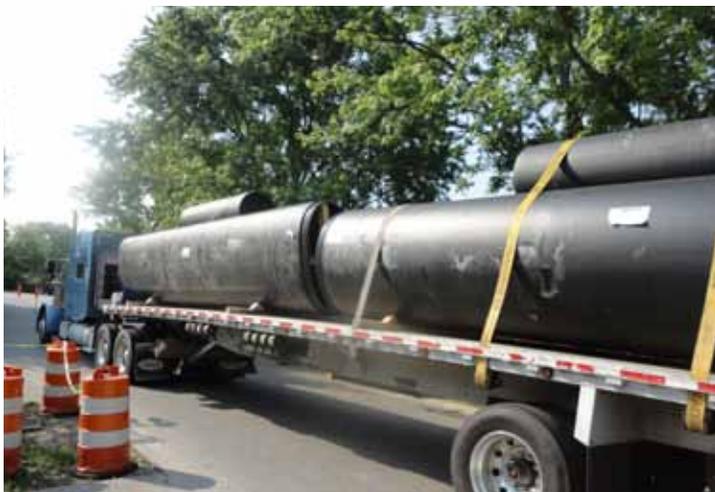
Snap-Tite supplied sections of ovalled Snap-Tite HDPE pipe to line the oval culvert. Snap-Tite delivered a total of 190 feet of pipe.

Snap-Tite pipe is made of high-density polyethylene (HDPE) pipe. Because of the flexibility of HDPE pipe, Snap-Tite has the ability to oval round pipe. Since the original pipe was 68 by 38 inches, Harrington suggested ovaling a 48-inch Snap-Tite pipe to make it easier to slip-line into the old culvert. For this project, the 48-inch pipe was ovalled to a diameter of 59 by 34 inches. Snap-Tite supplied 190 feet total of the ovalled pipe, provided in sections to be snapped together on site.

A unique feature of Snap-Tite is that it does not require fusion to join the HDPE pipe together. The ends of the Snap-Tite pipe are machined on each end. The machined male and female ends are then “snapped” together, piece-by-piece, on site using come-a-longs and chains. Once the pipe is joined, it is slipped inside the

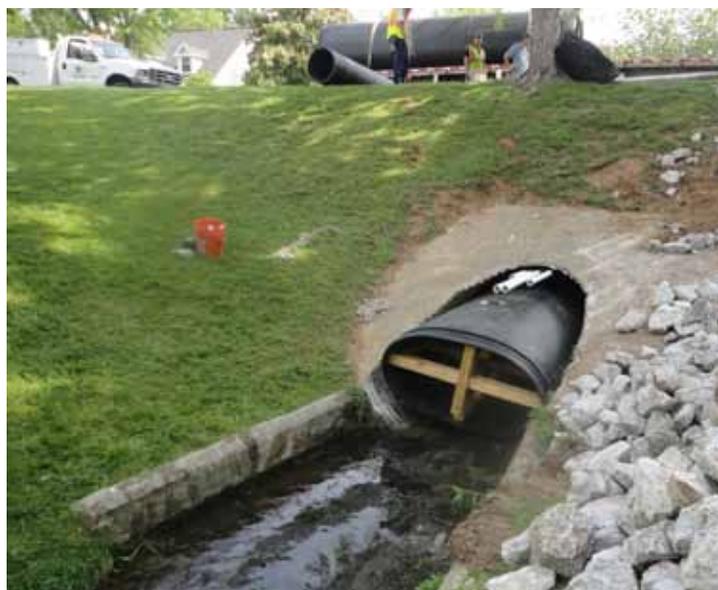
The Snap-Tite pipe liner was slip-lined into the old culvert one section at a time. Each section was snapped together using a come-a-long and chains.

During installation, the crew slid the first section of oval Snap-Tite pipe liner into the oval culvert. Then they snapped a second section of Snap-Tite pipe onto the first pipe liner section using only come-a-longs and chains. This was repeated until all sections of pipe were snapped and pushed through the old CMP culvert. Once the CMP was fully lined, grout was used to fill in any annular space or voids between the CMP and the pipe liner.
