Residential Property Left Undisturbed with Culvert Lining Solution

Franklin, Tennessee

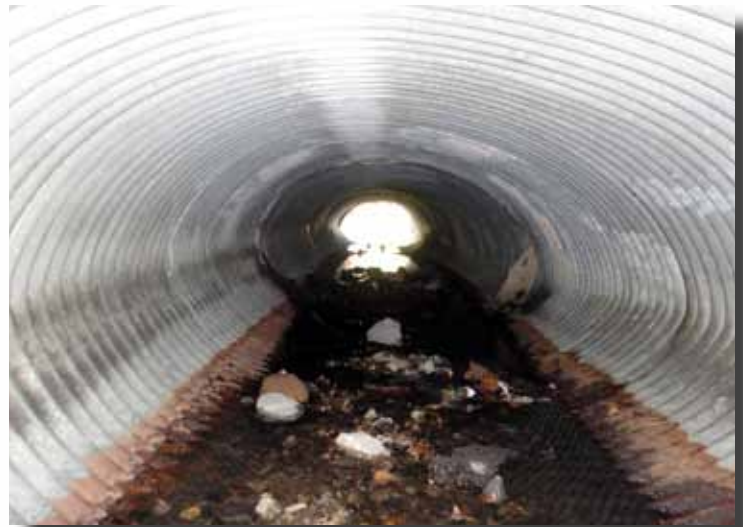
The original culvert was corroded and in bad shape. It was located in a residential neighborhood so if it failed it could compromise the foundation of some homes.

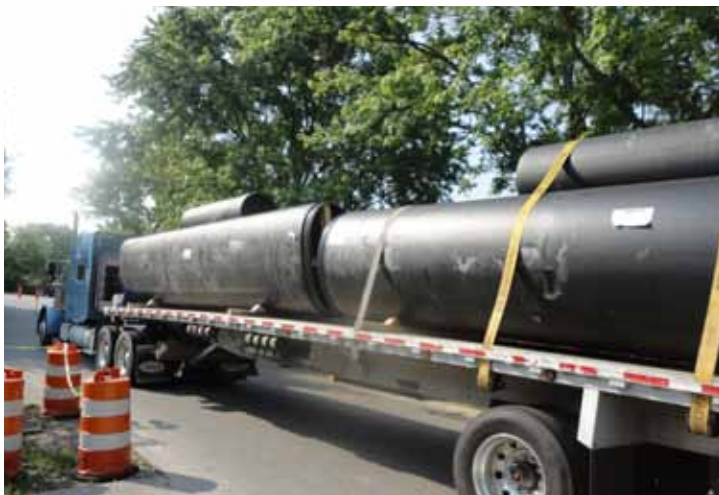
Snap-Tite supplied sections of ovalled Snap-Tite HDPE pipe to line the oval culvert. Snap-Tite delivered a total of 190 feet of pipe.

Snap-Tite pipe is made of high-density polyethylene (HDPE) pipe. Because of the flexibility of HDPE pipe, Snap-Tite has the ability to oval round pipe. Since the original pipe was 68 by 38 inches, Harrington suggested ovaling a 48-inch Snap-Tite pipe to make it easier to slip-line into the old culvert. For this project, the 48-inch pipe was ovalled to a diameter of 59 by 34 inches. Snap-Tite supplied 190 feet total of the ovalled pipe, provided in sections to be snapped together on site.

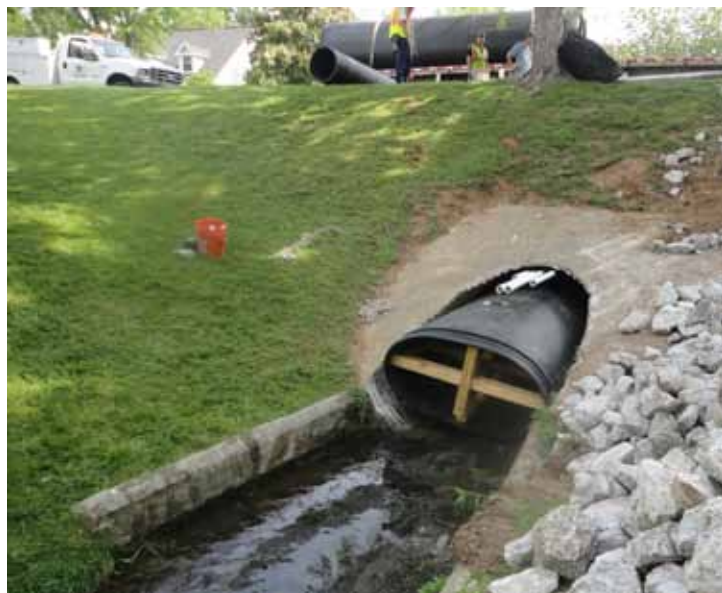
The Snap-Tite pipe liner was slip-lined into the old culvert one section at a time. Each section was snapped together using a come-a-long and chains.

During installation, the crew slid the first section of oval Snap-Tite pipe liner into the oval culvert. Then they snapped a second section of Snap-Tite pipe onto the first pipe liner section using only come-a-longs and chains. This was repeated until all sections of pipe were snapped and pushed through the old CMP culvert. Once the CMP was fully lined, grout was used to fill in any annular space or voids between the CMP and the pipe liner.
