## Oval Pipe Reline Cuts Down on Costs for Small Arkansas Town

Garner, Arkansas

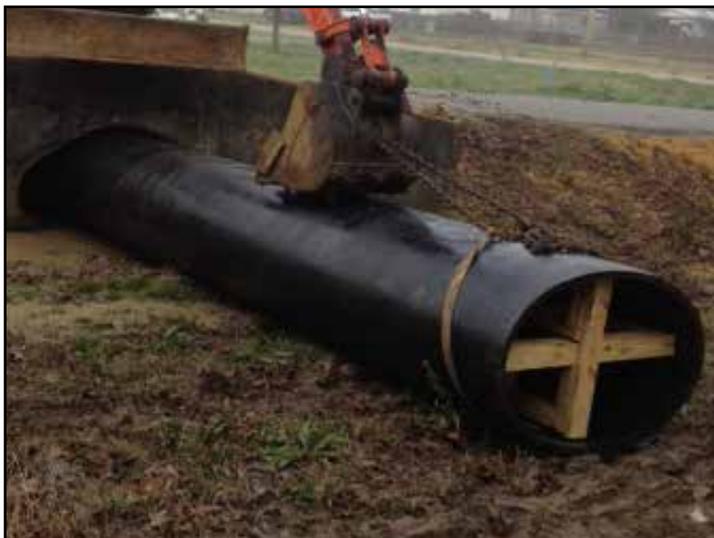
*Snap-Tite pipe liner is pulled inside one of the old culverts.*

Baldwin Construction served as the contractor on this project. They lined the old culverts with the new oval Snap-Tite pipe liner. Once the new pipes were pulled inside the old culverts, any annular space between the old and new pipes was filled in with grout. The pipe liner project also served as a demonstration for surrounding county officials

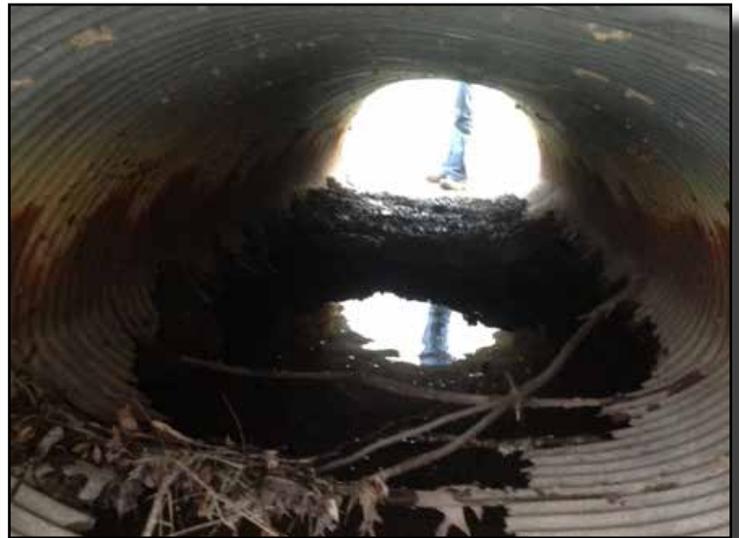
A large sink hole formed down the side of a main road in the small town of Garner, Arkansas. The four oval-shaped 30-year-old culverts serving as drainage pipes were completely rotted out, causing the sink hole. The road could have collapsed at any time. The town needed a quick cost-effective solution as it did not have the budget for an expensive dig and replace option. Plus, doing a complete replacement would mean closing down the road – something that the town wanted to avoid. There are about three school buses that travel that road each day. Closing down the road would mean rerouting them 10 to 12 miles out of the way.

*A look inside one of the damaged culverts.*

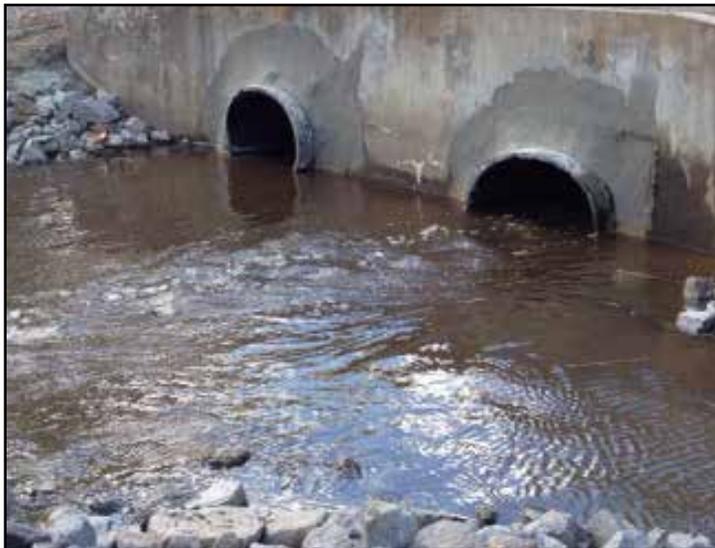
A view of the completed project with the pipe liners in place.

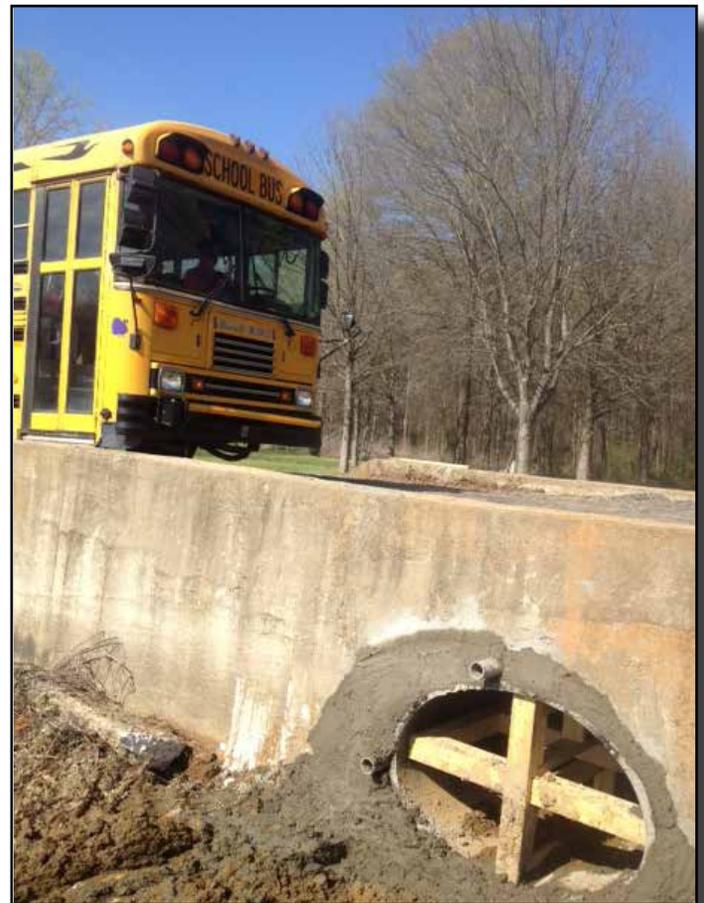
Traffic continued to flow during the installation. Here the annular space between the old culvert and pipe liner is filled in with grout. Struts are used when Snap-Tite pipe is oveled to hold the pipe in its oval shape. The struts are removed after the pipe is grouted in place.
