North Carolina City Saves Money by Relining Culvert with Snap-Tite® Pipe

Gastonia, North Carolina

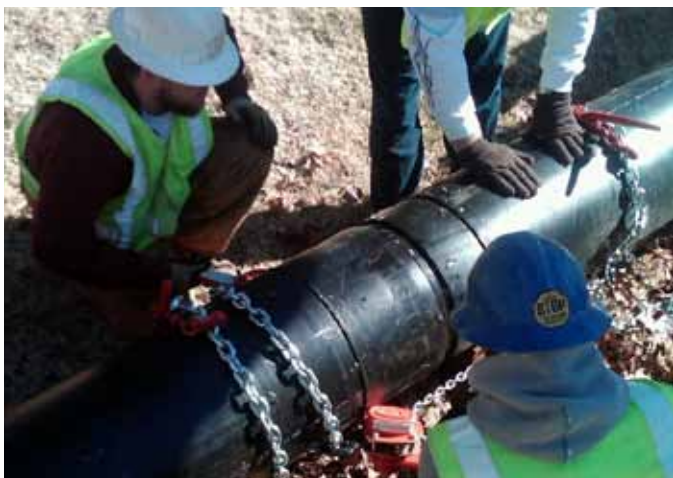
The city's crew used come-a-longs and chains to join the sections of Snap-Tite pipe liner together before slipping the pipe into the old culvert.

Two 21-foot sections and one 11-foot section of 16-inch diameter Snap-Tite® pipe were used to reline the 18-inch CMP. The city's crew used come-alongs and chains to join the Snap-Tite® pipe. After each section was joined, the liner was to be inserted into the existing CMP. However, an unseen bend in the 18-inch CMP pipe required some quick field alterations. The crew cut a bullet nose out of one end of the first section of Snap-Tite® pipe. The

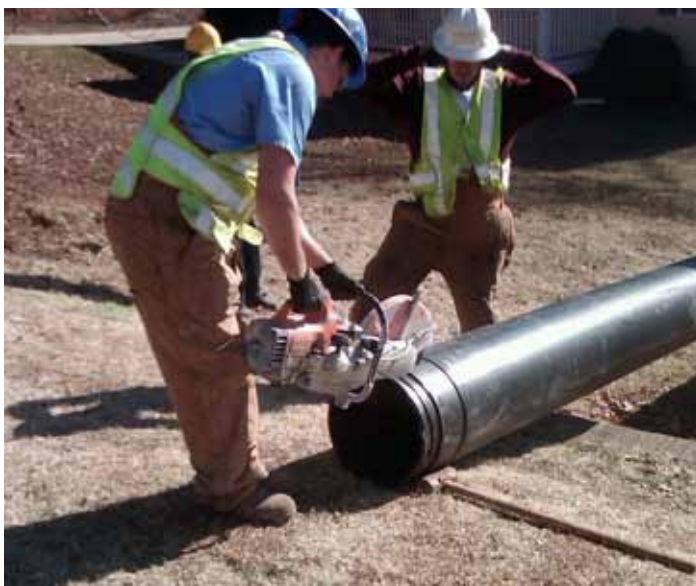
The city's crew cuts a bullet nose into one end of the 18-inch Snap-Tite pipe liner in order to slip the liner into the deflected old CMP culvert.

bullet nose reduced the outside diameter of the Snap-Tite® pipe end enabling the liner to successfully navigate through the deformation in the old pipe. The process of joining the Snap-Tite® liner and inserting it into an existing pipeline is repeated until the failing culvert is completely relined.
