Storm Drain Relined with Snap-Tite® to Protect Road Entrance to Maine School

Kennebunk, Maine

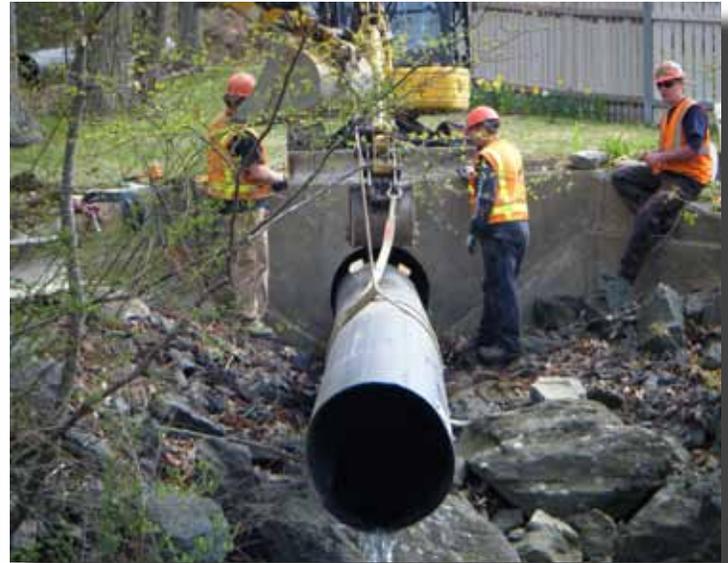
Snap-Tite pipe is slid inside the old storm drain. Relining the pipe is quicker and safer than a dig and replace method.

All that was required to snap the pipe liner together was a come-along and chains. To line the 30-inch CMP, one section of Snap-Tite pipe was first slid inside the old culvert. Then the next section was snapped on using the come-along and chains. This process was repeated until the liner was in place from end-to-end. Finally, grout was used to fill in any annular space between the old pipe and the new pipe liner.

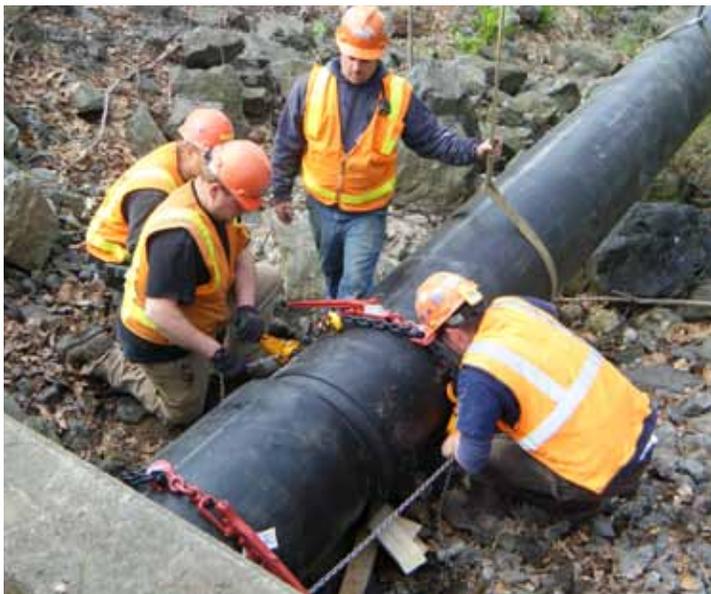
After the Snap-Tite pipe male and female end are snapped together, the joined section is slid inside the old CMP.

The Snap-Tite system is made of high-density polyethylene (HDPE) pipe. Snap-Tite's patented male/female machining at each end of the HDPE allows the pipe ends to be 'snapped' together, piece-by-piece, and pushed into the full length of the existing pipe. The pipe liner is available in lengths from two feet to 50 feet, and is available for culverts with diameters from eight inches to 84 inches. However larger diameters are available on special request.
