At Kennedy Space Center, Culvert Failure is Not an Option

Kennedy Space Center, Florida

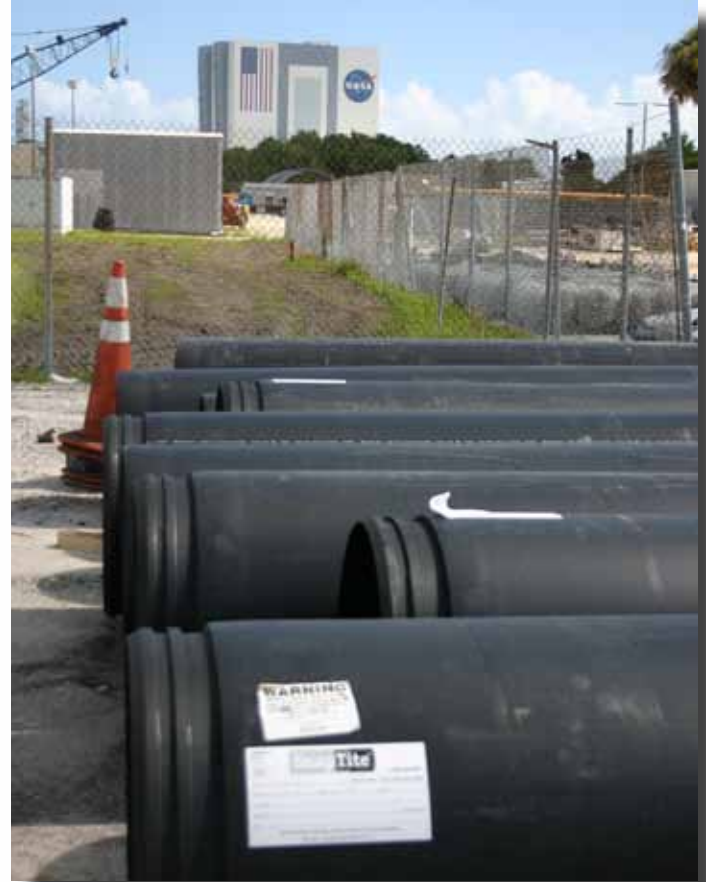
Snap-Tite is delivered to the Kennedy Space Center and awaiting installation.

Initially, three 60 foot-long 32-inch culverts were relined with 28-inch Snap Tite high-density polyethylene (HDPE) pipe. Snap-Tite pipe has machined "male" and "female" ends that are joined together without the use of butt fusion. Rather the ends are "snapped" together, creating a water-tight seal.

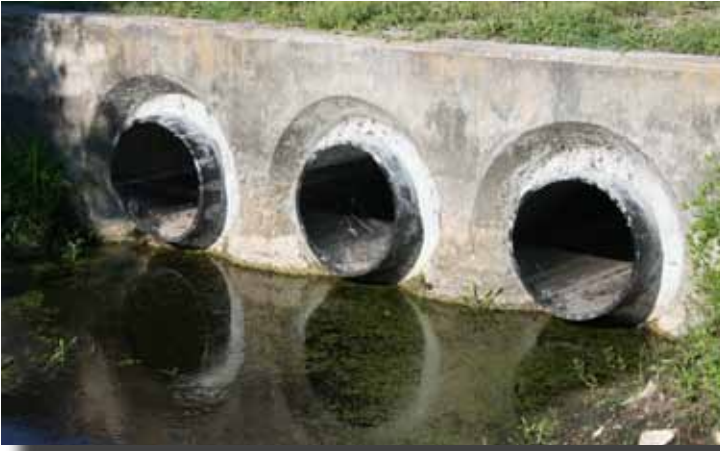
The three culverts after they are relined with Snap-Tite.

During installation of the Snap-Tite, the Yang Enterprises crew encountered three different scenarios for each of the culverts. According to Waters, the first culvert was the easiest to install. However, the second 32-inch culvert was more difficult to reline. Yang Enterprises had to cut parts of it out because the old culvert had deteriorated to the point that portions had collapsed or were deformed.

The third culvert was the most difficult to reline because of the amount of debris inside and the fact that it was failing. They solved the problem by bullet nosing the end of one of the Snap-Tite pipes to push it through to the end.

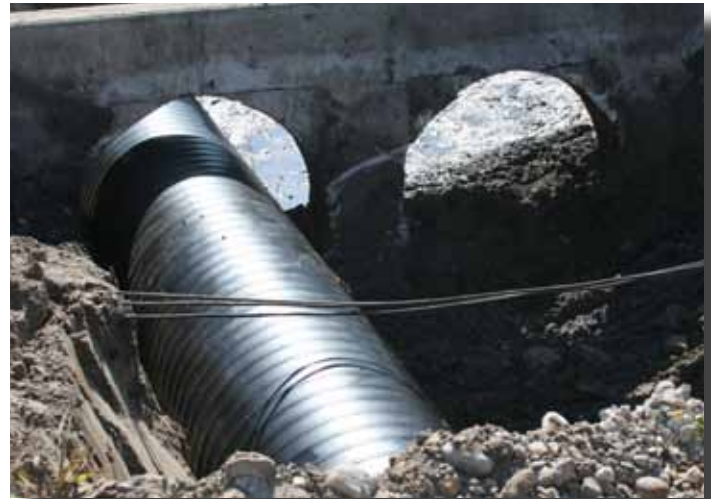
The closed profile pipe is pushed through to reline the other damaged culvert, without having to replace the headwall.

There were also two 48-inch CMP culverts that had partially collapsed. Kerr and Waters discussed and investigated additional options for a repair or replacement at this site. For the 48-inch CMPs Waters decided to use another type of HDPE pipe, in this case closed profile HDPE pipe (made with Profile Pipe Technologies, PPT, equipment). The profile pipe was joined using a bell and spigot method.

In order to maintain flow capacities at this site, ISCO's Kerr suggested the use of 36-inch inside diameter closed profile HDPE pipe for the two larger culverts. The pipe's low resistance to flow was critical to properly drain the area. The 36-inch pipe served as a liner for the damaged sections of the culverts, while also serving as a replacement pipe for the sections that had collapsed.

During the installation of the closed profile pipe, some live electric wires had to be shut off before the reline could begin. Once the power was off, the new pipe was pushed through the old pipe after sections of the collapsed culvert were removed. The existing headwall was not damaged during the reline and the new pipe was grouted into the opening. By using a culvert reline method as opposed to a dig and replace method, the headwalls were left in tact in both the Snap-Tite and closed-profile pipe projects, which eliminated the cost of having to put up a new headwall.
