Damaged Culvert Relined With Snap-Tite Pipe to Avoid Road Closures

Okemo Mountain, Ludlow, Vermont

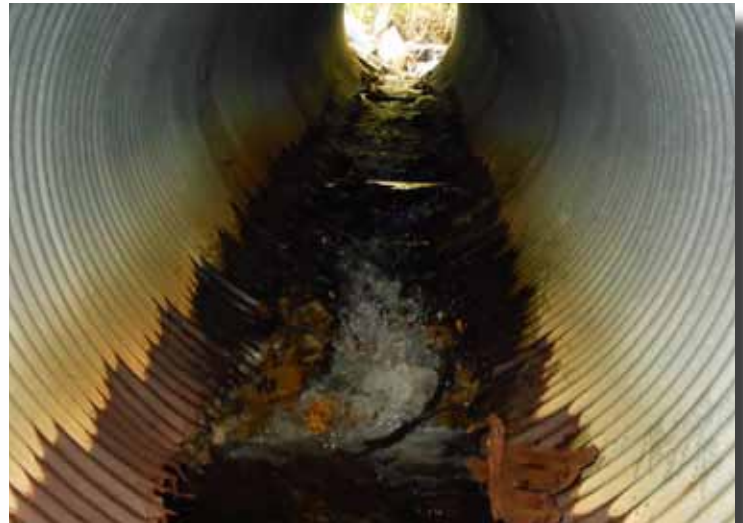
A 66-inch corrugated metal pipe (CMP) culvert was failing under a road that was the only access to multiple housing units from the Okemo Ski Mountain resort. The pipe began to deflect and sections of the bottom missing. There were scour holes inside the pipe in excess of three feet and parts of the road developed sink holes. As a result, this private road was reduced to a single lane and there were safety concerns for the motoring public going across it. A repair had to take place quickly because the winter ski season was right around the corner and inclement weather can complicate drainage construction.

Parts of the bottom of the old CMP culvert eroded completely so that parts of the pipe were missing.

TPW Management was concerned about underground utilities as well as digging deep to replace the pipe, especially since the existing pipe was on a ledge. The pipe was originally installed over a 10 percent slope, accounting for 16 feet of vertical change. The company, therefore, needed a no-dig solution.

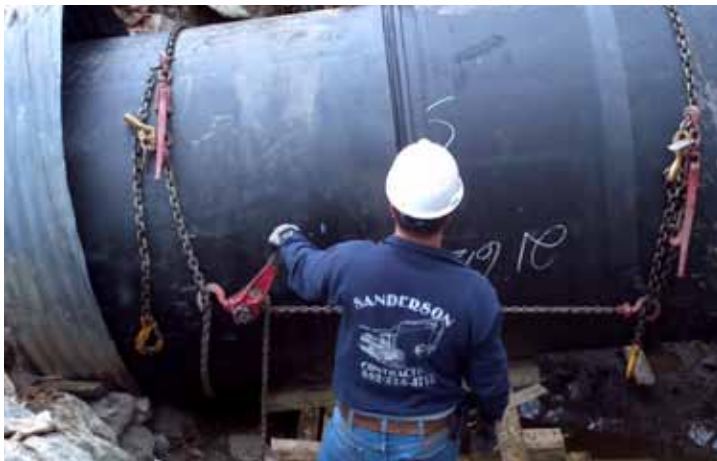
Sections of the Snap-Tite pipe are snapped together using only a come-along and chains.

Snap-Tite is made of high-density polyethylene (HDPE) pipe. Its patented male/female machining at each end of the HDPE allows the pipe ends to be 'snapped' together, piece-by-piece, and pushed into the full length of the existing pipe. The pipe liner is available in lengths from two feet to 50 feet, and is available for culverts with diameters from eight inches to 84 inches. However larger diameters are available on special request. Snap-Tite is also available in both round and oval diameters.

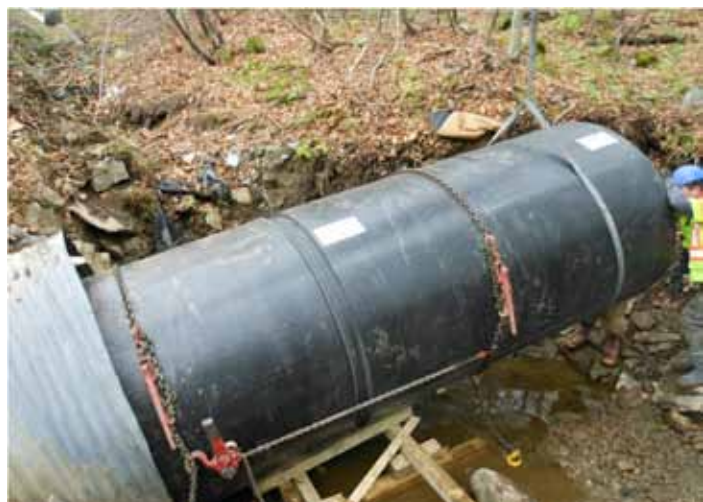
During installation, one nine-foot section of Snap-Tite pipe was slid inside the old culvert. Then the

The snapped sections of pipe are slid inside the old CMP, completely lining the deteriorated pipe.

next section was snapped on using a come-along and chains. This process was repeated for each section until the liner was in place from end-to-end. Finally, grout was used to fill in any annular space between the old culvert and the new pipe liner.

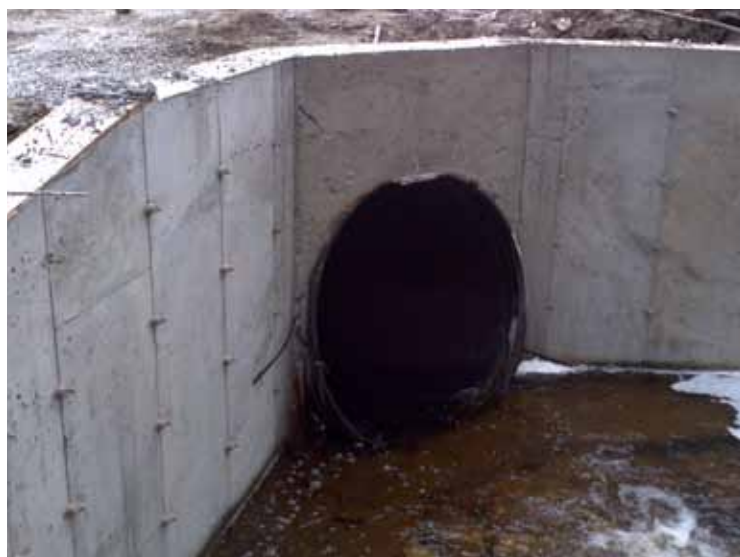
The fully lined pipe outperforms the pipe it replaces and flow is maximized.
