## Snap-Tite Pipe Relines Culvert in Oklahoma, Keeps Residential Street Traffic Moving During Installation

*McAlester, Oklahoma*

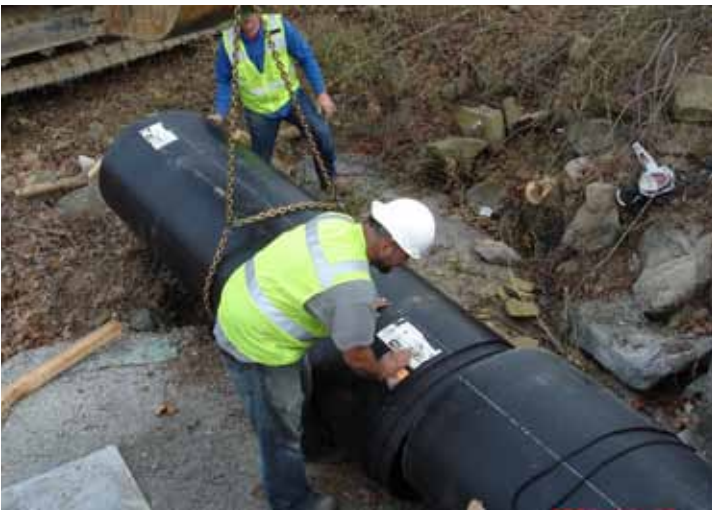
*The machined Snap-Tite male end is about to be 'snapped' to the female end of the pipe.*

of Transportation officials as well as engineering firms. During installation, one end of the Snap-Tite pipe liner was slipped into the CMP culvert and then snapped on to the next Snap-Tite end. Once the liner was in place, the space between the old pipe and the liner was filled in with grout. The installation was an overall success.

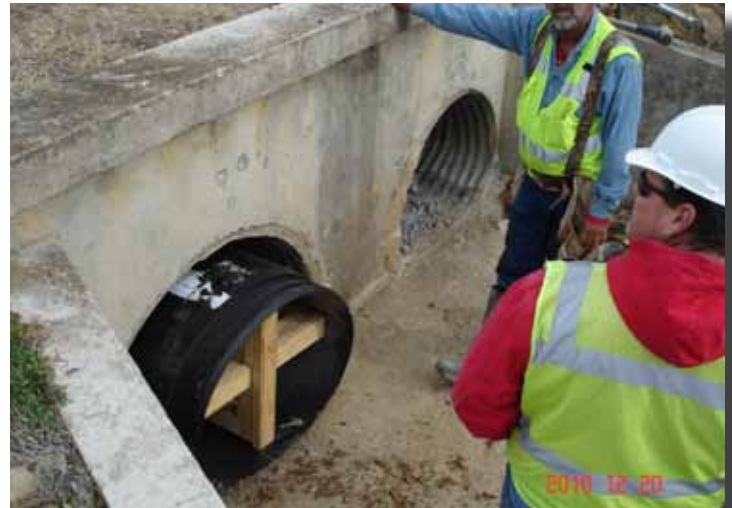
*The oval-shaped Snap-Tite is slid inside the old damaged CMP.*

Standard M326 for rehabilitating culverts. In order to fit inside the misshaped CMP, Snap-Tite supplied 32-inch Snap-Tite pipe that was compressed down into a 37 by 27 inch oval liner using an "ovalling" machine at a Snap-Tite plant. This pipe liner gave the city an opportunity to repair the culvert without having to disrupt the essential residential road and allowed the city's maintenance workers to handle the installation without having to hire outside contractors.

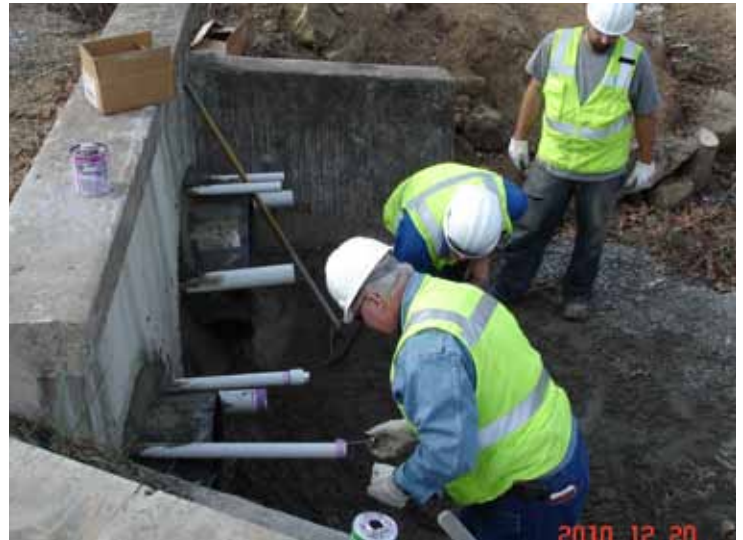
*Any space between the old CMP and the new Snap-Tite liner is filled in with grout.*

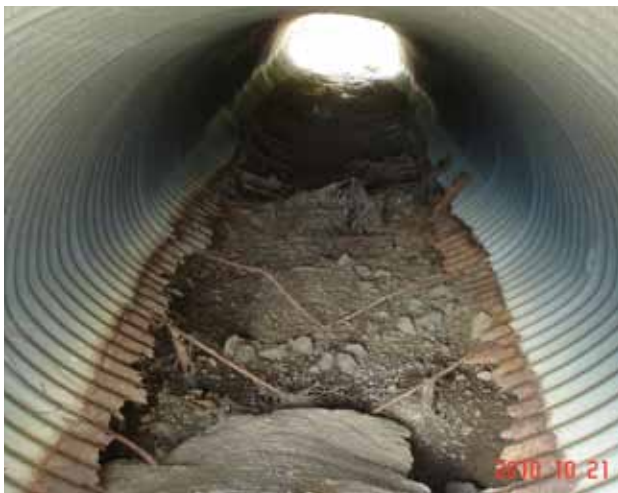
Corrugated metal pipe (CMP) culverts are failing at an alarming rate throughout the U.S. These culverts were installed 40 to 50 years ago and have exceeded their design life. The City of McAlester, Oklahoma needed to fix a rusted and oval (49 inches by 33 inches) CMP culvert that was also partially missing its bottom. This CMP was located on a residential street, which was the only road leading into a subdivision. Digging up the road would have prevented access for many homeowners.

*Before: the damaged CMP before it is relined.*

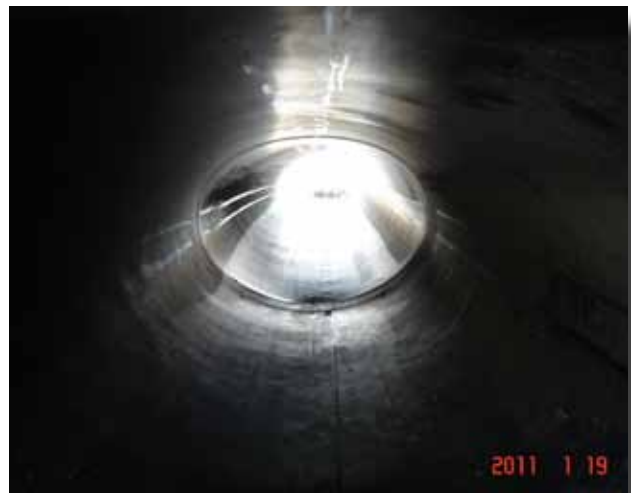
*After: the culvert newly relined with Snap-Tite.*
