Residential Street Spared with Snap-Tite® Culvert Reline

Santee, CA

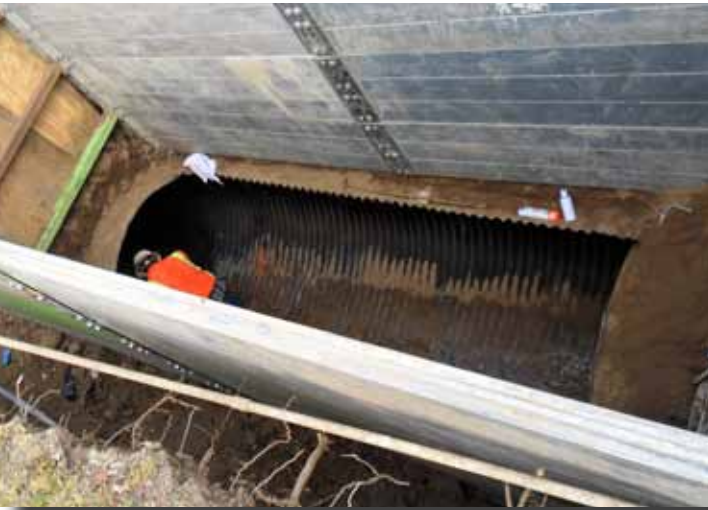
The pit where the deteriorated culvert needed to be relined.

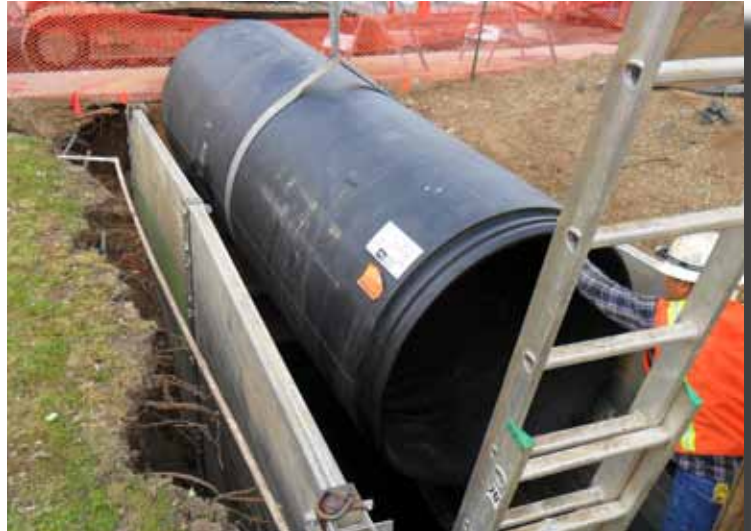
Snap-Tite® pipe is lowered into the pit in order to reline the old CMP culvert.

In this case, eleven-foot sections of Snap-Tite® pipe were lowered into the pit. The pit was approximately 10-feet deep, 13-feet long and eight-feet wide. The Snap-Tite® pipe liner could not be snapped outside of the pit because there was no room to wrap the chains around and to place the come-alongs on the outside of the pipe. So the pipe was “snapped” inside the pit with the come-alongs and chains, which were attached to a bar the contractor manufactured for each end of the pipe.

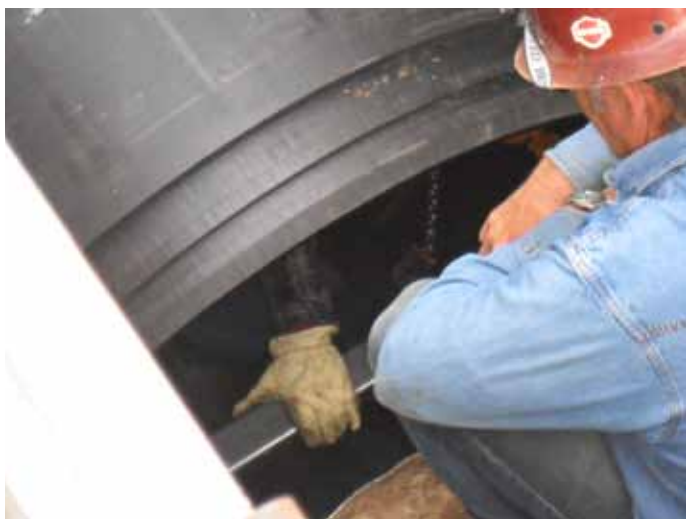
The Snap-Tite® pipe liner ends are snapped on the inside of the pit and then pushed through the old pipe to reline it.

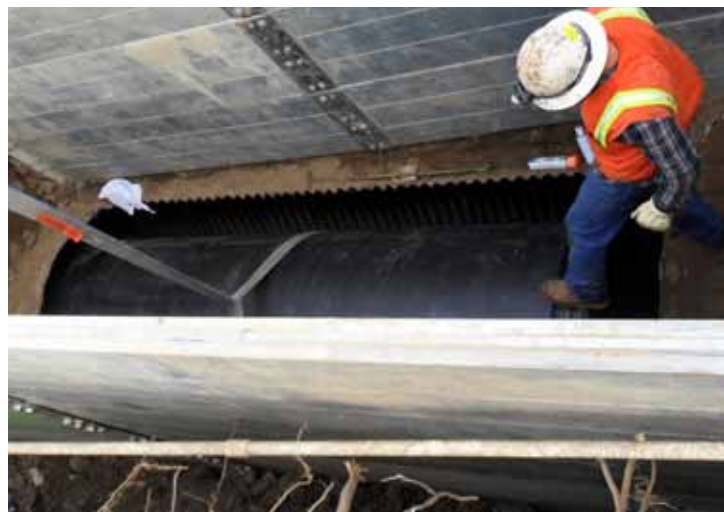
A pipe liner section is pushed through the old existing pipe so that another Snap-Tite® section can be snapped together.
