# Big Pipe Restores Function to Levee, Protects Florida Wetlands

St. Johns River Water Management District, Fellsmere, FL

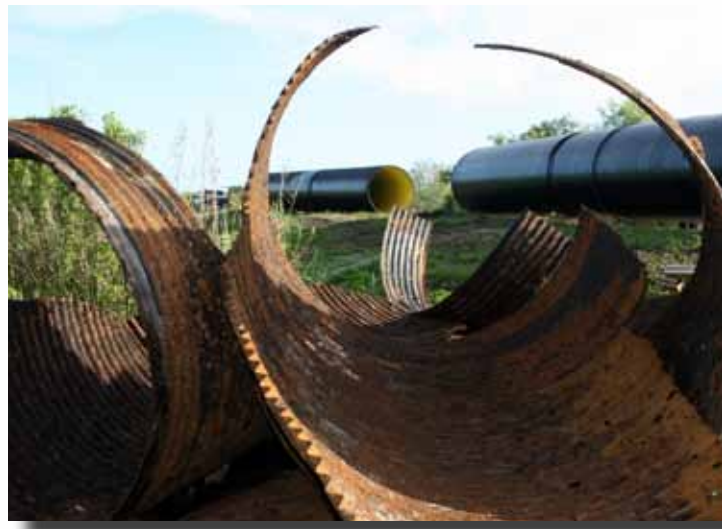
A view of the excavated deteriorated corrugated metal pipes with the new profile wall pipe liner in the background.

The material chosen to reline the pipe was 60-inch diameter ProCor profile wall pipe manufactured by Profile Pipe Technologies (PPT) and supplied by ISCO Industries.

The pipe underneath the levee was in poor shape up to about five feet from the gate where it had completely worn out. Shaune Rogers, one of Shenandoah's divers, had earlier excavated and removed the parts that had completely failed. In the sections where there was no old pipe, the new profile wall pipe extended past the culvert close to the gate.

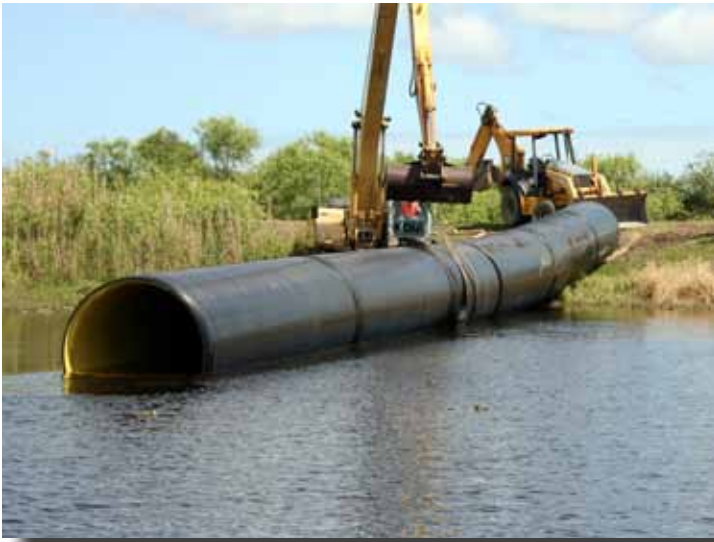
*The electrofused PPT pipe was placed in the water to be submerged under water and pushed into the old pipe.*

The PPT profile wall pipe, once it was fused and tested, was placed into the water with the aid of two of Shenandoah's divers. The divers then helped guide and submerge the pipe underwater.

The divers pushed and slipped the new pipe into the old pipe, stopping short of the flood gates.
