Snap-Tite® Pipe Relines Damaged Culvert Under Entrance to Texas DOT Maintenance Yard

Stanton, TX

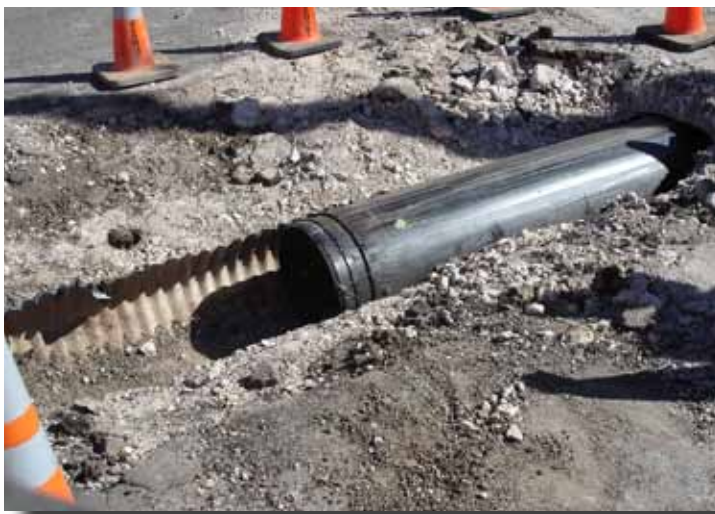
Pipe liner going in where old CMP has completely deteriorated.

All the equipment that was required to snap the pipe liner pieces together were come-alongs and chains. Once the Snap-Tite® pipe liner lengths were snapped together, the crew pushed the joined liner through the old CMP culvert and then filled in any annular space with grout.

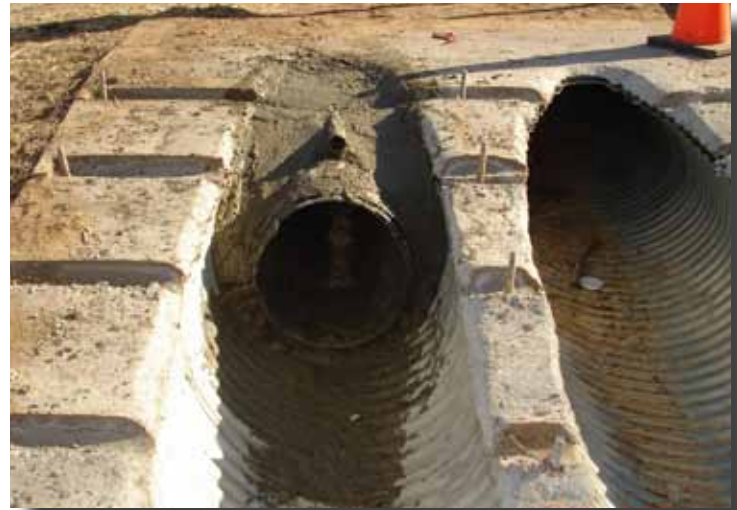
The new Snap-Tite® pipe liner installed and grouted.

The pipe lining of the old culvert began at 9:30 a.m. and was completed in one day. The grouting process took place the following day. The TXDOT maintenance crew was able to do the work themselves without having to hire contractors, saving the Odessa District time and money. The entire installation was a success.
