Mineral Company Relines Damaged Culvert Under Railroad with Snap-Tite®, Improves Flow with Hydro-Bell

Trona, California

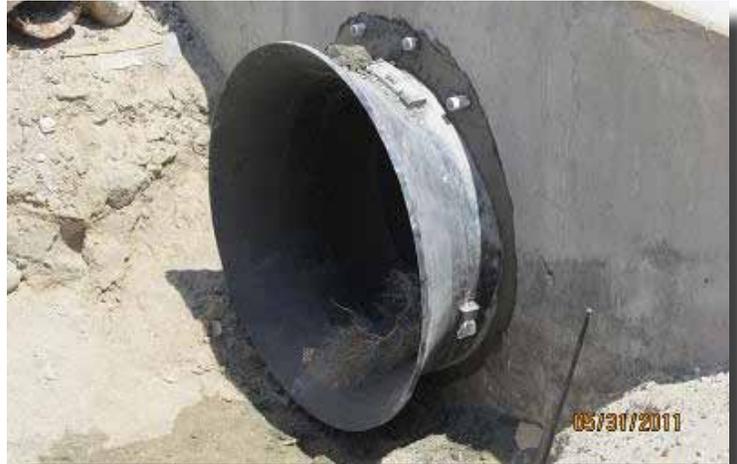
The Snap-Tite pipe with the Hydro-Bell end are in place after installation. The old culvert is relined without any entrance losses.

The mineral company's crew worked quickly to reline the damaged culvert. The Snap-Tite® pipe was snapped together and inserted into the damaged CMP. To snap the pipe sections together, the crew did not need any special equipment and was able to use only a come-along and chains. At the end, the Hydro-Bell was also snapped on to the end of the Snap-Tite® pipe, creating a leak-free piping system. Grout was used to fill in any annular space between the old culvert and the new liner.

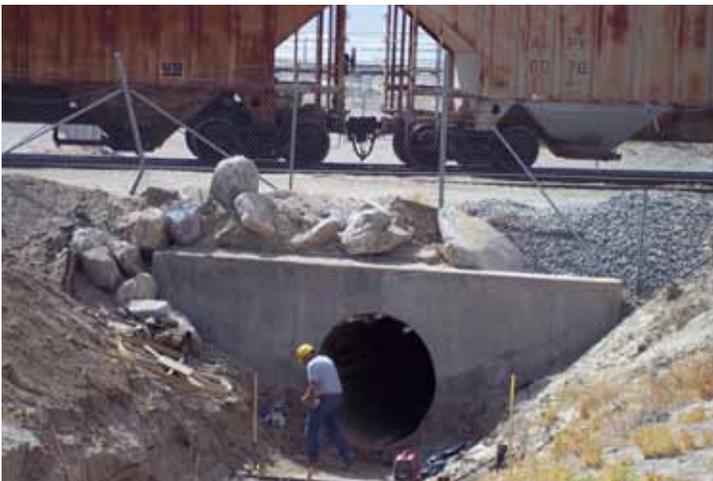
Work takes place on repairing the culvert without disruption to rail service. The Snap-Tite pipe liner and Hydro-Bell are installed under the railway tracks.

The whole time the crew worked, the rail line remained open and in use, so the company continued to use rail to send and receive materials. The culvert rehabilitation was completed quickly with no disruption. Also, the Snap-
