The City of Valdosta Chooses Snap-Tite for No-Dig Solution

Valdosta, Georgia

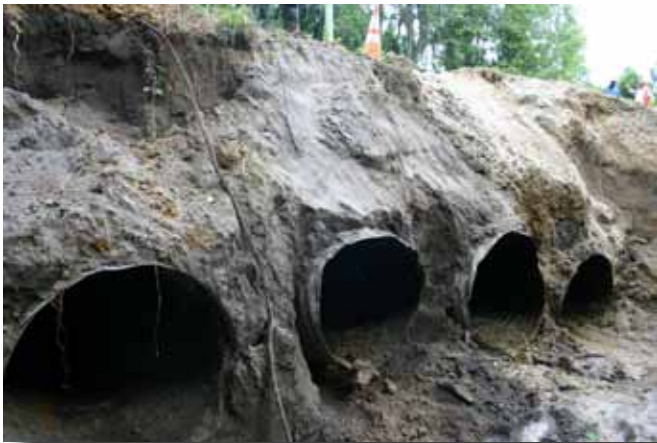
The culvert consisted of four badly corroded pieces of corrugated metal pipe in a row.

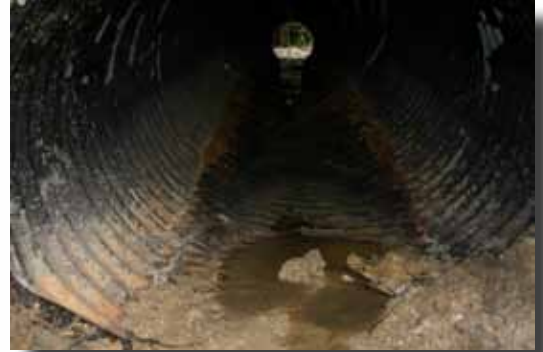
The bottom of the corroded corrugated metal pipe prior to the Snap-Tite installation.

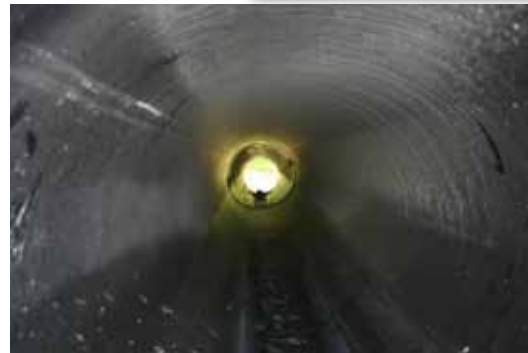
The culvert after the Snap-Tite installation.

pipe, which has a patented male/female machining at each end of the HDPE, is 'snapped' together, piece-by-piece, and pushed into the full length of an existing pipe. Any annular space and voids between the old culvert and new liner are filled in with grout.

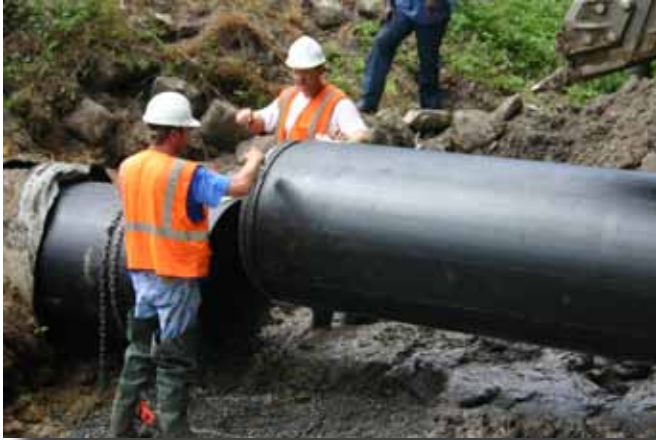
The city of Valdosta crew installs Snap-Tite.

All the equipment that was required to snap the pipe liner pieces together were come-a-longs and chains. Once the Snap-Tite® pipe liner lengths were snapped together, the crew pushed the joined liner through the old CMP culvert and then filled in any annular space with grout.

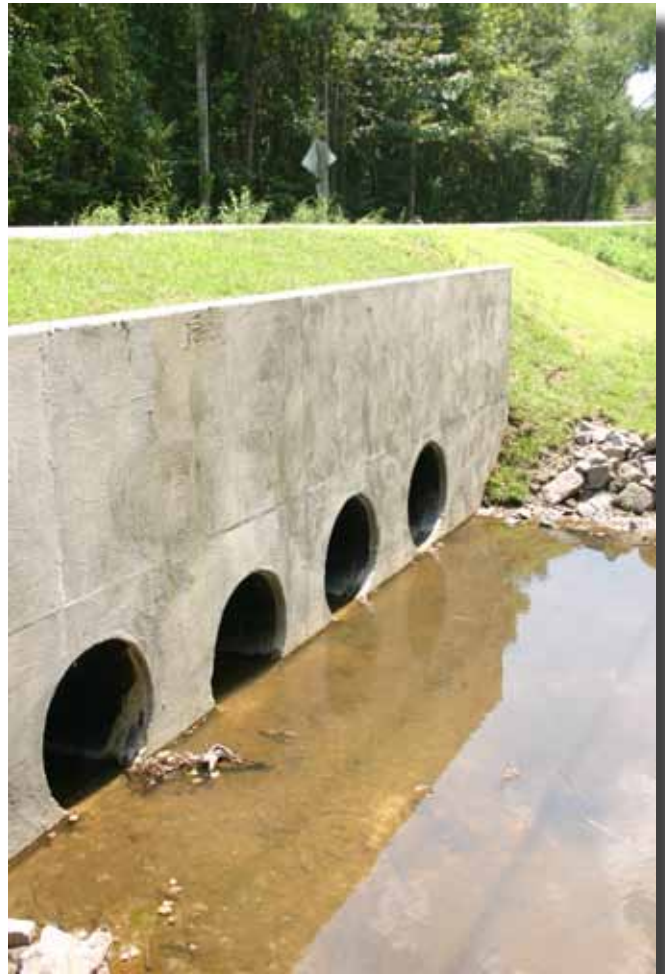
The completely rehabbed culvert.
