U.S. Army Engineers Take Proactive Approach to Levee Repair

Vicksburg, Mississippi

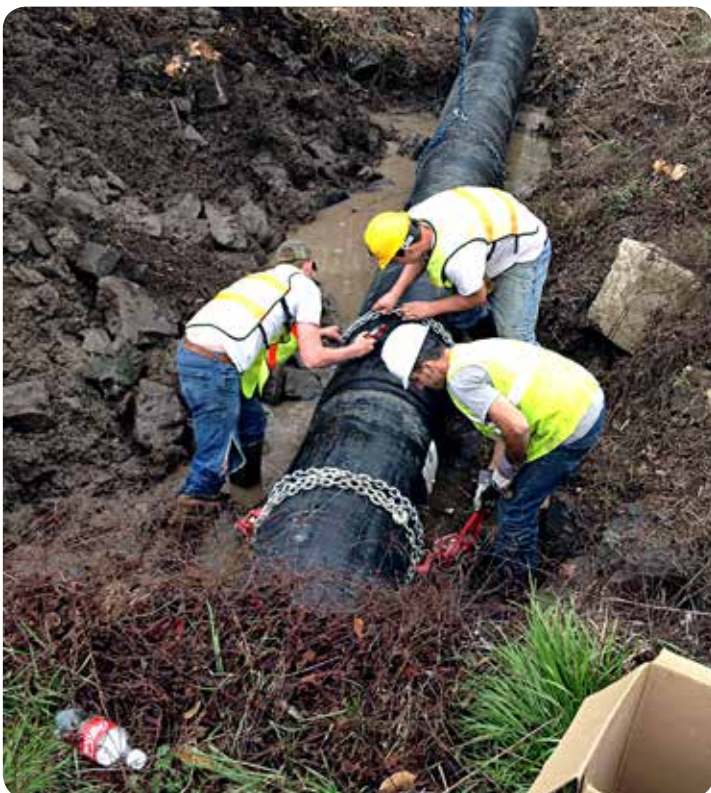
A construction crew installs Snap-Tite HDPE pipe liner into a CMP that is part of a levee system in the Southern United States.

A unique feature of Snap-Tite is that it does not require fusion to join the HDPE pipe together. The ends of the Snap-Tite pipe are machined on each

end. The machined male and female ends are then “snapped” together, piece-by-piece, on site using come-a-longs and chains.

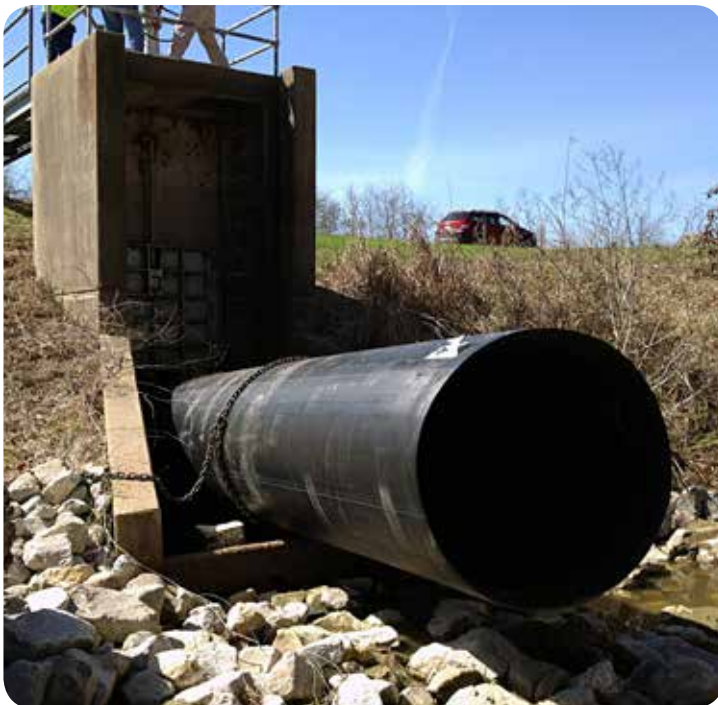
Snap-Tite HDPE pipe is used to line a failing culvert within a levee system.

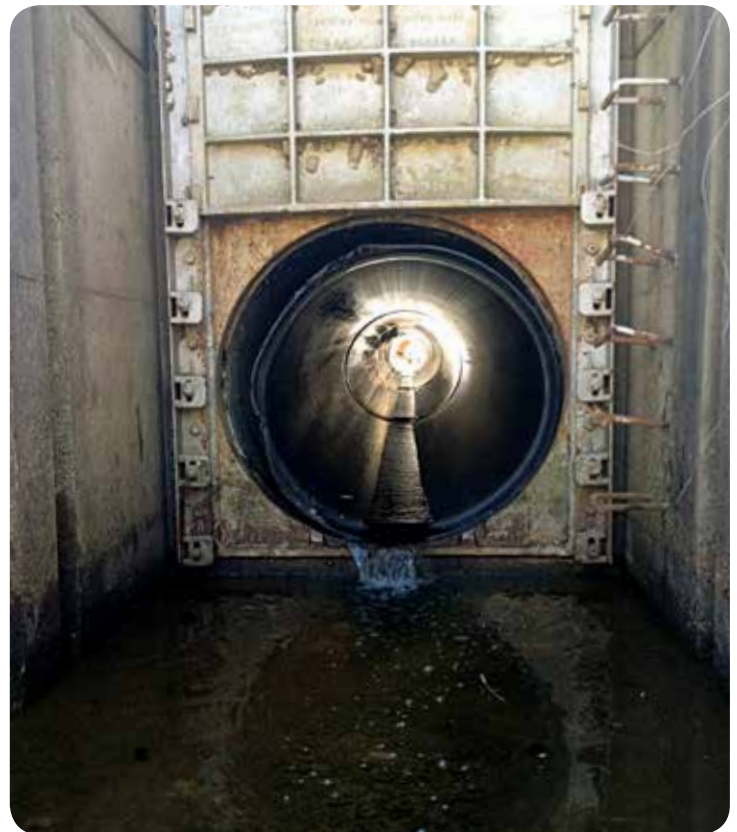
Snap-Tite HDPE pipe is inserted into an existed CMP prior to annual grouting.
