## Culverts Relined in Colorado Mountain Pass

*Wolf Creek Pass, Highway US 160, Colorado*

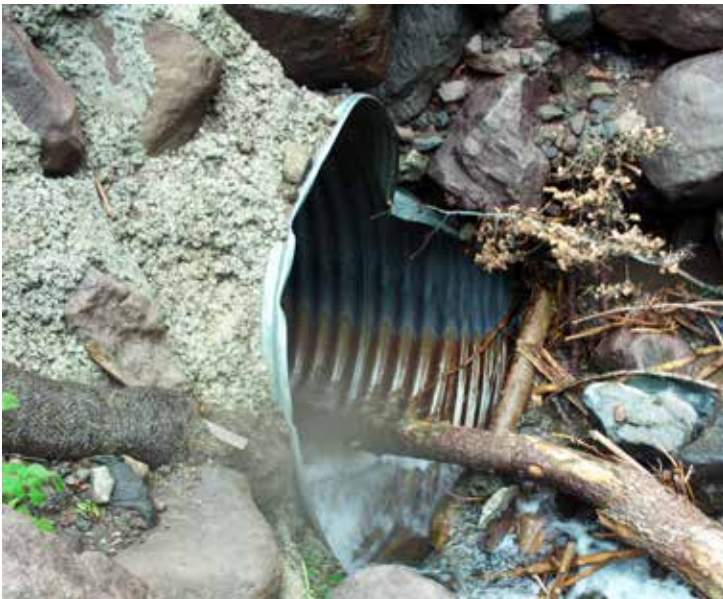
Major repairs were taking place on highway US 160, including paving and widening that affected the road through the mountain pass. Located underneath the section of highway in the mountain pass, there were two culverts that were worn out. Leaving the culverts in this state of disrepair could result in an entire road collapse. The Colorado Department of Transportation (CDOT) decided to

*One of the damaged culverts before it was repaired.*

The reline project in Wolf Creek Pass involved two culverts, one was 48 inches in diameter and the other was 72 inches in diameter. Snap-Tite supplied 140 feet of 42-inch HDPE Snap-Tite pipe, delivered in 24-foot sections, for the 48-inch diameter culvert and 181 feet of 63-inch HDPE Snap-Tite pipe, delivered in 24-foot sections, for the 72-inch culvert.

First, the crew cleaned out any debris inside or around the old pipes. Then, one section of the new Snap-Tite pipe liner was pushed inside the first culvert. Once most of the liner was inside, a second section of Snap-Tite pipe was snapped on

to the first section using only come-a-longs and chains. This process was repeated until the old culvert was fully lined with the new Snap-Tite pipe. Then the crew used the same method of installation to line the second culvert. Finally, the contractor’s crew grouted any annular space between the old culvert and the new pipe liner.

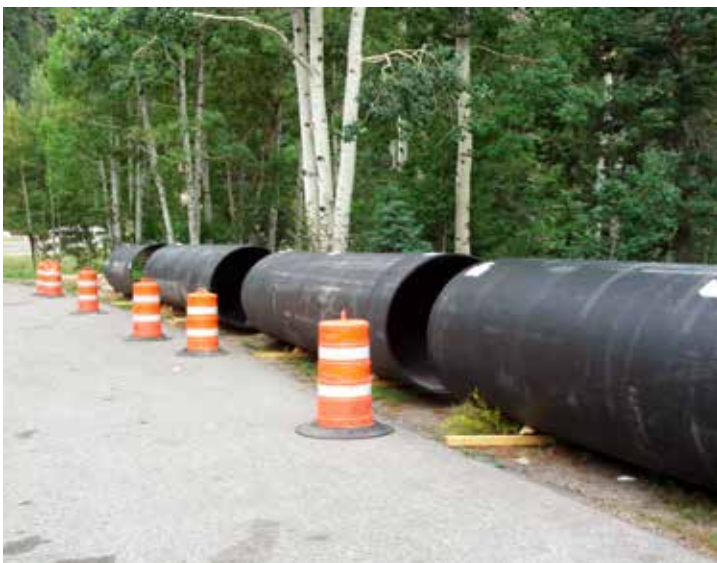
*Sections of Snap-Tite HDPE pipe awaiting installation on the side of the road.*
