Culverts Relined in Colorado Mountain Pass

Wolf Creek Pass, Highway US 160, Colorado

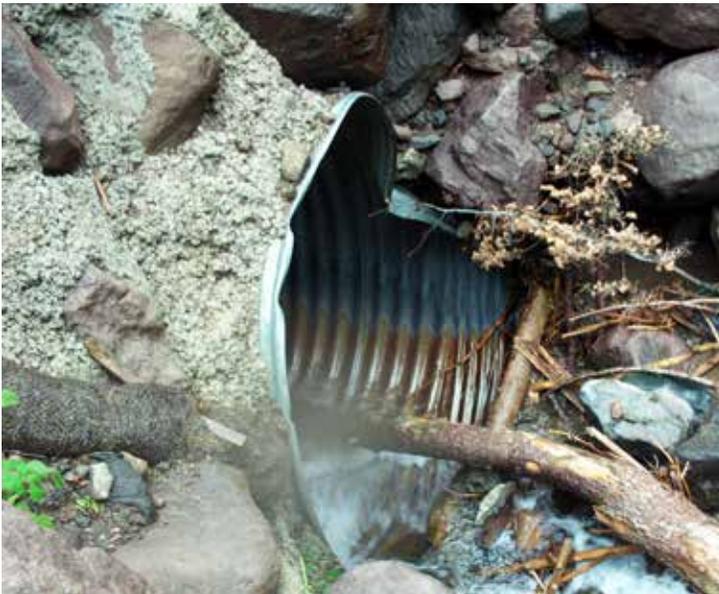
Major repairs were taking place on highway US 160, including paving and widening that affected the road through the mountain pass. Located underneath the section of highway in the mountain pass, there were two culverts that were worn out. Leaving the culverts in this state of disrepair could result in an entire road collapse. The Colorado Department of Transportation (CDOT) decided to

One of the damaged culverts before it was repaired.

CDOT worked with Snap-Tite representative Russ Wosk on a culvert relining solution. Made of high-density polyethylene (HDPE) pipe, the Snap-Tite culvert lining system is a no-dig solution for repairing old culverts because it does not require extensive excavation and does not require road closures or disruption to traffic. In addition, no extensive equipment or training is necessary to install the Snap-Tite pipe, so repairs could take place in a lim-

The reline project in Wolf Creek Pass involved two culverts, one was 48 inches in diameter and the other was 72 inches in diameter. Snap-Tite supplied 140 feet of 42-inch HDPE Snap-Tite pipe, delivered in 24-foot sections, for the 48-inch diameter culvert and 181 feet of 63-inch HDPE Snap-Tite pipe, delivered in 24-foot sections, for the 72-inch culvert.

First, the crew cleaned out any debris inside or around the old pipes. Then, one section of the new Snap-Tite pipe liner was pushed inside the first culvert. Once most of the liner was inside, a second section of Snap-Tite pipe was snapped on

to the first section using only come-a-longs and chains. This process was repeated until the old culvert was fully lined with the new Snap-Tite pipe. Then the crew used the same method of installation to line the second culvert. Finally, the contractor’s crew grouted any annular space between the old culvert and the new pipe liner.

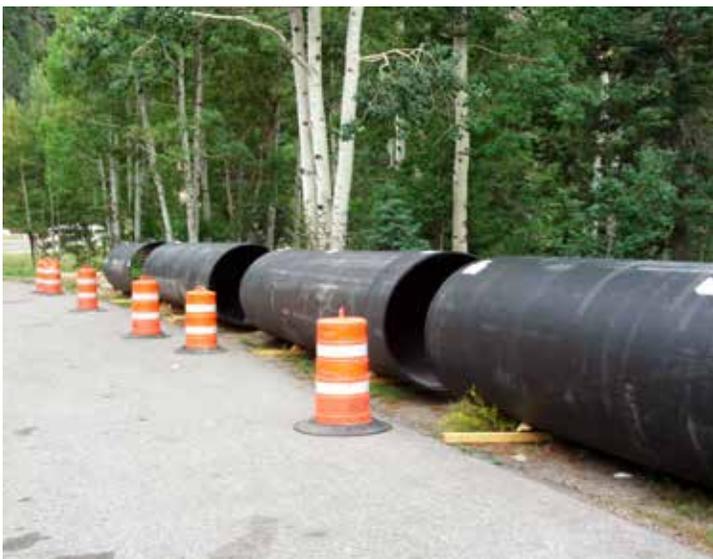
Sections of Snap-Tite HDPE pipe awaiting installation on the side of the road.

A unique feature of Snap-Tite is that it does not require fusion to join the HDPE pipe together. The ends of the Snap-Tite pipe are machined on each end. These male and female ends are “snapped” together on site using come-a-long and chains. The Snap-Tite pipe is slipped inside the old culvert and grouted into place.
