Snap-Tite® Lines Oval Culvert under Remote Alaskan Airport Taxiway, Flights Resume as Scheduled

Yakutat, Alaska

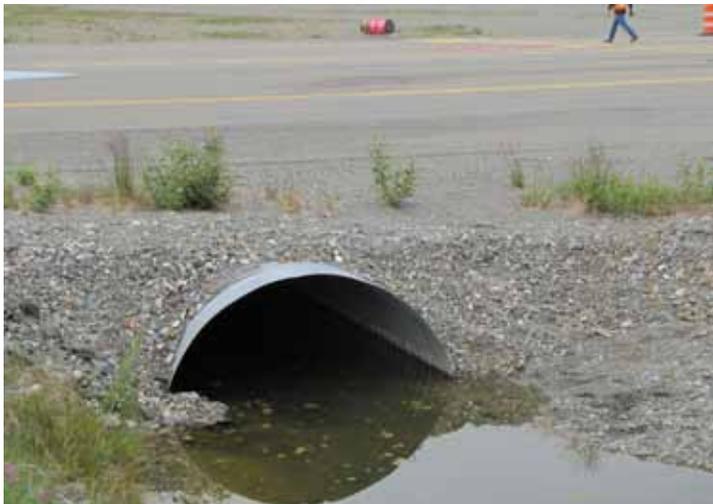
The CMP buckeling under the pressure of the traffic on the taxiway.

At the Yakutat Airport, a major airline was not able to use its main taxiway to reach the runway for take-off due to a failing oval culvert underneath. The culvert showed signs of collapse under the weight of the Boeing 737-800 series aircraft that used the taxiway. The steel pipe was only five years old and though it did not show signs of corrosion, it was failing. The arched corrugated metal pipe (CMP) culvert was 6'9" by 4'11". Besides aircraft trafficking over this taxiway, the 737 rear landing gear also sat right on top of the underlying pipe, contributing to the pressure placed on the culvert. The U.S. Federal Aviation Administration (FAA) required the airport to fix the problem immediately and have the taxiway up and running.

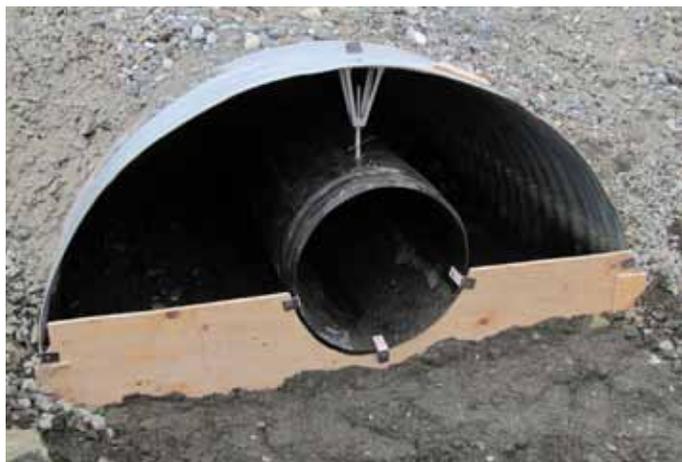
The first bulkhead is created after the pipe liner is inserted and before the grout is pumped in.

Prior to inserting the Snap-Tite® pipe into the culvert, all the sections of the Snap-Tite® pipe were snapped together outside of the channel. Then, the joined pipe was rolled down into the channel and inserted inside the culvert. Once the Snap-Tite® pipe liner was in, the channel was de-watered. The liner was secured in place using metal stabilizing jacks from the top of the culvert to the liner. Then the first bulkhead was put in place and grouting tubes inserted for the initial phase of the grouting process. The first phase of grout was pumped in through the tubes above the Snap-Tite® pipe liner starting at the center and alternating side-to-side from both ends.

Then the second bulkhead was put in place for the second grouting phase, just over the pipe liner. The second phase of grout was pumped in similarly to the first method. Next a vent and observation ports were cut on the top of both ends of the CMP.

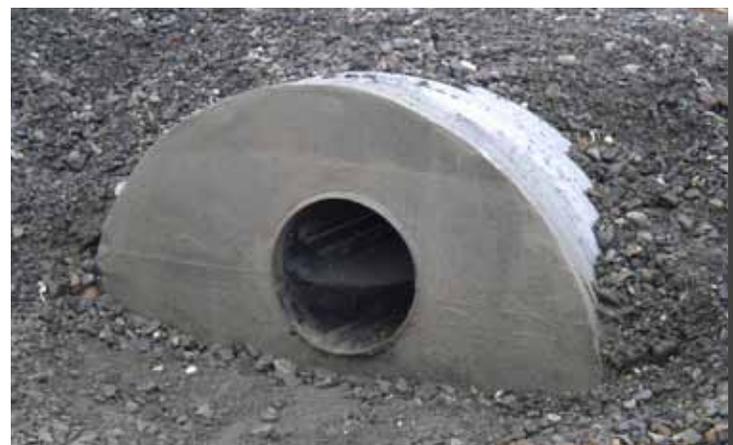
The installation is complete. The culvert is lined with Snap-Tite® pipe and the annular space is filled in with high-pressure grout.

The old culvert was successfully lined with the 24-inch Snap-Tite® pipe. It took a total of 85 cubic yards of grout to fill the annular space. In addition, throughout the project, grout cubes were taken and tested. The grout

yields and strengths were better than expected (approximately 3700 psi) and the taxiway opened back up to normal operations on schedule.
