Levee Pipe Relined with Large Diameter HDPE Pipe to Prevent Flooding

Prestonsburg, KY

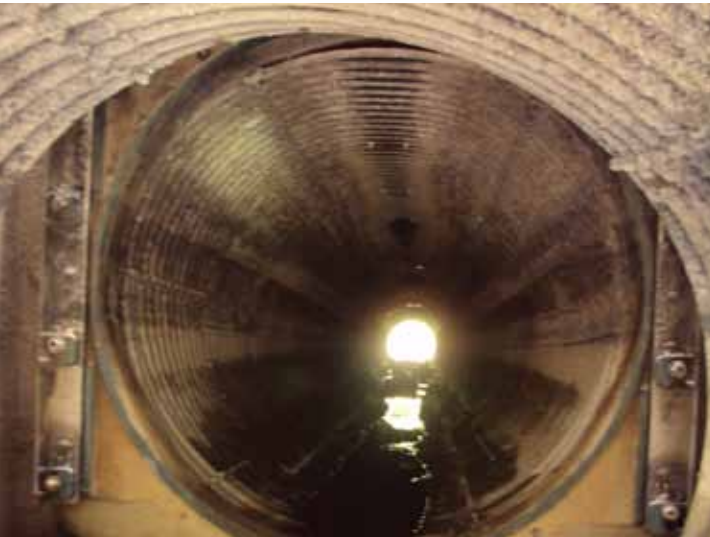
Parts of the old culvert were collapsing. Repair was essential to prevent flooding.

Indiana Reline, the contractor, lined the 96-inch CMP with the 72-inch HDPE pipe. They electrofused the pipe at the joints and then slid it inside the old pipe. The use of electrofused joints assured a watertight seal. Finally, the contractor grouted any annular space between the old CMP and the new profile wall pipe.

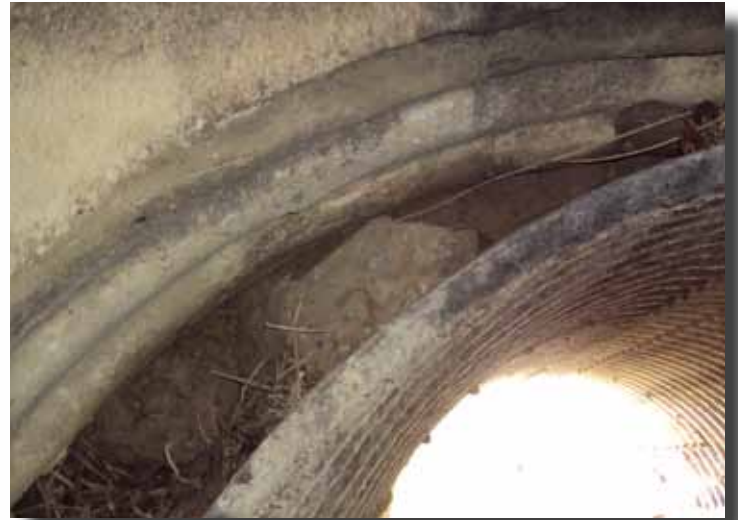
The old levee culvert was damaged and failing in several areas of the length of the pipe. Flooding was a concern.

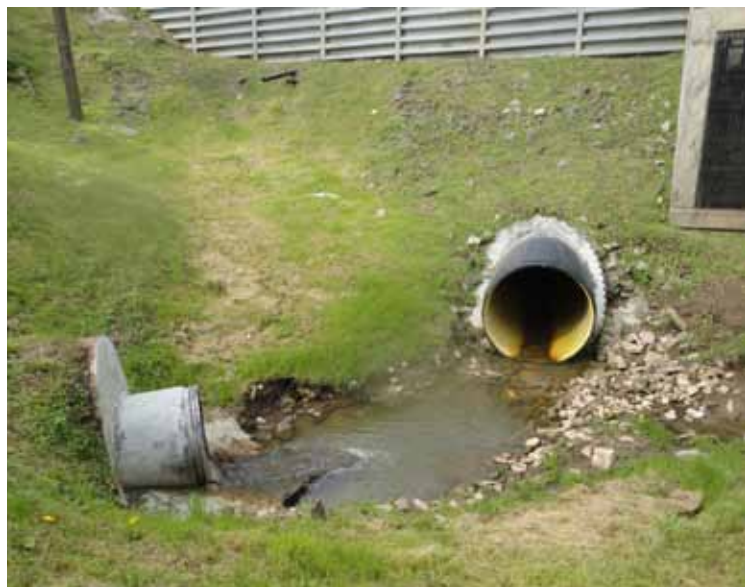
Once the culvert was relined, the flow through the culvert improved.

Relining the CMP culvert was the best option because it eliminated the need to dig and replace the old pipe. There was no excavation necessary of the pipe or the area surrounding the levee. Once the pipe was relined, the flow through the pipe was increased by 19 percent.
