Levee Pipe Relined with Large Diameter HDPE Pipe to Prevent Flooding

Prestonsburg, KY

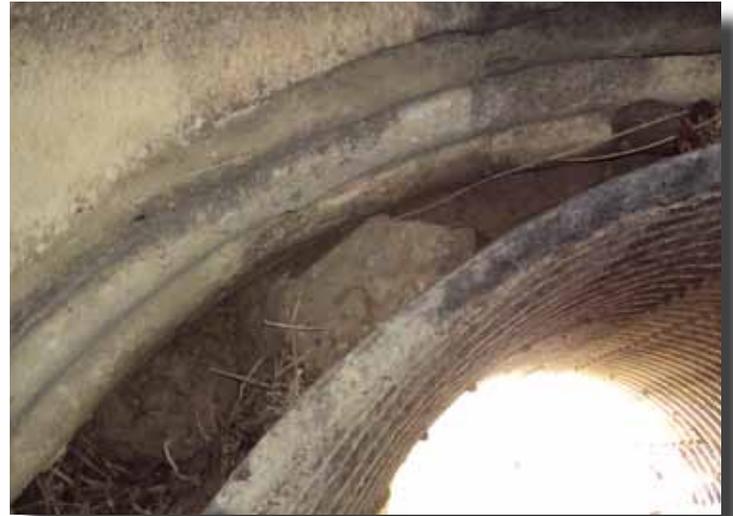
The poor condition of the 96-inch corrugated metal pipe (CMP) included several sections that were eroded or collapsing. If the pipe failed, which could happen at any moment in its current condition, the city would be flooded. A repair solution was urgent.

The old levee culvert was damaged and failing in several areas of the length of the pipe. Flooding was a concern.

Indiana Reline, the contractor, lined the 96-inch CMP with the 72-inch HDPE pipe. They electrofused the pipe at the joints and then slid it inside the old pipe. The use of electrofused joints assured a watertight seal. Finally, the contractor grouted any annular space between the old CMP and the new profile wall pipe.

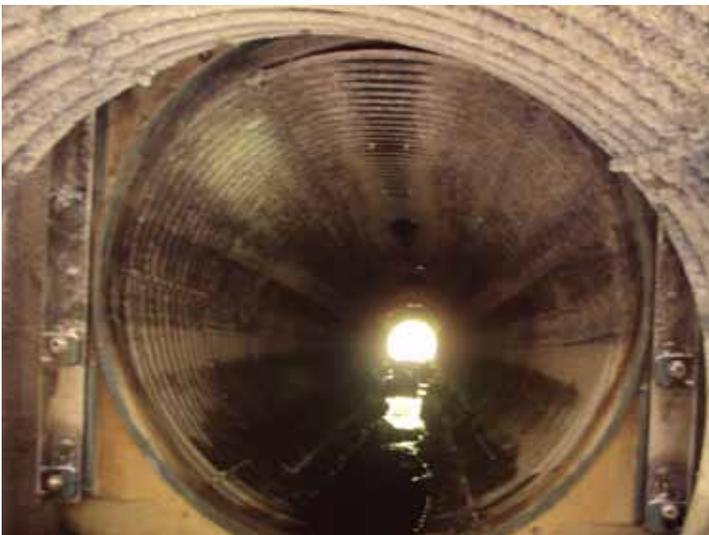
Parts of the old culvert were collapsing. Repair was essential to prevent flooding.

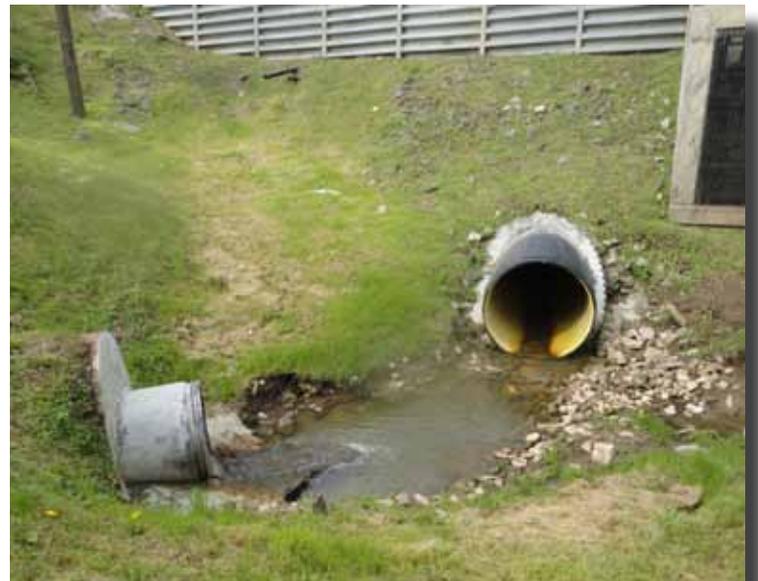
Once the culvert was relined, the flow through the culvert improved.

Relining the CMP culvert was the best option because it eliminated the need to dig and replace the old pipe. There was no excavation necessary of the pipe or the area surrounding the levee. Once the pipe was relined, the flow through the pipe was increased by 19 percent.
