## New Mexico DOT Saves Money and Time Relining Multiple Culverts with Snap-Tite HDPE Pipe

Carlsbad, NM

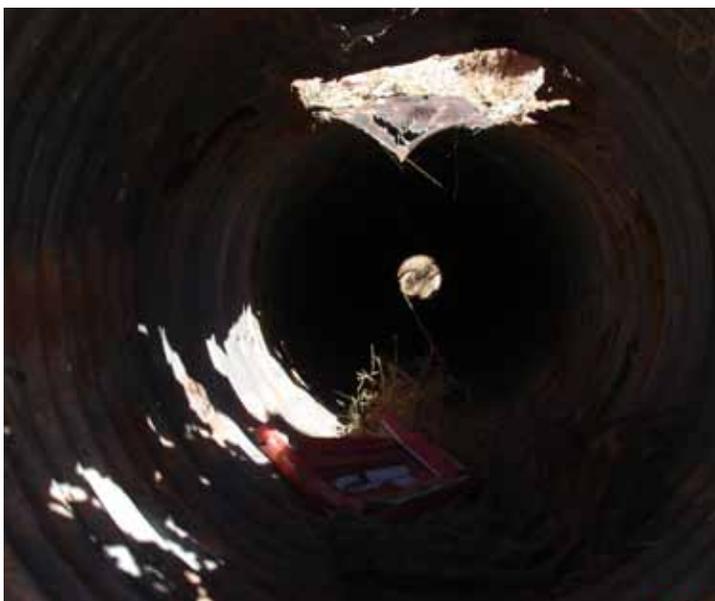
The New Mexico Department of Transportation (NMDOT) District Two was faced with multiple corrugated metal pipe (CMP) culverts along highway SR 31 that were rusting from the top down due to salts on the highway. Typically, CMP culverts corrode and deteriorate on the bottom first, but these were falling apart at the top, which meant the road was in great danger of collapse. In total, the NMDOT District Two needed to rehabilitate 13 CMP culverts ranging in diameters from 24 inches to 42 inches.

*A view of the culvert from the inside. Note the hole at the top where the culvert has completely deteriorated and caved in on itself.*

The Snap-Tite installation process usually involves snapping the Snap-Tite pipe ends together using only a come-along and chains, inserting the Snap-Tite liner into the old damaged culvert, and then filling in the annular space and any voids between the old CMP and new Snap-Tite liner with grout.

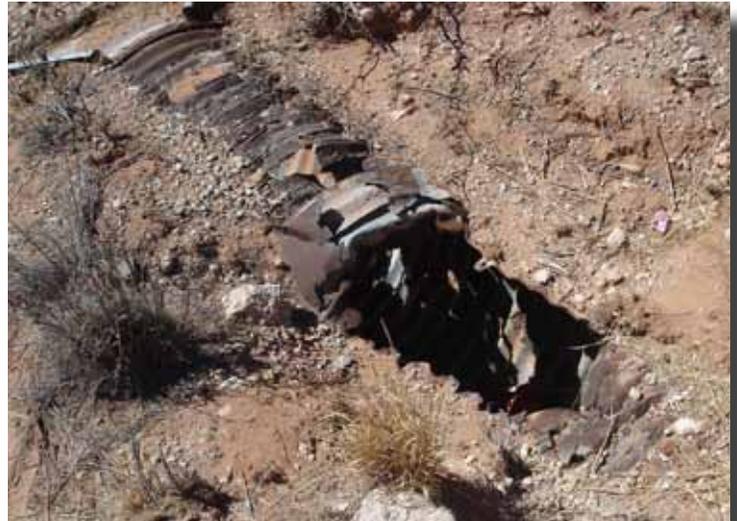
*One of the deteriorated culverts underneath SR 31. This one is severely rusted and eroded on top.*

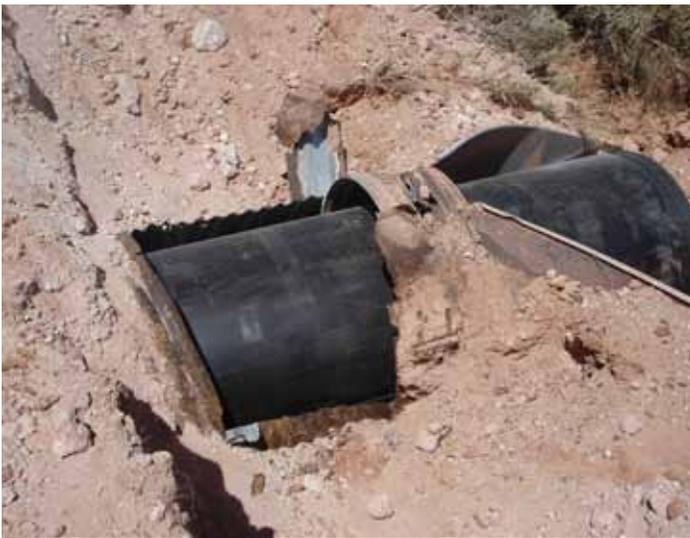
*The Snap-Tite liner lengths are snapped together onsite and slid inside the deteriorated culverts. The Snap-Tite liner is going into another culvert that has disintegrated on top.*

After installing several of the culverts, the DOT crew developed a system of using two back-hoes to snap the pipe together and to slide it inside the old culverts. Towards the end, they became fast and efficient at snapping and lining, so it only took about two weeks to reline and grout all the damaged culverts under the highway.

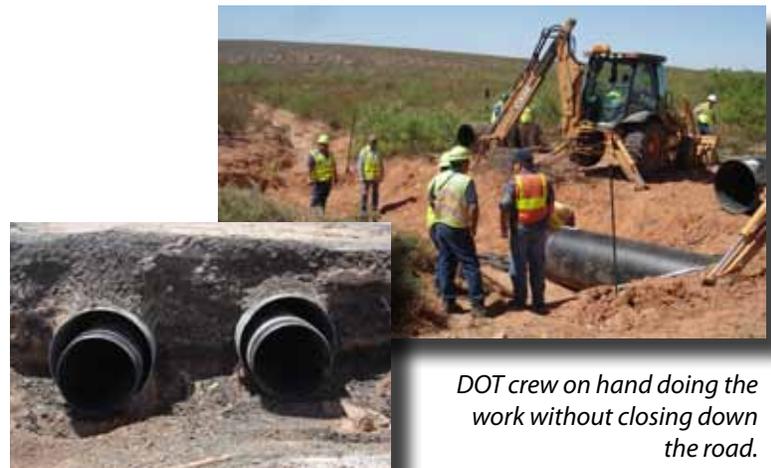
*Two culverts side-by-side with the Snap-Tite liner in place, awaiting grout.*

*DOT crew on hand doing the work without closing down the road.*
