## Columbia, KY RCP Culverts

### Abstract

The prime contractor for the Columbia Bi-Pass project for the Kentucky Department of Transportation District 8 faced an expensive problem with little time for decision making. This Field Report presents an existing application where an installation of a Reinforced Concrete Pipes (RCP) pipe just one year before was failing and rehabilitated using Snap-Tite HDPE Pipe.

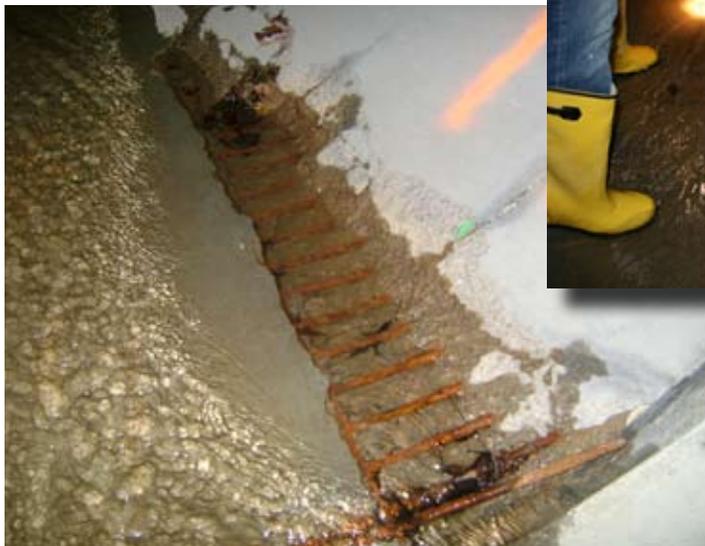
*You can see the cracking and exposed re-bar on the original RCP.*

Cracking along the parts of the culvert were popping up, along with exposed re-bar inside the pipe. The joints started to separate, exposing the gaskets. On the southbound pipe the water on the inlet side was actually flowing under the first two sections of the RCP pipes. And, in one part of the northbound pipe, the RCP had collapsed over eight inches. At this rate, the culvert was due to collapse at any moment.

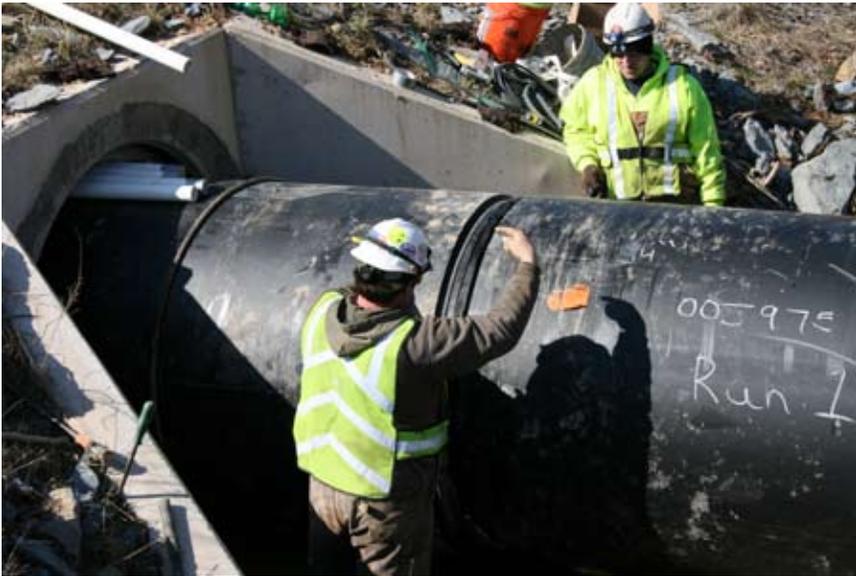
Harrington then brought in Chris Wisheart with Indiana Reline to perform the installation. The contractor, with the approval from District 8, decided to proceed with Snap-Tite as its method of choice for the application. Snap-Tite and Indiana Reline moved quickly to build the pipe, ship it, snap it and install it

and cables. "Hot soils" do not affect Snap-Tite, as the HDPE pipe works well in any pH range, with no corrosion.

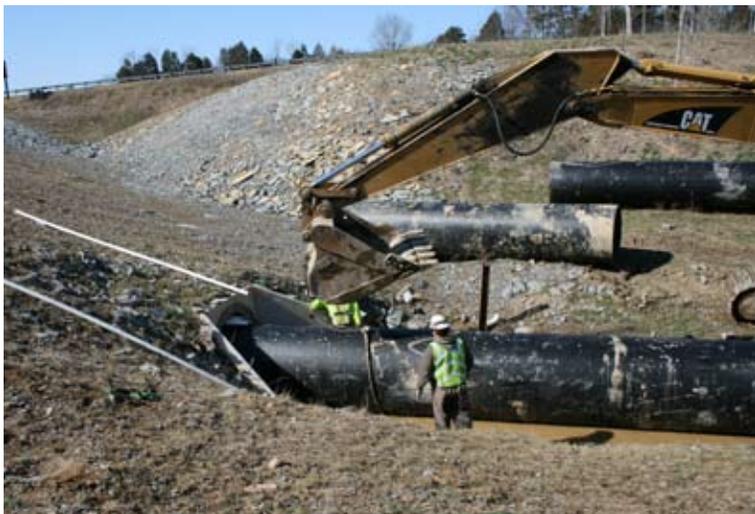
*The completely rehabilitated culvert.*

They then grouted the liner into place a few days later, completing the project with a culvert better than before and with increased flow capabilities.
