## North Carolina City Saves Money by Relining Culvert with Snap-Tite® Pipe

*Gastonia, North Carolina*

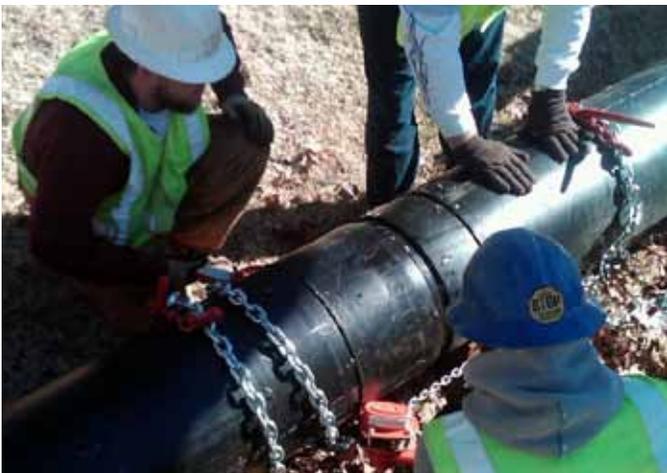
*The city's crew used come-a-longs and chains to join the sections of Snap-Tite pipe liner together before slipping the pipe into the old culvert.*

Two 21-foot sections and one 11-foot section of 16-inch diameter Snap-Tite® pipe were used to reline the 18-inch CMP. The city's crew used come-alongs and chains to join the Snap-Tite® pipe. After each section was joined, the liner was to be inserted into the existing CMP. However, an unseen bend in the 18-inch CMP pipe required some quick field alterations. The crew cut a bullet nose out of one end of the first section of Snap-Tite® pipe. The

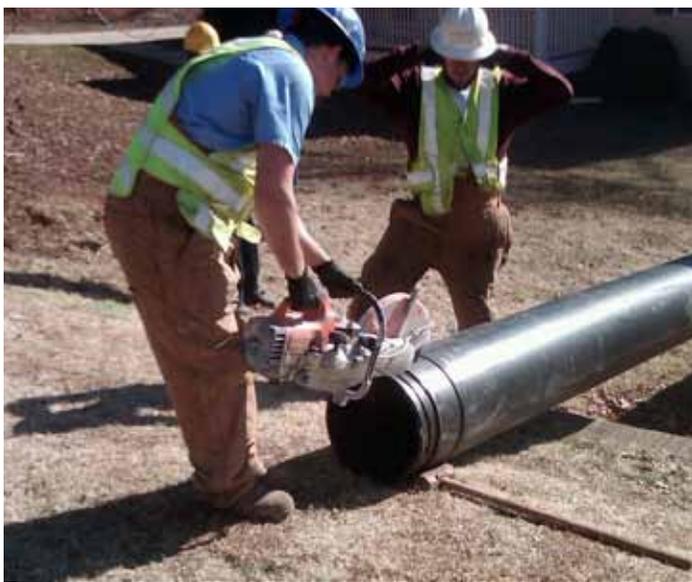
*The city's crew cuts a bullet nose into one end of the 18-inch Snap-Tite pipe liner in order to slip the liner into the deflected old CMP culvert.*

bullet nose reduced the outside diameter of the Snap-Tite® pipe end enabling the liner to successfully navigate through the deformation in the old pipe. The process of joining the Snap-Tite® liner and inserting it into an existing pipeline is repeated until the failing culvert is completely relined.
