## Culvert Below Highway Entrance Ramp Fails, Relined with No-Dig Snap-Tite®

Greensburg, PA

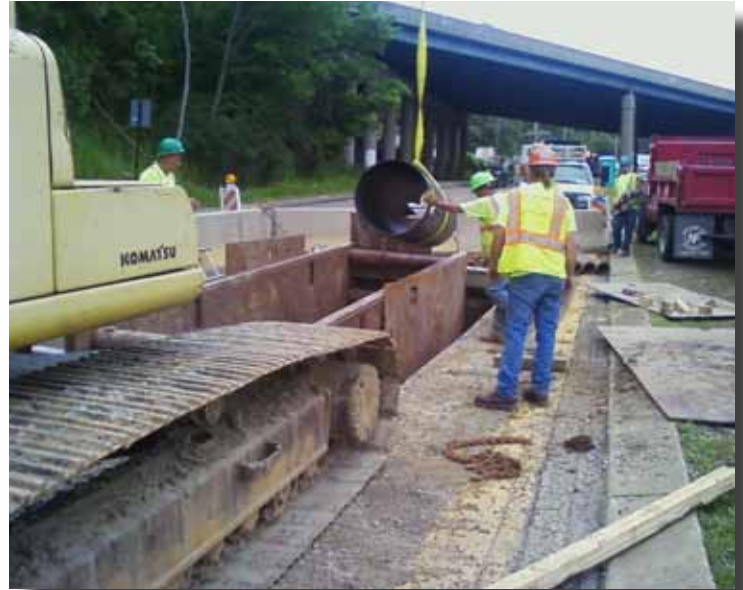
*One section of the Snap-Tite pipe is lowered down to begin the reline process.*

The culvert reline had to take place in a trench box, which limited the length of the pipe sections to nine feet. It took 10 minutes per joint to snap the pieces together. No specialty equipment is required to snap the pipe sections together during installation. Often the pipe can be snapped using only a come-along and chains. First, one of the pipe sections is inserted into the old culvert. Then the next section of Snap-Tite® pipe is snapped onto the first section. Finally, the sections are slid inside the old culvert and another section is snapped on until the culvert is fully lined with the Snap-Tite® pipe.

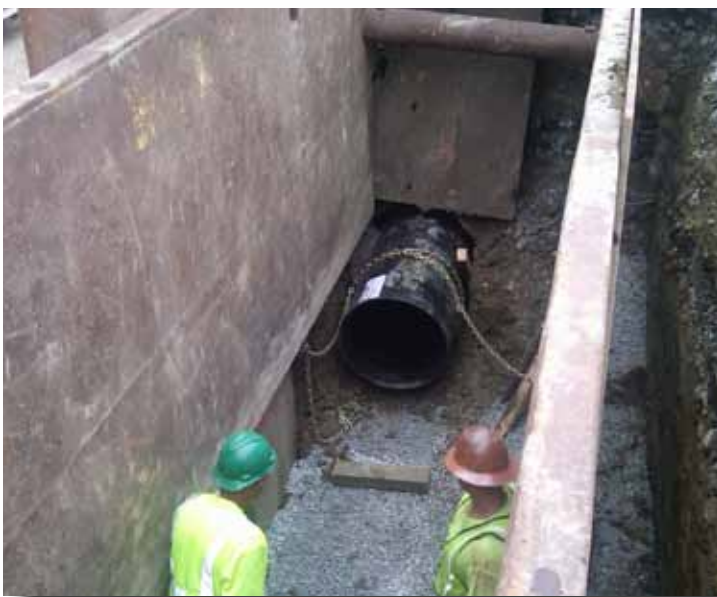
*The Snap-Tite® pipe section is pushed inside the old culvert and then will be snapped to another end of Snap-Tite® pipe using only a come-along and chains.*
