Louisville Levee Culvert Relined with Snap-Tite

Louisville, KY

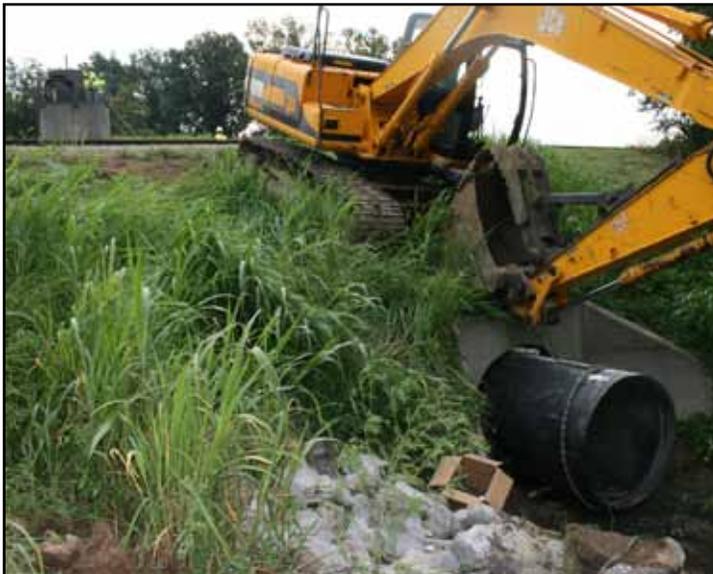
The Snap-Tite pipe was snapped together and slid inside the old levee culvert. In the background, the Hydro-Bell is being lifted into the gate house. Once inside the gate house, the Hydro-Bell was attached to the Snap-Tite pipe liner.

Temple & Temple was able to install the new culvert liner and Hydro-Bell in two days. First, Temple & Temple slid one section of the 48-inch Snap-Tite pipe liner into the old levee culvert. Then they snapped the ends of the Snap-Tite pipe sections together using come-alongs and chains and pushed the rest of the pipe liner into the culvert until it was fully lined. Neither the levee nor the railroad that ran above the culvert were disturbed during this process.

The Hydro-Bell was then lowered into an opening on top of the gate house, and down into it, in order to attach it to the Snap-Tite pipe liner already installed inside the old culvert. The Hydro-Bell was extrusion welded onto the Snap-Tite pipe inside the gate house.

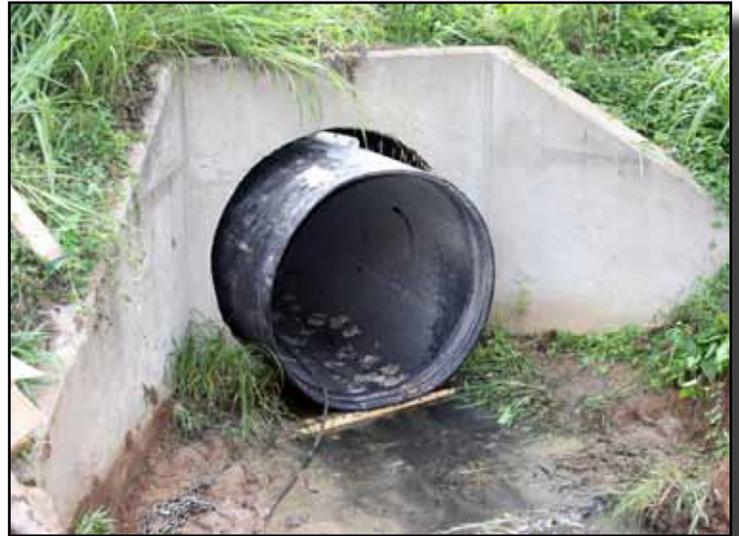
The Snap-Tite pipe is slid inside the old culvert. Once it is fully installed, grout will be used to fill in any annular space between the old culvert and new pipe.

Finally, any annular space between the old culvert and new Snap-Tite pipe liner was filled in with grout. The installation was a success and MSD was happy with the material.

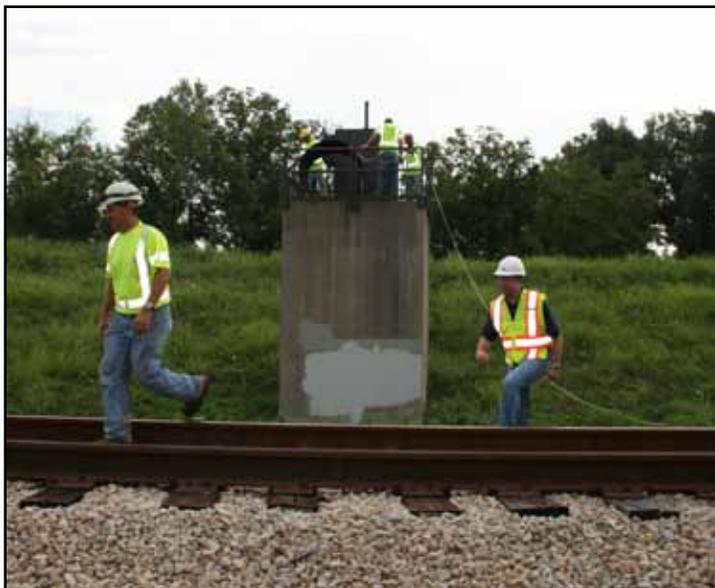
A closer look at the Hydro-Bell as it is lowered down into the gate house. The gate house is on the opposite end of the railroad tracks from where the liner was slid inside the old culvert.
