Snap-Tite Pipe Relines Culvert in Oklahoma, Keeps Residential Street Traffic Moving During Installation

McAlester, Oklahoma

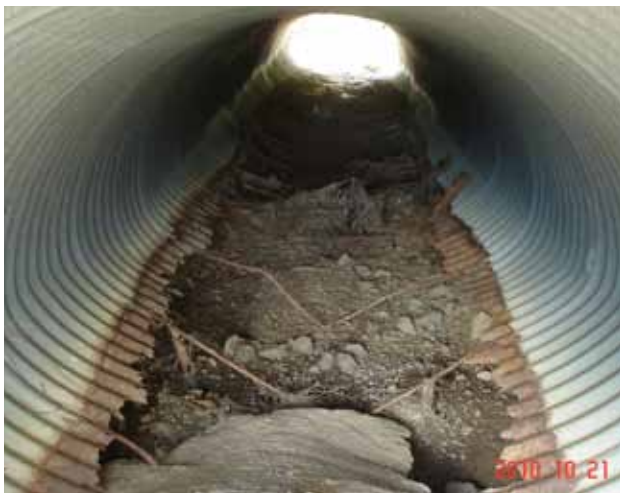
Corrugated metal pipe (CMP) culverts are failing at an alarming rate throughout the U.S. These culverts were installed 40 to 50 years ago and have exceeded their design life. The City of McAlester, Oklahoma needed to fix a rusted and oval (49 inches by 33 inches) CMP culvert that was also partially missing its bottom. This CMP was located on a residential street, which was the only road leading into a subdivision. Digging up the road would have prevented access for many homeowners.

Before: the damaged CMP before it is relined.
