Culvert in Arizona Relined with Snap-Tite®, Local Environment Protected

Organ Pipe Cactus National Monument, Arizona

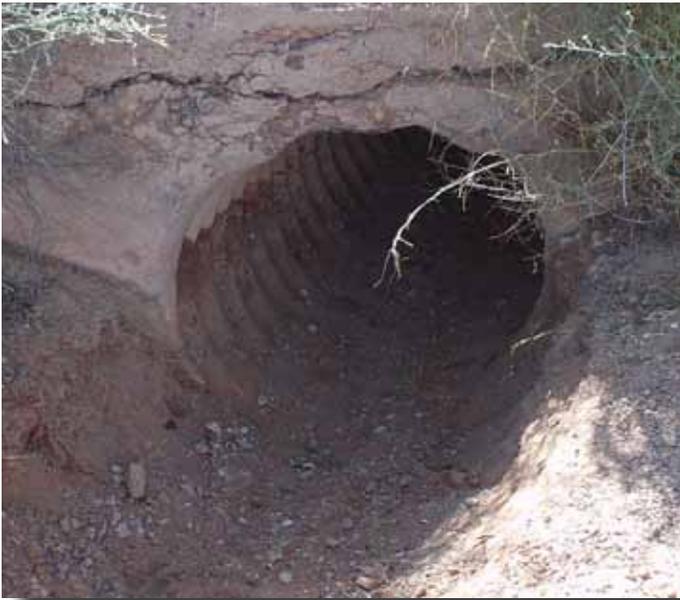
The deteriorated corrugated metal culvert in need of repair.

The contractor chosen for the project was Technology Construction Inc. Marcos Nattress, project manager with Technology Construction, worked with Snap-Tite representative Michael Harriman to develop a solution for the culvert repair. Harriman suggested the use of 14-inch DR 32.5 high-density polyethylene (HDPE) Snap-Tite pipe to reline the existing damaged culvert, therefore eliminating the need to dig and replace the current culvert.

It took only one day to line the deteriorating 18-inch CMP with the 14-inch Snap-Tite pipe. The grouting between the liner and the old culvert was completed one week later when the rest of the road work was complete.

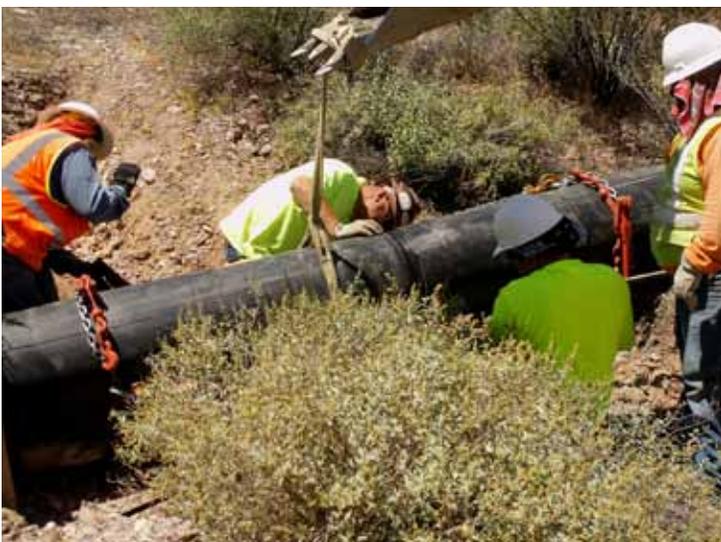
Snap-Tite's unique "snap" joint does not require any mechanical joints or a fusion process to join the pipe, increasing the speed and ease of installation. As each Snap-Tite pipe length is slid into place, the male end is connected to the female end of the preceding pipe section. The pipe, once slid inside of the old culvert, is then grouted into place. The Snap-Tite joint also features a water tight gasket to withstand the grouting application. In addition, once lined with Snap-Tite, the culvert has an increased flow rate even though the diameter of the pipe is smaller than before.

The Snap-Tite pipe 'snap' taking place on location at the culvert relining.
