## Residential Street Spared with Snap-Tite® Culvert Reline

Santee, CA

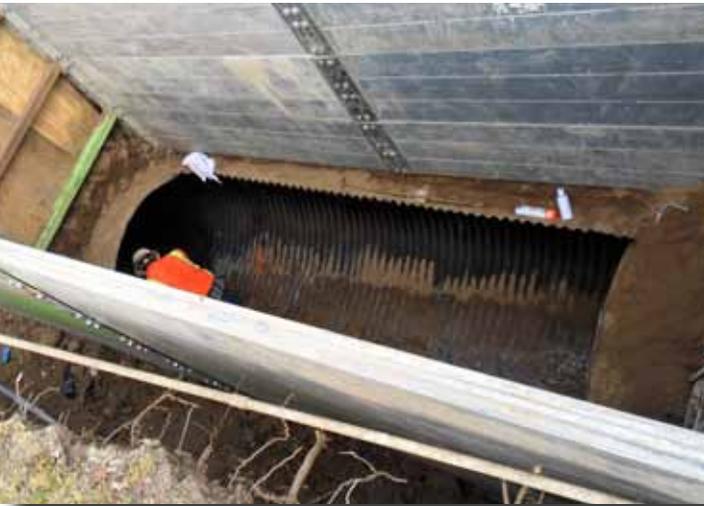
*The pit where the deteriorated culvert needed to be relined.*

The City of Santee, California needed to repair two failing 72-inch corrugated metal pipe (CMP) culverts located near a homeowner's yard. Both culverts had deteriorated and one even started to cave-in on itself, forming a large sinkhole. The sinkhole disrupted water service to approximately 30 residents and initially blocked access to the road leading into the residential cul-de-sac. The sinkhole grew to 20 to 30 feet wide and four to six feet deep.

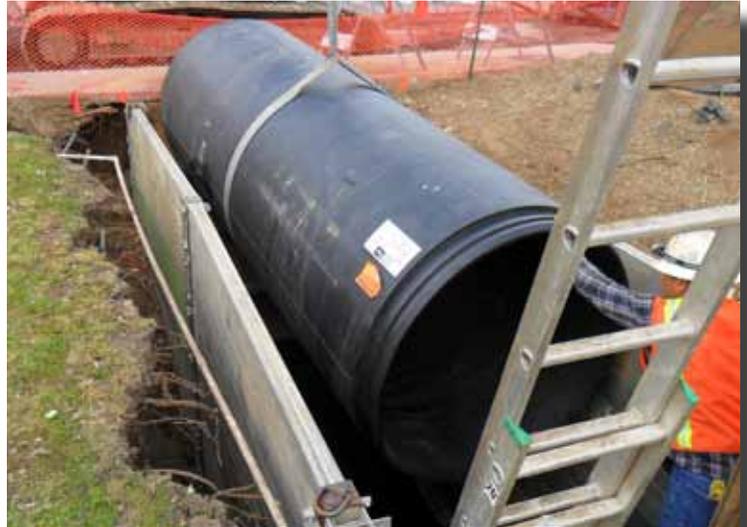
*Snap-Tite® pipe is lowered into the pit in order to reline the old CMP culvert.*

The pipe liner chosen for the project was 54-inch Snap-Tite®. The only way not to disturb the road or the residential property was to install the new liner inside a small pit. Typically, a Snap-Tite® installation occurs on the side of the road to reline a culvert, also avoiding the need to dig up a road.

In this case, eleven-foot sections of Snap-Tite® pipe were lowered into the pit. The pit was approximately 10-feet deep, 13-feet long and eight-feet wide. The Snap-Tite® pipe liner could not be snapped outside of the pit because there was no room to wrap the chains around and to place the come-alongs on the outside of the pipe. So the pipe was “snapped” inside the pit with the come-alongs and chains, which were attached to a bar the contractor manufactured for each end of the pipe.

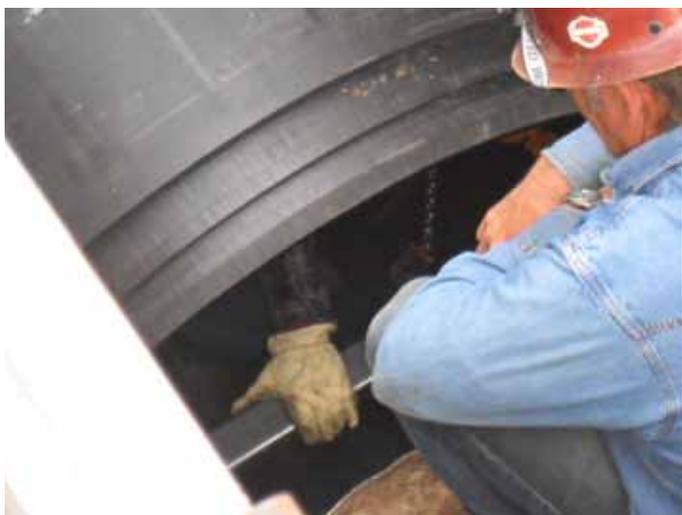
*The Snap-Tite® pipe liner ends are snapped on the inside of the pit and then pushed through the old pipe to reline it.*

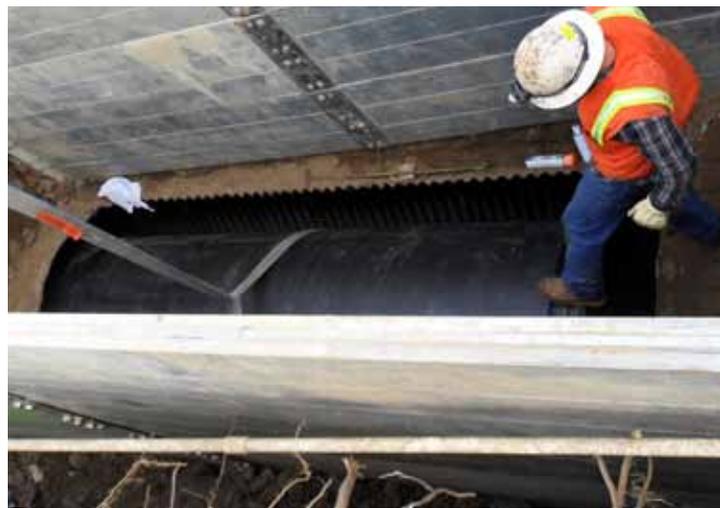
*A pipe liner section is pushed through the old existing pipe so that another Snap-Tite® section can be snapped together.*
