## Snap-Tite® Pipe Relines Damaged Culvert Under Entrance to Texas DOT Maintenance Yard

Stanton, TX

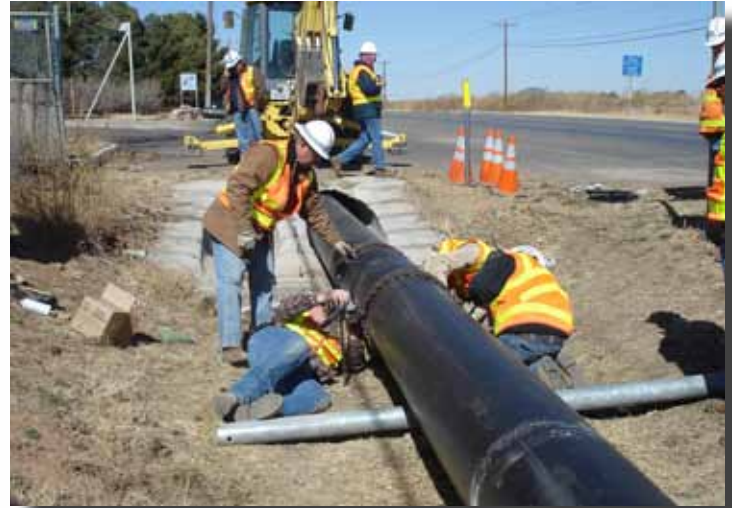
*DOT maintenance crew snaps the culvert liner pipe together with come-alongs and chains.*

The no-dig HDPE Snap-Tite® culvert-lining pipe, which has a patented male/female machining at each end of the HDPE, is 'snapped' together, piece-by-piece, and pushed into the full length of an existing pipe. Any annular space and voids between the old culvert and new liner are filled in with grout.

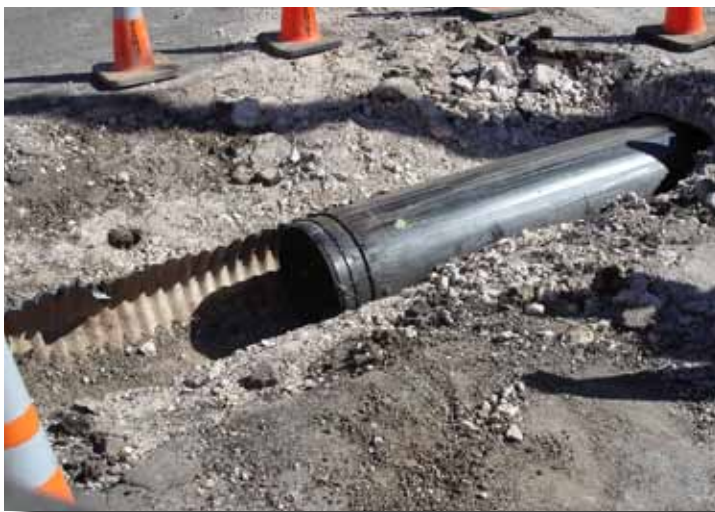
*Pipe liner going in where old CMP has completely deteriorated.*

All the equipment that was required to snap the pipe liner pieces together were come-alongs and chains. Once the Snap-Tite® pipe liner lengths were snapped together, the crew pushed the joined liner through the old CMP culvert and then filled in any annular space with grout.

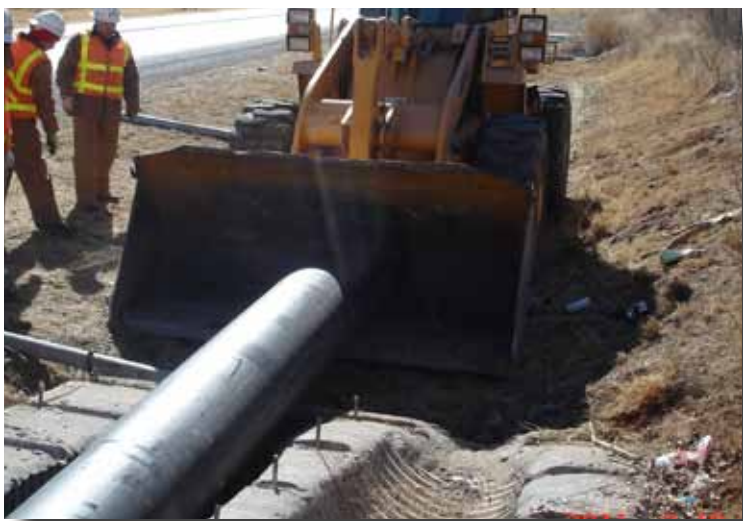
*The last section of Snap-Tite® pipe liner is pushed in through the length of the old deteriorated pipe after it is snapped together with one already partially inside the old pipe.*

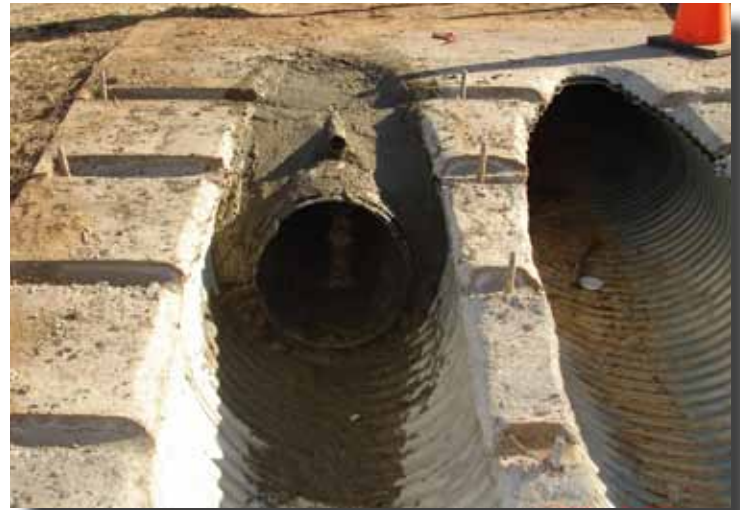
*The new Snap-Tite® pipe liner installed and grouted.*

The pipe lining of the old culvert began at 9:30 a.m. and was completed in one day. The grouting process took place the following day. The TXDOT maintenance crew was able to do the work themselves without having to hire contractors, saving the Odessa District time and money. The entire installation was a success.
