New Pipe Technology Helps Fish and Aquatic Life Swim Upstream

Halton Region, Ontario, Canada

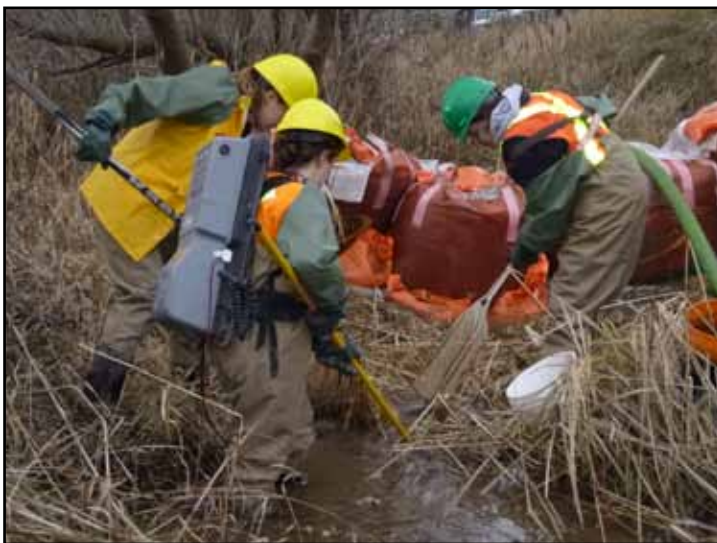
The fish extraction specialist is shocking the water to stun the fish and bring them to the surface so they can be netted and relocated.
