Snap Tite®

Field Report

PENNSYLVANIA DEPARTMENT OF TRANSPORTATION USES SNAP-TITE TO SAVE NEARLY \$9 MILLION ON I-99 CULVERT REHABILITATION

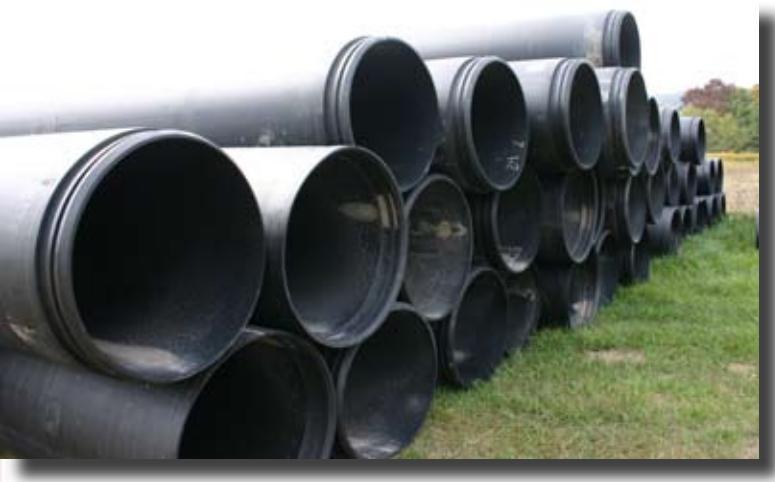
Snap-Tite pipe waiting for installation.

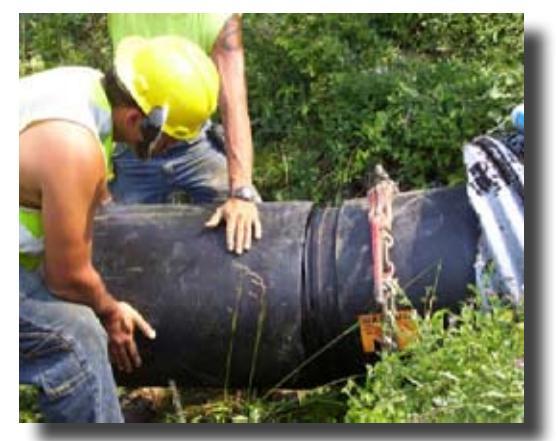
Snapping together.

The sections of Snap-Tite were shipped to the jobsite with machined ends already completed. They were then placed horizontally to the roadway at each culvert. Once the host pipe was ready to be lined, a section of Snap-Tite was aligned with the pipe and partially inserted into the pipe. The next section of pipe was then aligned with the pipe, a lubricant was sprayed on the ends of the pipe and a rubber gasket was added. The pipes were then simply snapped together with a come along. The result is a water-tight joint with inside and outside diameters that are the same as those of the pipe. This means there will be no flow restrictions or coupling hang-ups.

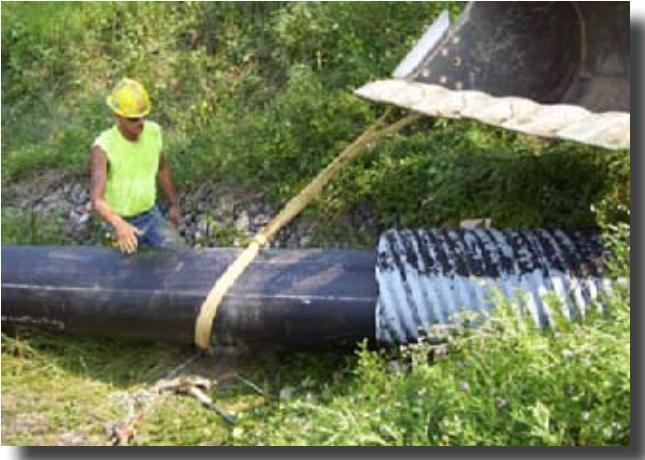
Snap-Tite pushed into place.

The pipe was then pushed or pulled through the deteriorated host pipe. This procedure was repeated until the entire pipe was lined. Bulkheads were then constructed at each end of the pipe. Then a flowable fill grout was then pumped around the HDPE pipe and the host pipe. Enough grout was pumped into the annular space to fill all the voids that had been created by the water escaping from the host pipe. Savings for the project compared to traditional open cut methods amounted to almost \$9 million. These savings took into consideration expenses needed for pipe installation, traffic control and user delay costs.

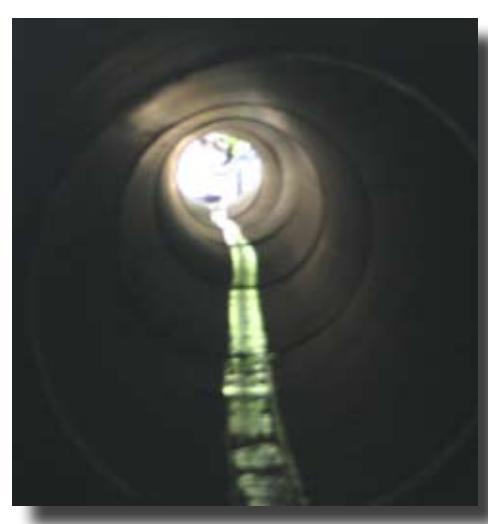
Water flowing through the completely rehabbed culvert.
