Field Report

Three Damaged Culverts Beneath Railroad Tracks Relined with Snap-Tite®

Coffeyville, Kansas

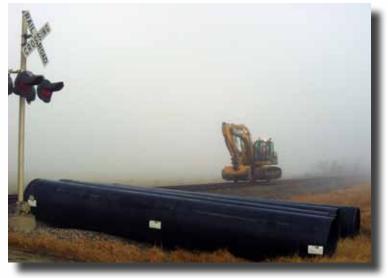
High railing the excavator to the project site. The excavator is used to push the pipe into the culvert.

The railroad company's crew set up to reline the culverts with 42-inch outside diameter Snap-Tite pipe. Since the repairs were taking place in a somewhat remote location, an excavator and other supplies were brought to the site using a method called "high railing." This method entails driving the equipment down the railroad tracks to the site.

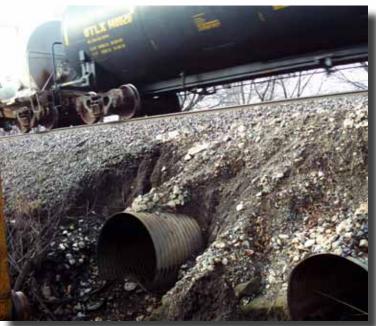
The corrugated metal pipe culverts were in bad shape and needed to be replaced without disrupting the rail service.

Drainage culverts installed 40 - 50 years ago are now past their design life and failing. Union Pacific (UP) Railroad, a major U.S. railroad, needed to replace three failing culverts underneath its railroad tracks near Coffeyville, KS. The three corrugated metal pipe (CMP) culverts were completely worn out. Leaving them in this condition might result in a total track collapse, disrupting service. Each of the old culverts was approximately 50 feet in length and 48 inches in diameter.

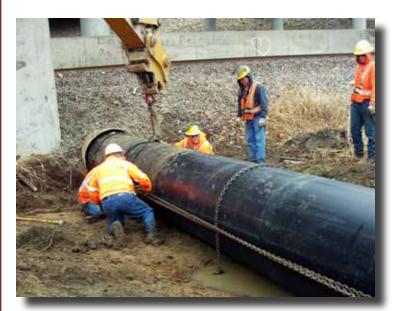
A section of Snap-Tite is pushed inside the old culvert and then snapped together at the machined ends.

For each of the culverts, the crew started with one standard 24-foot section of Snap-Tite pipe. Snap-Tite pipe comes in lengths from two to fifty feet, depending on the needs of a project and the space available to snap the pieces together. The crew slid the first 24-foot section into the old culvert, making sure part of it remained outside of the pipe. Then they snapped another section of Snap-Tite pipe using only come-a-longs and chains. Then the joined section was slid further inside the pipe until the old pipe was fully lined. This was done in the same way for each of the culverts. Finally, any annular space or voids was filled in with grout, resulting in three fully rehabbed culverts.
