Snap-Tite® Chosen as a Quick, Cost-Effective Solution for Denver's Southeast Metro Stormwater Authority

South Metro Denver, Colorado

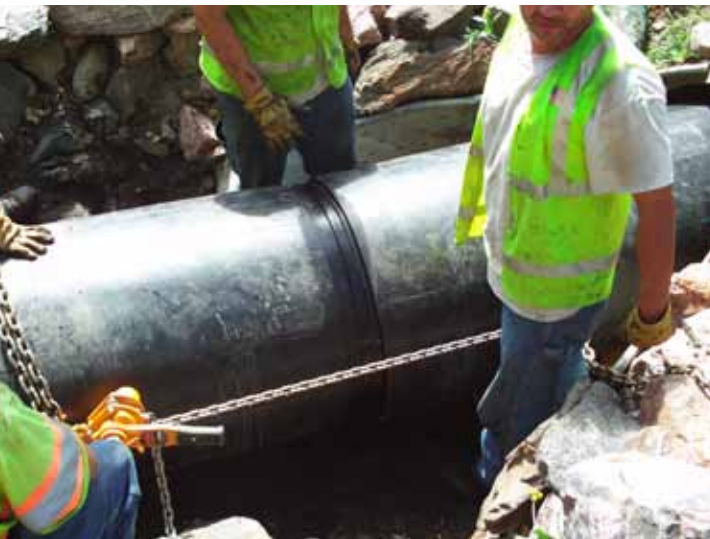
SEMSWA crews join the Snap-Tite pipe sections using a come-along and chains.

The SEMSWA crews were able to quickly move the 30-inch Snap-Tite pipe in place for lining the CMPs using a mini excavator. For each of the culverts, one section of Snap-Tite pipe was slid inside the old culvert. Then the next section was snapped on using a come-along and chains. This process was repeated for each culvert until the liner was in place from end-to-end. Finally, grout was used to fill in any annular space between the old wood culverts and the new pipe liner.

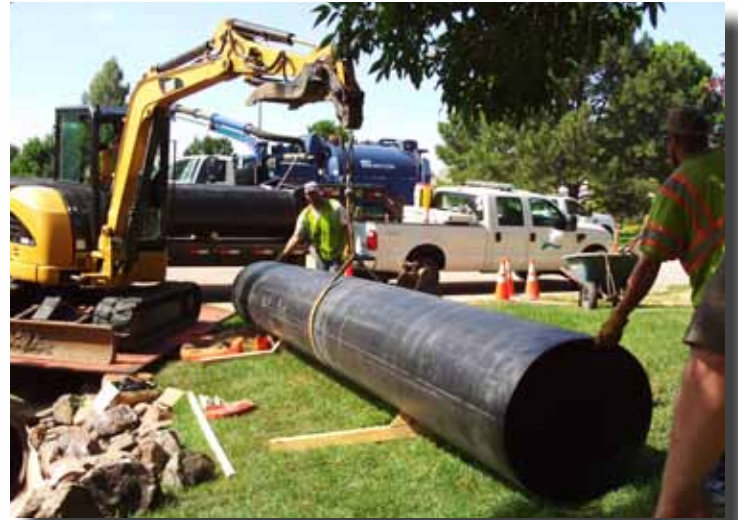
The Snap-Tite pipe is moved in place to line the old CMP using a mini excavator.

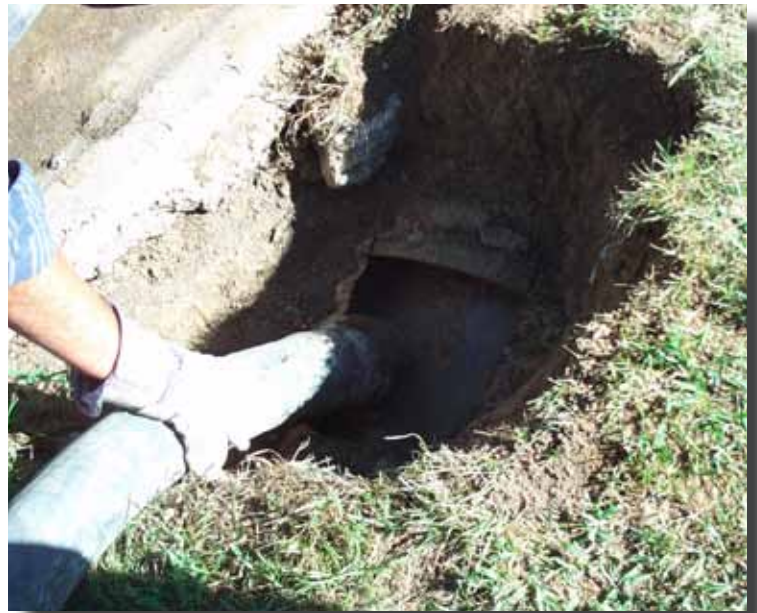
Any annular space between the old CMP and the Snap-Tite pipe liner is filled in with grout.
