## Colorado Wood Culverts from the 1920s Relined with Snap-Tite® Pipe

*Unawep Canyon, Mesa County, Colorado*

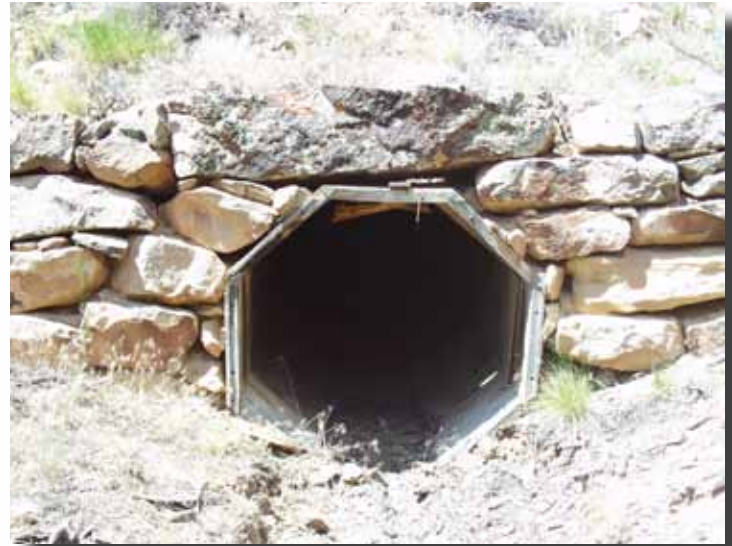
The Colorado Department of Transportation (CDOT) was resurfacing and fixing parts of Highway 141 in Unawep Canyon. Located south of Grand Junction up in Unawep Canyon, there were four 36-inch octagonal wood culverts underneath a two-lane highway. These culverts were installed sometime in the 1920s and were completely worn. Leaving them "as is" for much longer meant the entire road could collapse. In addition, there was minimal access to the wood culverts because they

*One of the octagonal wood culverts installed in the 1920s. This one measured 36 inches in diameter.*

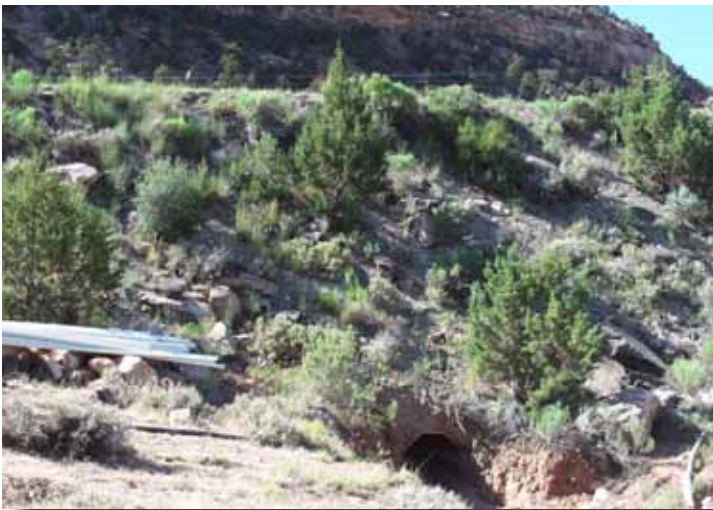
were underneath about 60 feet of fill. Digging and replacing the culverts would be costly and force a shut down of the highway, which is the only road running through the canyon. The CDOT needed a no-dig solution that would allow them to repair the wood culverts without closing down the road during the project.

*Here is an example of the 60-feet of deep fill (cover) over the wood culverts that was too cumbersome to dig.*

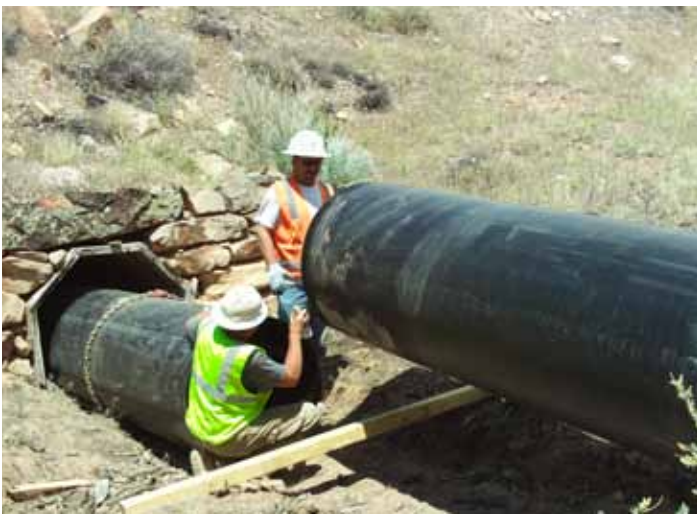
The crew is prepping the 30-inch Snap-Tite pipe for another joining.

There was no need to use specialty equipment on the project installation. To join the pipe, the contractor only needed to use a come-along and chains. Wosk was also onsite to assist the contractor and answer any questions about the joining process.

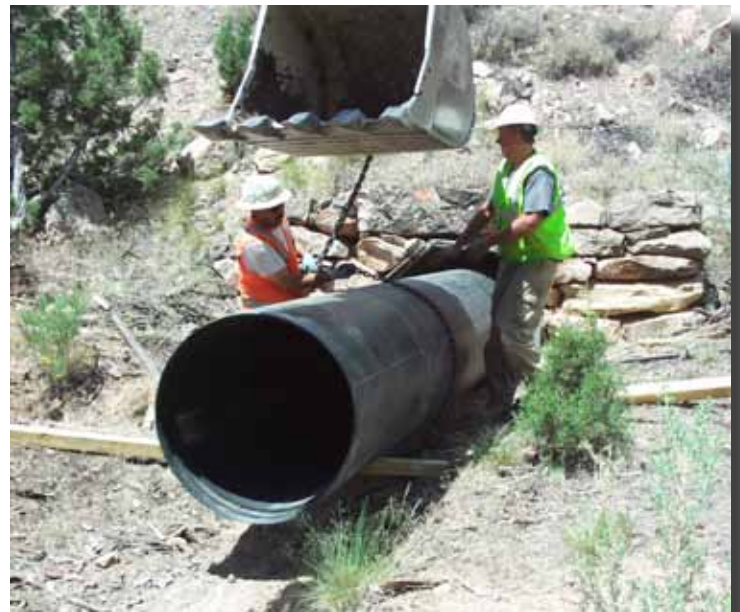
The Snap-Tite pipe is pushed inside the old culvert. Once the snapped liner is slid in place, any annular space between the liner and culvert is filled in with grout.

For each of the culverts, one section of Snap-Tite pipe was slid inside the old culvert. Then the next section was snapped on using the come-along and chains. This process was repeated for each culvert until the liner was in place from end-to-end. Finally, grout was used to fill in any annular space between the old wood culverts and the new pipe liner.
