## Mississippi DOT District Relines Culvert with Snap-Tite® Pipe

*White Oak, Mississippi*

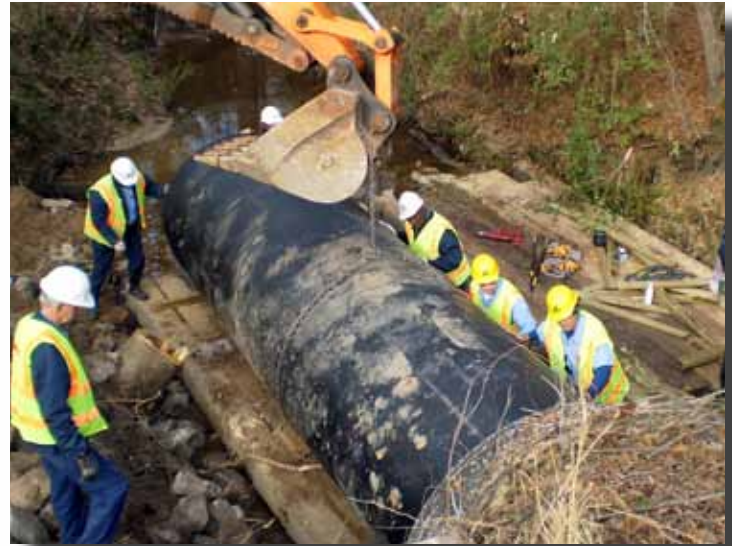
*The Snap-Tite® pipe is slid inside the old CMP culvert.*

The high-density polyethylene (HDPE) Snap-Tite® pipe has a patented male/female machining at each end of the pipe sections. The machined sections are 'snapped' together, piece-by-piece, and pushed into the full length of an existing pipe. Any annular space and voids between the old culvert and new liner are filled in with grout. The pipe liner is available in lengths from two feet to 50 feet, and is available for culverts with diameters from eight inches to 84 inches. Snap-Tite® also meets American Association of State Highway and Transportation Officials (AASHTO) Standard M326 for rehabilitating culverts.

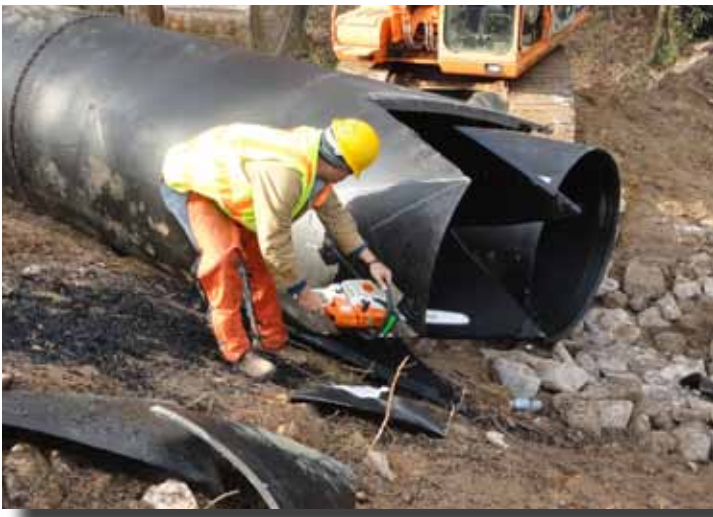
*A DOT maintenance worker cuts a bullet nose on one end of a Snap-Tite® pipe section.*

The day of the installation, one of the damaged culverts deflected down to only a 59-inch opening. Harrington suggested cutting one end of the Snap-Tite® pipe into a bullet nose, a method used to push a Snap-Tite® liner into a deflected culvert.

On site, the DOT crew cut the bullet nose on one end of a section of Snap-Tite® pipe in order to get it through the deflection of the old pipe. Once the bullet nose pushed through past the deflection point, the rest of the pipe slid through the old pipe with ease.

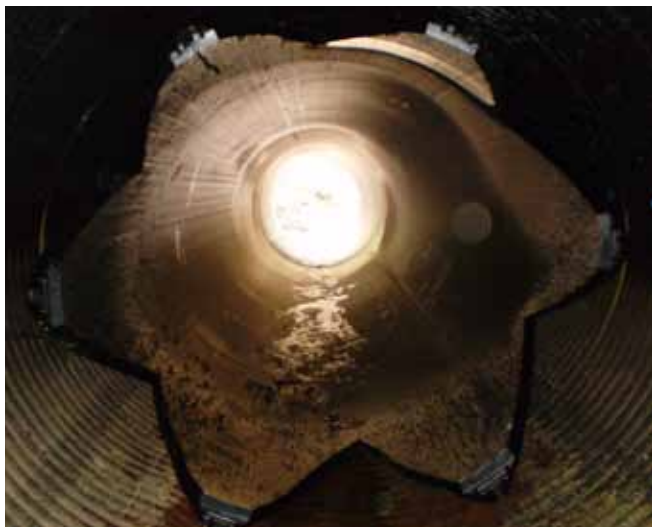
*The bullet nose Snap-Tite® end of the pipe is slid through the deflected old culvert.*

"I was amazed with the strength and durability of the Snap-Tite® liner, yet it was flexible enough to conform to the shape of the deflected host pipe," said Dugas. "We field-cut a bullet-nose with relative ease, and the 63-inch liner slid right through a problem joint with only 59 inches of clearance. The joints are solid, with absolutely no infiltration, and the ease with which they snapped together was unexpected."

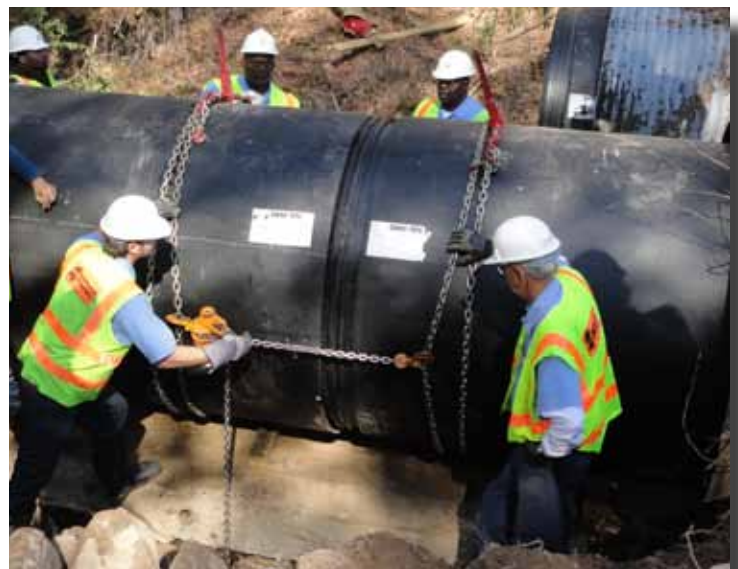
*The Snap-Tite® pipe ends are snapped together using only a come-a-long and chains.*

Then to snap the sections of Snap-Tite® pipe together, the crew only needed to use chains and a come-a-long. There was no specialty equipment required.

"We experienced a few growing pains during our first snap, but subsequently became rather proficient at the process, accomplishing most snaps in less than 15 minutes, most of which was manipulating the pipe into place and placing chains and come-a-longs," added Dugas. "Snap-Tite® is strong yet flexible. The joints are solid and snap together with relative ease. We are pleased with the performance of Snap-Tite® in this application."
