## ARIZONA DEPARTMENT OF TRANSPORTATION USES SNAP-TITE FOR CULVERT REHABILITATION

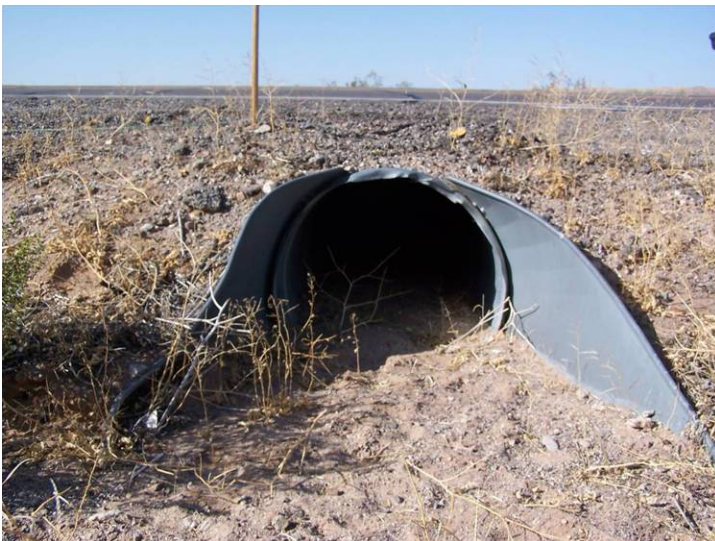
*The outside of the culvert to be rehabilitated.*

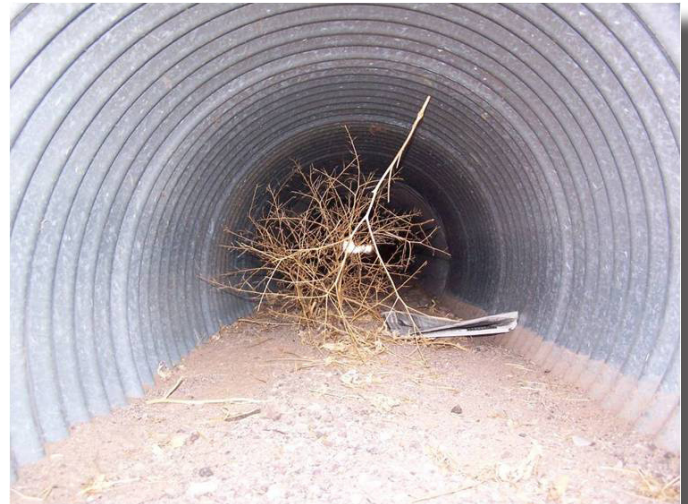
*With 8" – 10" of sediment inside the 30" CMP, the culvert had to be cleaned prior to installation of 24" Snap-Tite pipe.*

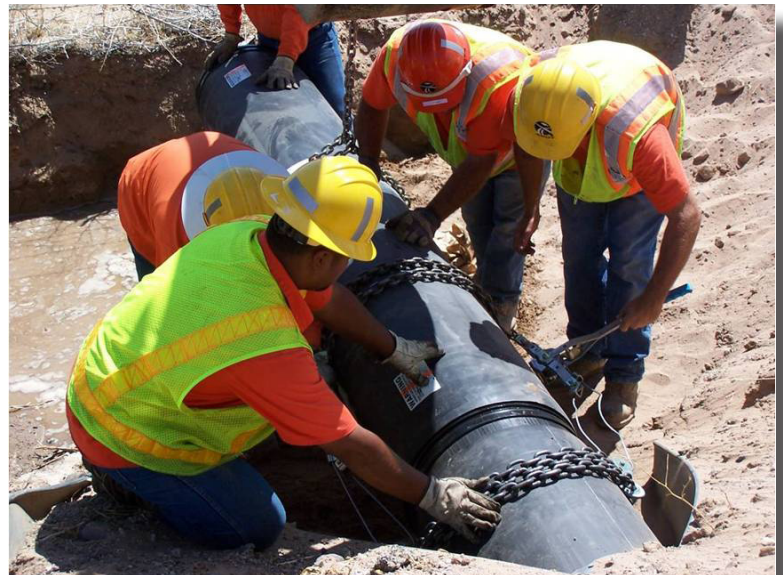
The Snap-Tite lining system is joined together with a machined joint on the ends of the pipe with the inclusion of a gasket. It is simply snapped together. The resulting joint is water-tight with an inside and outside diameter the same as that of the pipe. This means there will be no flow restrictions or coupling hang-ups during the installation process.

*The Snap-Tite pieces mechanically connect with chains & come-a-longs.*

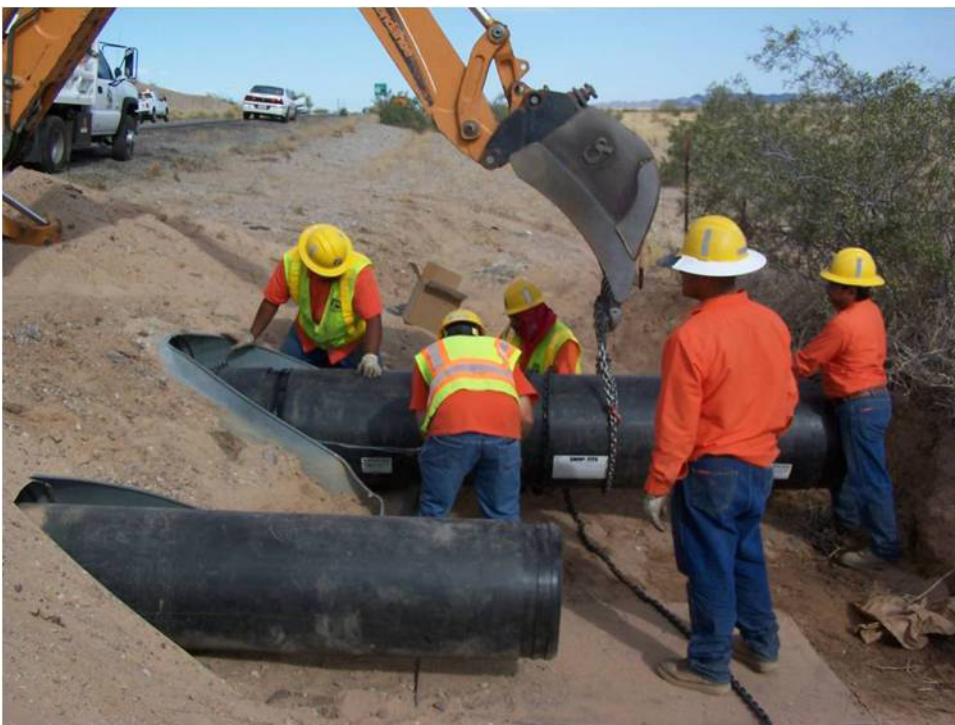
*Equipment used to align pipe.*
