ARIZONA DEPARTMENT OF TRANSPORTATION USES SNAP-TITE FOR CULVERT REHABILITATION

Abstract

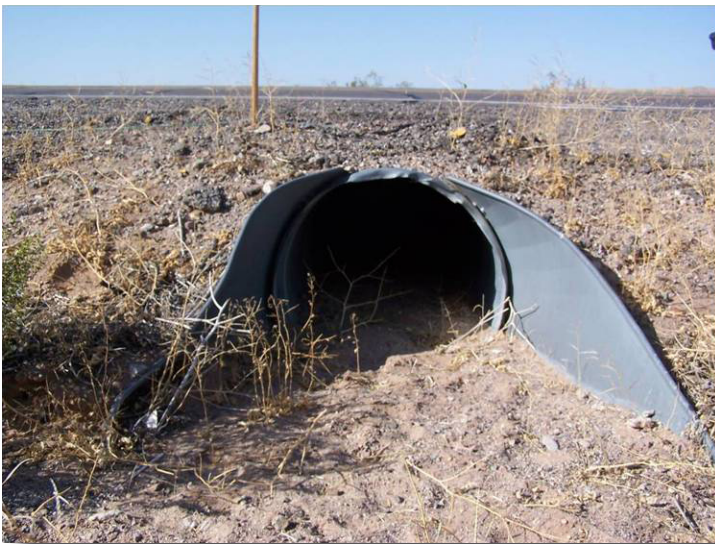
The outside of the culvert to be rehabilitated.

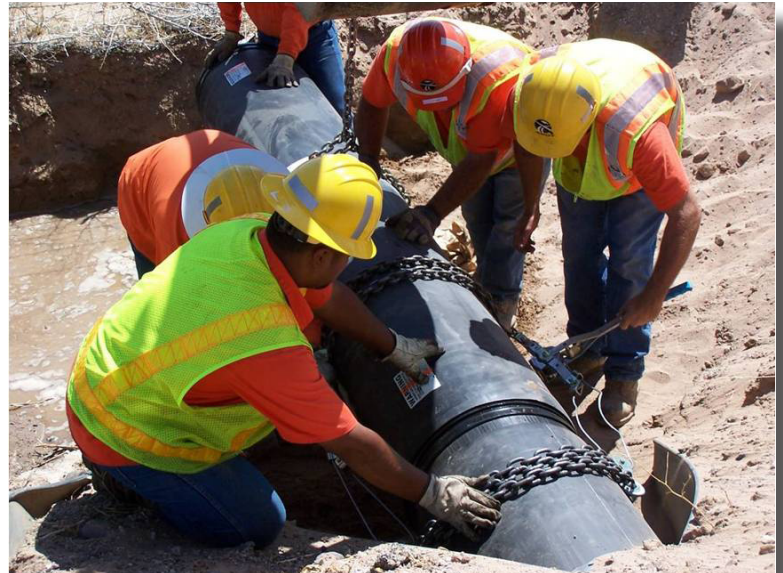
The Snap-Tite pieces mechanically connect with chains & come-a-longs.

The Snap-Tite lining system is joined together with a machined joint on the ends of the pipe with the inclusion of a gasket. It is simply snapped together. The resulting joint is water-tight with an inside and outside diameter the same as that of the pipe. This means there will be no flow restrictions or coupling hang-ups during the installation process.
