## Colorado Wood Culverts from the 1920s Relined with Snap-Tite® Pipe

*Unawep Canyon, Mesa County, Colorado*

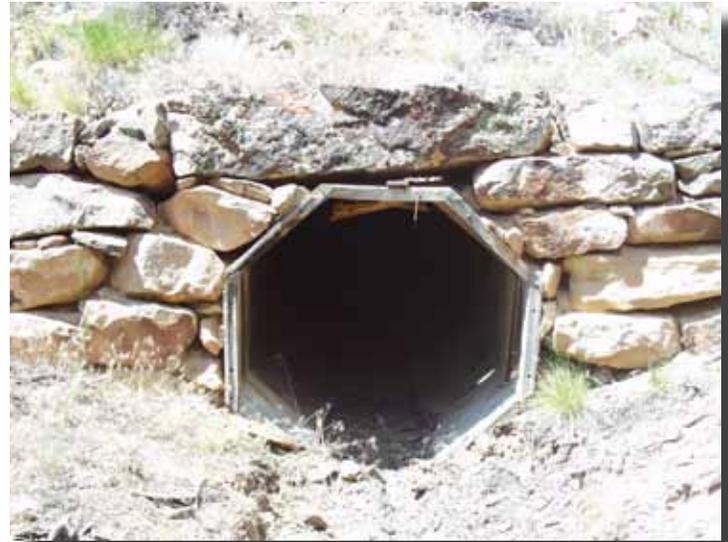
*One of the octagonal wood culverts installed in the 1920s. This one measured 36 inches in diameter.*

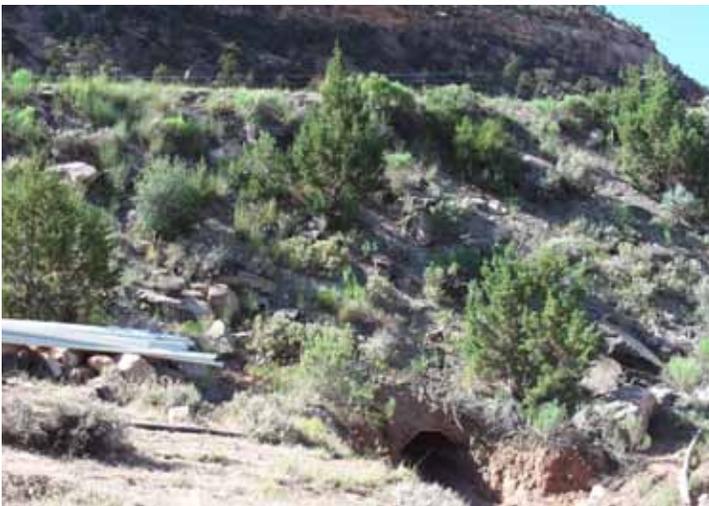
*Here is an example of the 60-feet of deep fill (cover) over the wood culverts that was too cumbersome to dig.*

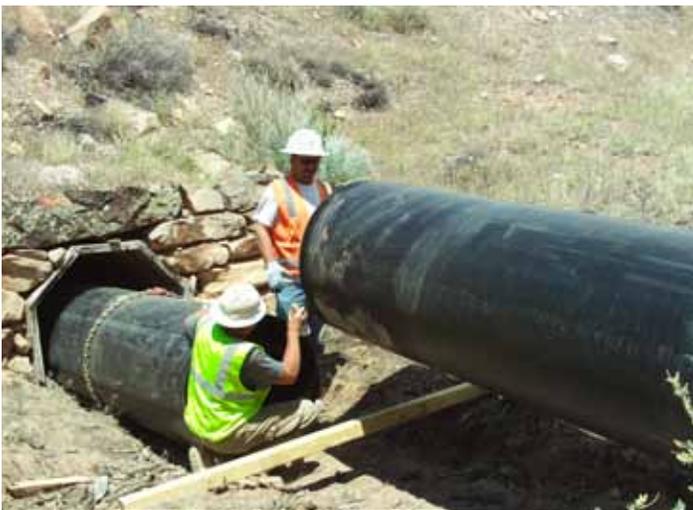
*The crew is prepping the 30-inch Snap-Tite pipe for another joining.*

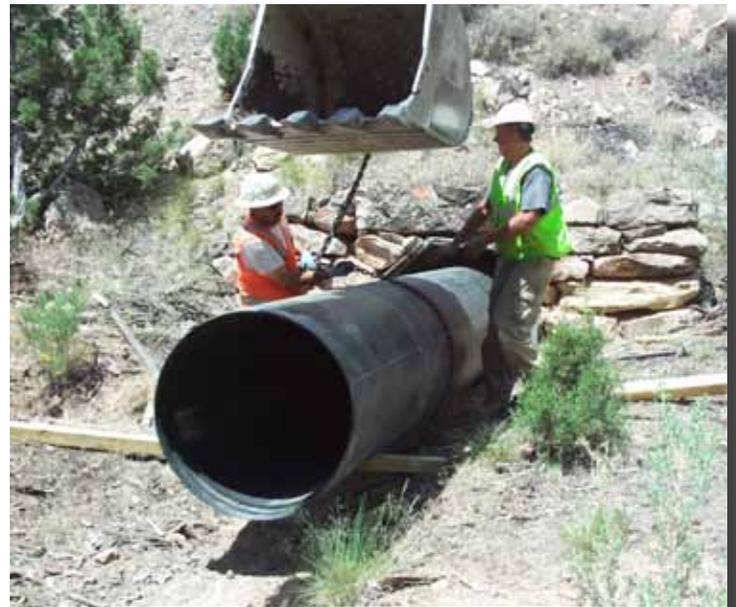
*The Snap-Tite pipe is pushed inside the old culvert. Once the snapped liner is slid in place, any annular space between the liner and culvert is filled in with grout.*

For each of the culverts, one section of Snap-Tite pipe was slid inside the old culvert. Then the next section was snapped on using the come-along and chains. This process was repeated for each culvert until the liner was in place from end-to-end. Finally, grout was used to fill in any annular space between the old wood culverts and the new pipe liner.
