Mississippi DOT District Relines Culvert with Snap-Tite® Pipe

White Oak, Mississippi

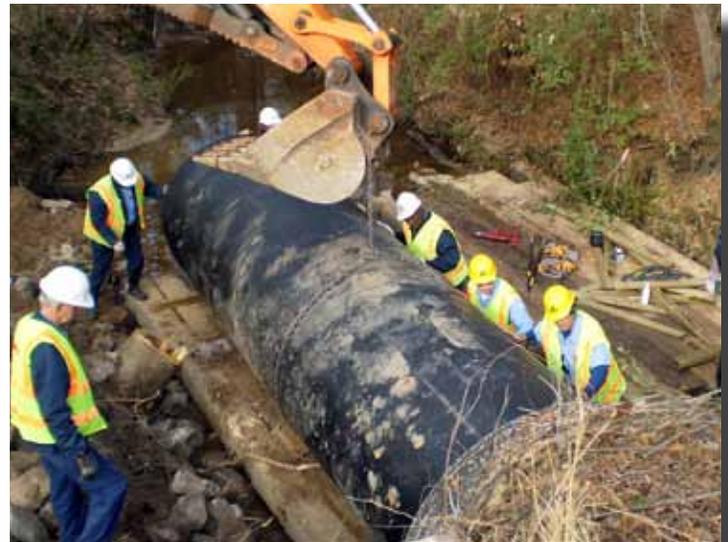
The Snap-Tite® pipe is slid inside the old CMP culvert.

The high-density polyethylene (HDPE) Snap-Tite® pipe has a patented male/female machining at each end of the pipe sections. The machined sections are 'snapped' together, piece-by-piece, and pushed into the full length of an existing pipe. Any annular space and voids between the old culvert and new liner are filled in with grout. The pipe liner is available in lengths from two feet to 50 feet, and is available for culverts with diameters from eight inches to 84 inches. Snap-Tite® also meets American Association of State Highway and Transportation Officials (AASHTO) Standard M326 for rehabilitating culverts.

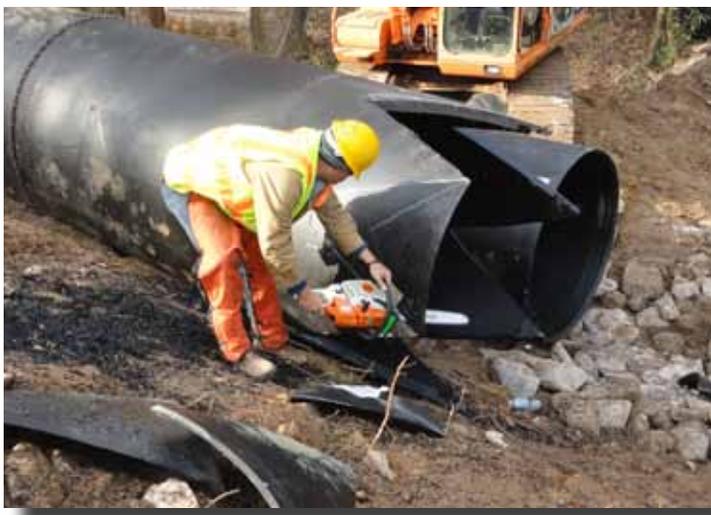
A DOT maintenance worker cuts a bullet nose on one end of a Snap-Tite® pipe section.

The day of the installation, one of the damaged culverts deflected down to only a 59-inch opening. Harrington suggested cutting one end of the Snap-Tite® pipe into a bullet nose, a method used to push a Snap-Tite® liner into a deflected culvert.

On site, the DOT crew cut the bullet nose on one end of a section of Snap-Tite® pipe in order to get it through the deflection of the old pipe. Once the bullet nose pushed through past the deflection point, the rest of the pipe slid through the old pipe with ease.

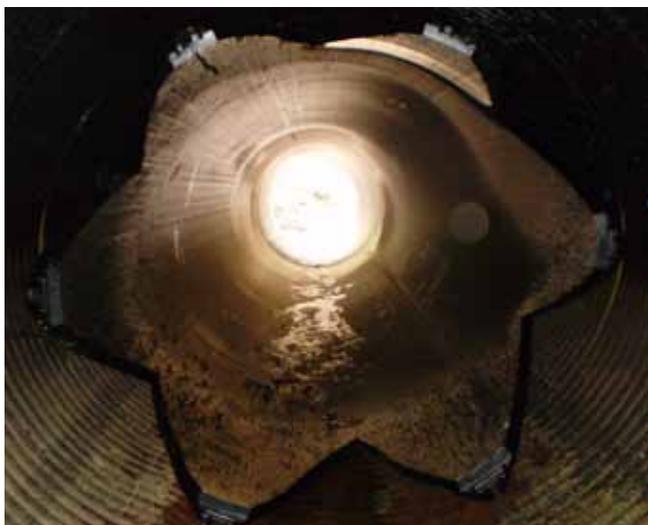
The bullet nose Snap-Tite® end of the pipe is slid through the deflected old culvert.

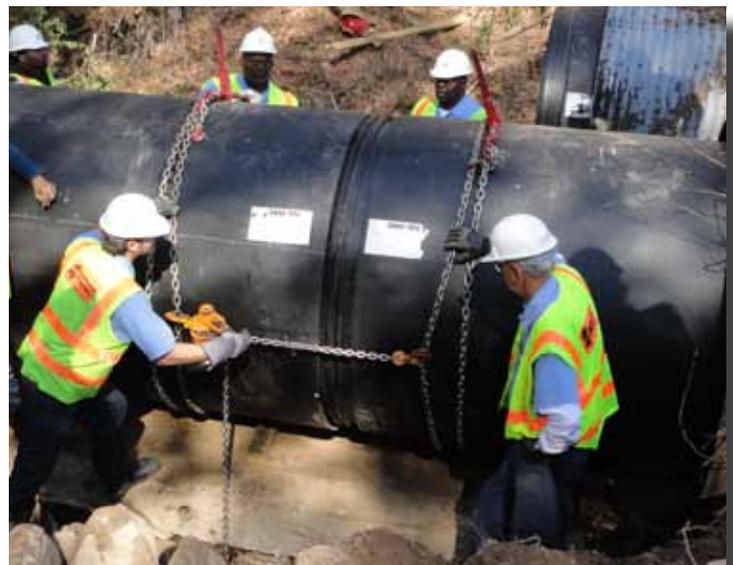
The Snap-Tite® pipe ends are snapped together using only a come-a-long and chains.

Then to snap the sections of Snap-Tite® pipe together, the crew only needed to use chains and a come-a-long. There was no specialty equipment required.
